HAZARDOUS MATERIALS SURVEY AND 2022 REASSESSMENT 52 UNIVERSITY PRIVATE, OTTAWA, ON

Project No.: Z2021101HZ / CCC-230252-00

University of Ottawa

McIntosh Perry Limited (MPL)

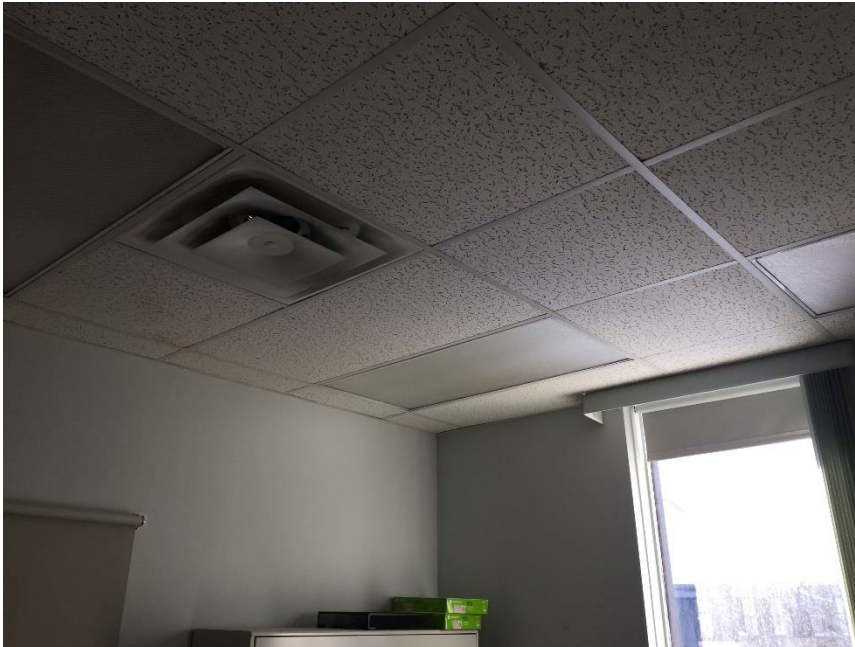
- Suspended ceiling tiles (2' X 4' pinholes varying sizes with medium fissures) were observed in various locations. The laboratory analytical results of ceiling tile samples collected from Room 105 indicate that this material does not contain asbestos.
- Suspended ceiling tiles (2' X 4' pinholes with large fissures) were observed in various locations. The laboratory analytical results of ceiling tile samples collected from Room 111 indicate that this material does not contain asbestos.

Photo 1: Typical view of non-asbestos-containing suspended ceiling tiles with medium fissure observed within Room 105.

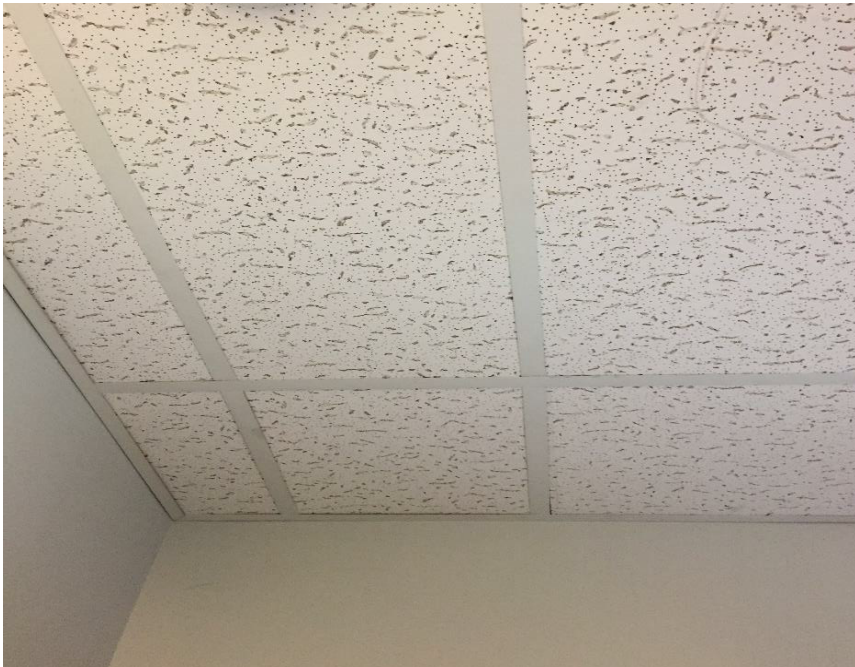
Photo 2: Typical view of non-asbestos-containing suspended ceiling tiles with large fissures observed within Room 111.

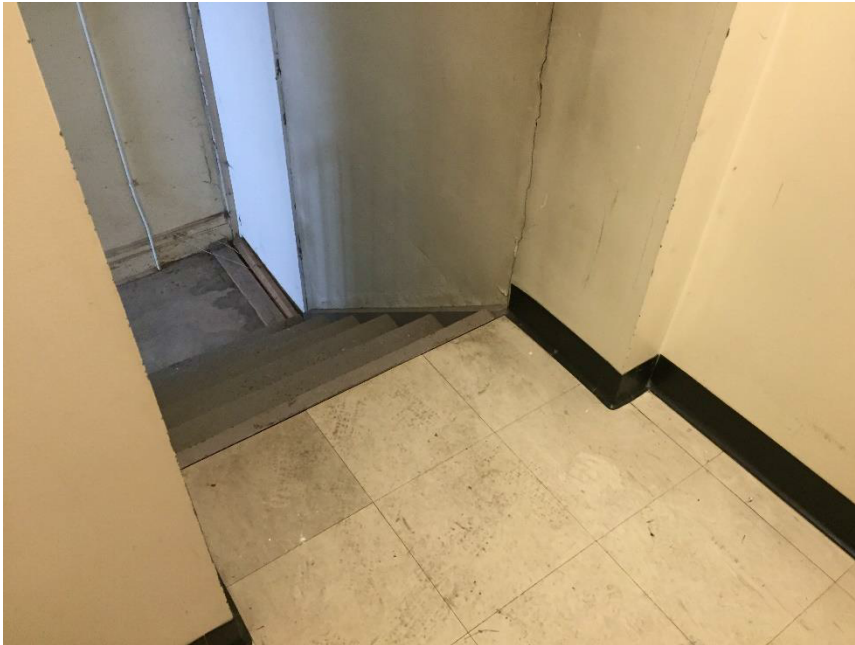
- Vinyl floor tiles (12" x 12" – Beige with brown streaks) were observed in Room 106. The laboratory analytical results of the vinyl floor tile samples collected from the Room 106 indicate that this material contain **2% Chrysotile asbestos** and considered non friable. This material was observed in good condition. The associated mastic (black) was found not to contain asbestos.
- Vinyl floor tiles (12"x12" – White and grey flakes) were observed and previously sampled in Room 110. The laboratory analytical results of the samples collected indicated that this material contains **17.2% Chrysotile asbestos** and considered non friable. This material was observed in good condition.

Photo 3: View asbestos-containing vinyl floor tile (beige with brown) within Room 106

- Materials identified to contain asbestos that are in good condition and do not pose a risk to workers or occupants can be managed in place. Prior to renovation/demolition activities that may disturb the ACMs, these materials must be removed following appropriate Type 1/2/3 asbestos abatement work procedures as detailed in O. Reg. 278/05 and disposed of as asbestos waste under O. Reg. 347;

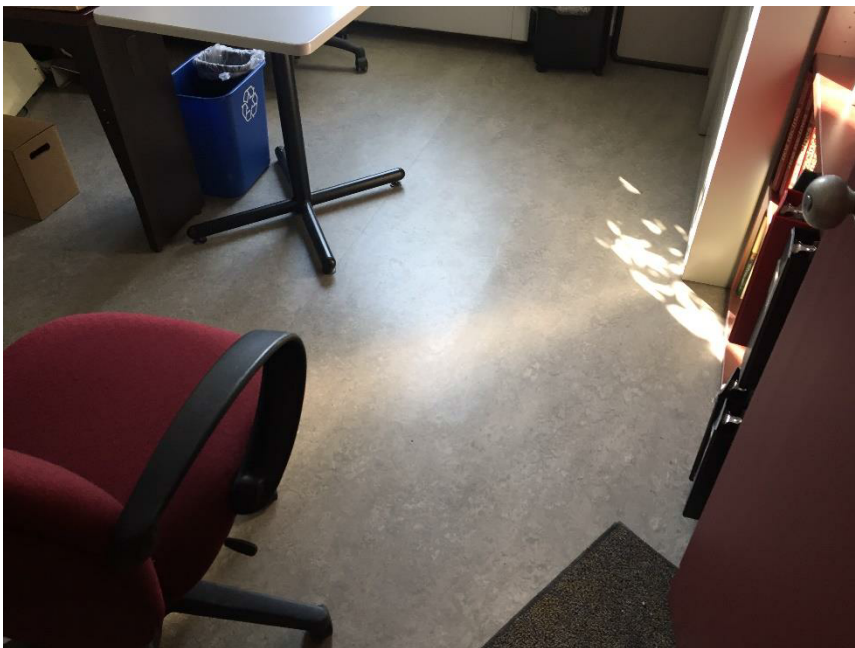
- Vinyl sheet flooring (Grey) was observed and sampled in Room 101. The laboratory analytical results of the vinyl sheet flooring samples collected indicate that this material does not contain asbestos. The associated mastic (Clear) was also determined not to contain asbestos.
- Vinyl sheet flooring (White/Blue) was observed and sampled in Room 111. The laboratory analytical results of the vinyl sheet flooring samples collected indicate that this material does not contain asbestos.

Photo 4: View of non asbestos containing vinyl sheet flooring within Room 101.

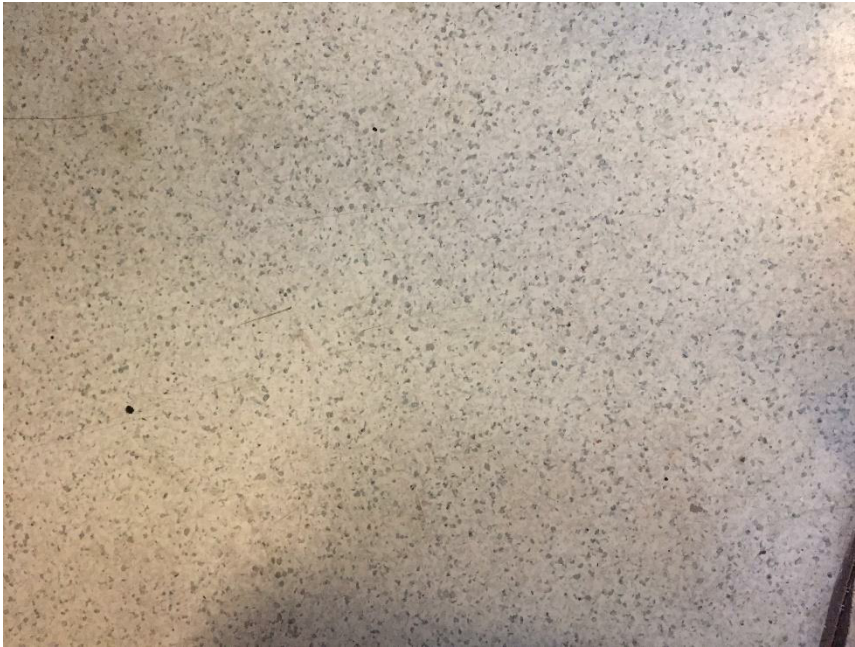
Photo 5: View of non-asbestos containing vinyl floor sheet (white/blue) within Room 111

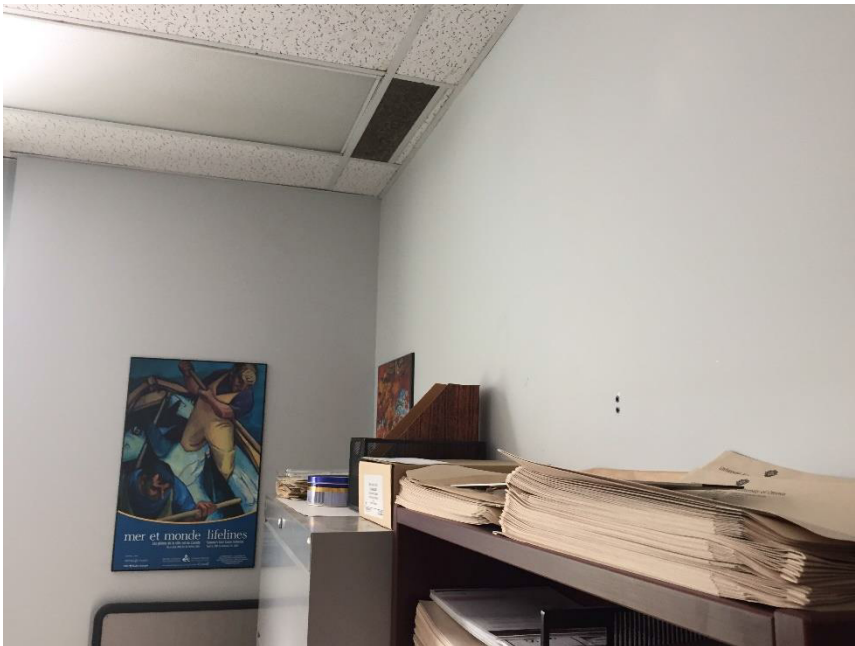
Drywall joint compound was observed and previously identified to contain **2% Chrysotile asbestos** throughout the first and second floor of the subject building. Since drywall joint compound is a homogeneous material, all areas must be treated as asbestos-containing unless additional bulk sampling and analysis proves otherwise. This material was observed in good condition.

Photo 6: View of asbestos-containing drywall within Room 101

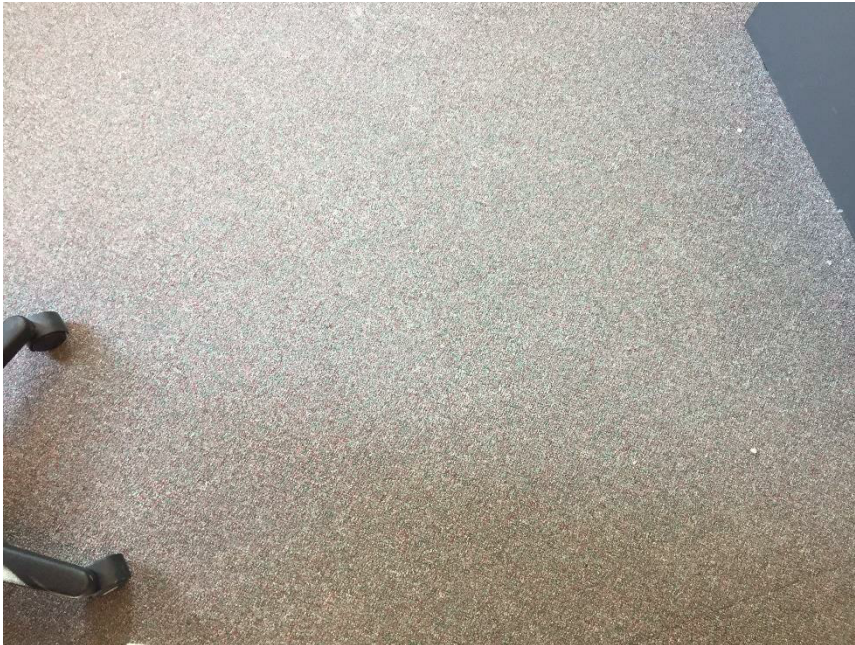
Photo 7: View of carpet within some specific locations within the subject building

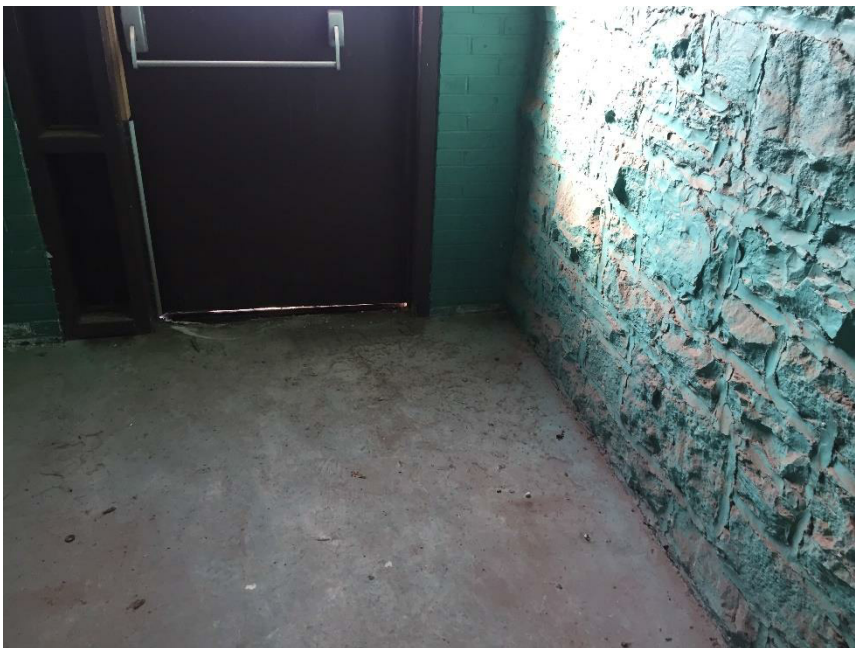
The paint finishes highlighted in pink in the above table are considered lead-containing paints or surface coatings with concentrations greater than 0.1% lead by weight. These paint finishes were observed to be in good condition with the exception of select areas that were observed in poor condition.

Photo 8: View of lead-containing green paint within the subject building

Paints identified to contain lead that are in poor condition must be immediately repaired and/or stabilized following a minimum Type 1/2 lead abatement procedures as per OMOL “Lead on Construction Project” dated April 2011.

Paints identified to contain lead that are in fair condition should be either repaired (where possible) and/or closely monitored for signs of further deterioration.

Paints identified to contain lead that are in good condition and do not pose a risk to workers or occupants can be managed in place.

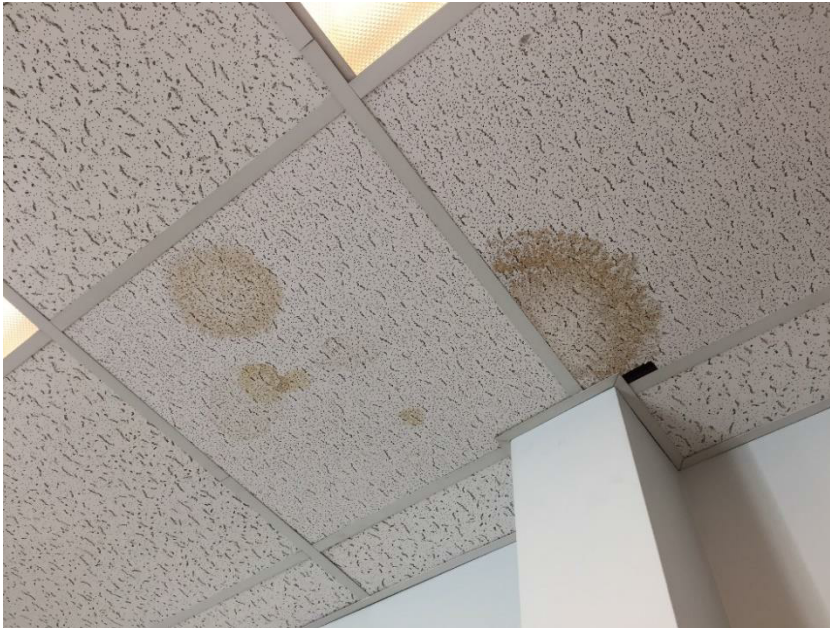
A visual survey of the subject building was conducted to determine if any water damaged was present. MPL identified select areas throughout the subject building, where materials were affected by water damage.

Photo 9: View of water damaged suspended ceiling tiles observed in Room 206.

Water stained/damaged ceiling tiles observed throughout the subject building should be replaced as part of regular maintenance and the underlying cause of the water leakage should be identified and repaired.

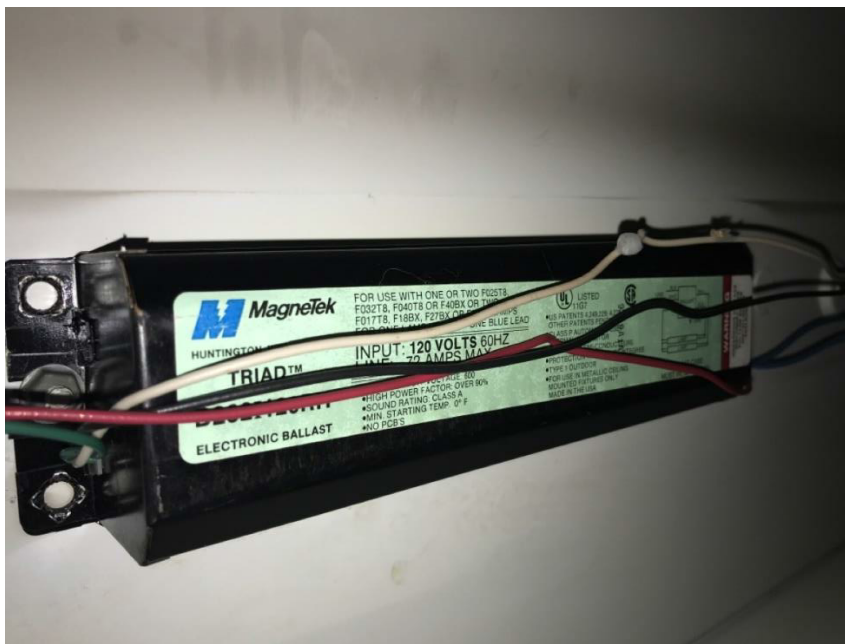
MPL did not observe any PCBs containing electrical transformers within the subject building. Transformers that could be assessed were observed to be dry-type.

Photo 10: View of non-PCB containing light ballasts observed in Room 0018.

Since no PCB-containing equipment was observed or suspected to be present during the site survey, no further action is required.
