HAZARDOUS MATERIALS SURVEY AND 2022 REASSESSMENT 542 KING EDWARD AVENUE, OTTAWA, ON

Project No.:0Z2021101HZ / CCC-230252-00

University of Ottawa

McIntosh Perry Limited (MPL)

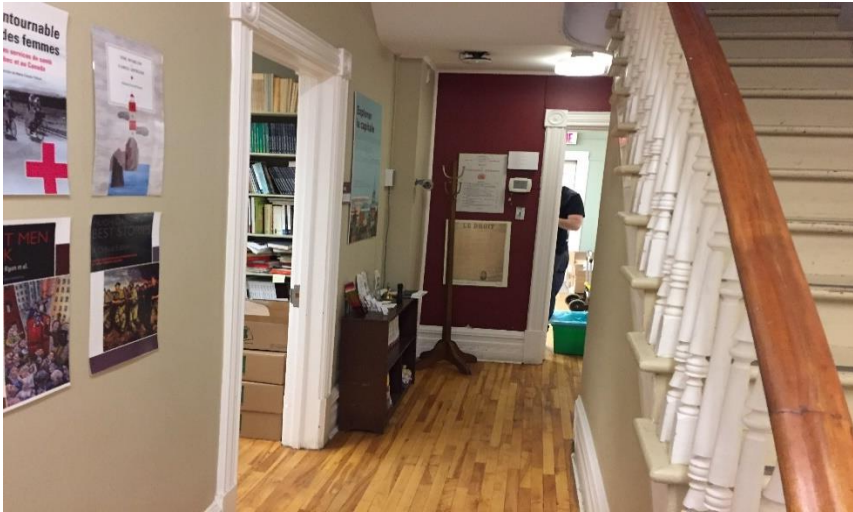
Photo 1: Representative view of typical finishes throughout the first level of subject building.

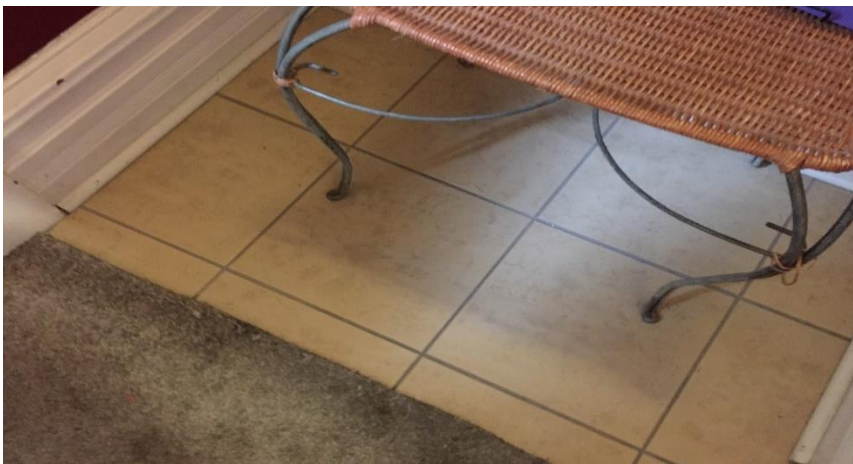
To avoid damage and compromising the integrity of the material, no bulk samples of the ceramic tiles grout were collected. Prior to renovation/demolition, ceramic tile grout should be examined and tested for asbestos content. Ceramic tile grout should therefore be considered to contain asbestos until bulk samples and analysis proves otherwise.

Photo 2: View of ceramic floor tile with suspect asbestos-containing grout on ground floor Room 100.

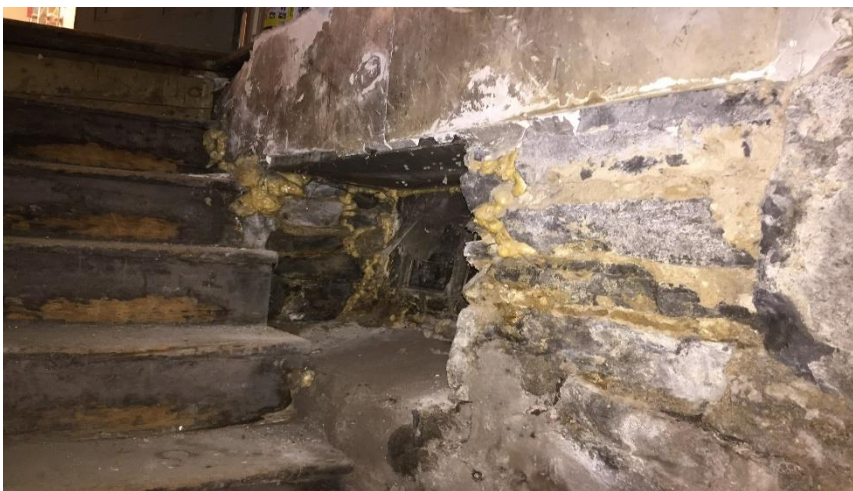
The paint finishes highlighted in pink in the above table are considered lead-containing paints or surface coatings with concentrations greater than 0.1% lead by weight. These paint finishes were observed to be in good condition with exception of selected areas in poor condition.

Photo 3: View of lead-containing paint (Grey) on plaster in poor condition in the Basement Room 003.

Paints identified to contain lead that are in poor condition must be immediately repaired and/or stabilized following a minimum Type 1/2 lead abatement procedures as per OMOL “Lead on Construction Project” dated April 2011.

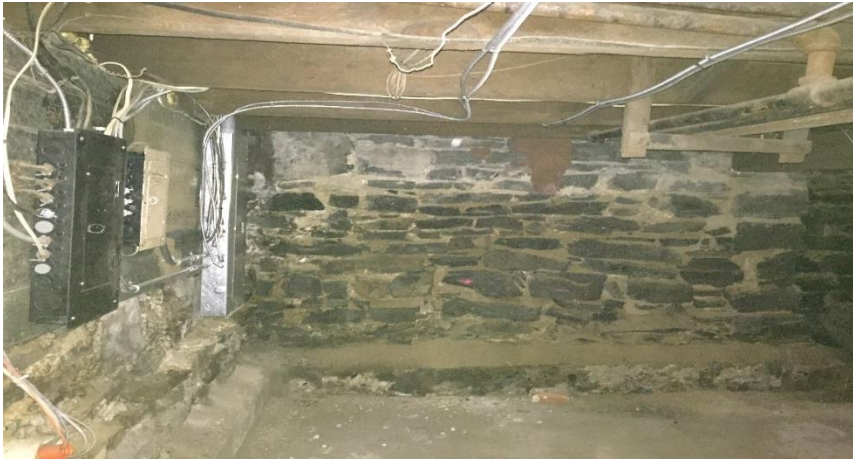
A visual survey of the subject building was conducted to determine if any water damaged was present. MPL observed signs of dampness throughout the basement stone foundation walls and perimeter concrete floor which appears to be caused by water infiltration.

Photo 4: View damp staining on stone foundation wall in the Basement level.

Further investigation should be conducted into the cause of water infiltration and necessary repairs completed.

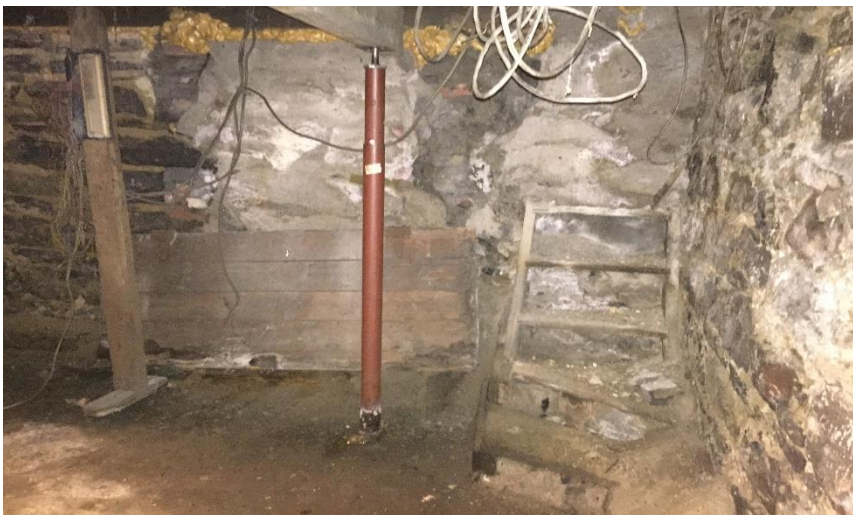
Photo 5: View damp staining on concrete floor in the Basement level.

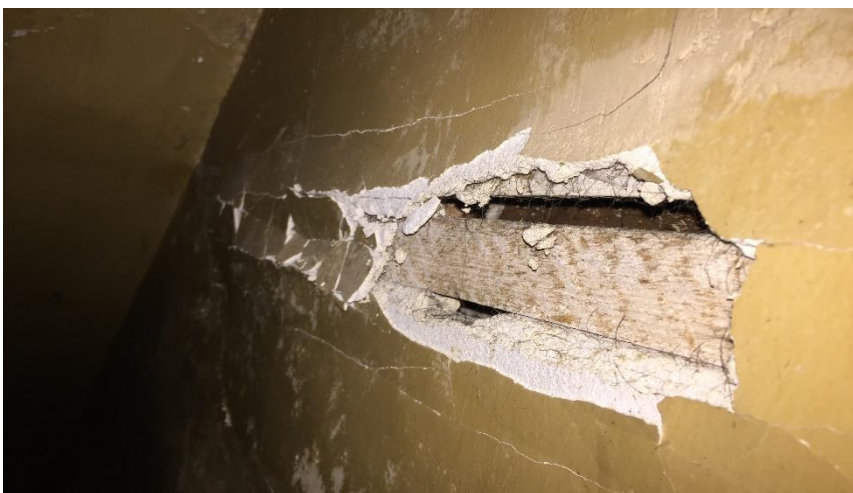
Photo 6: View of the lead-containing paint (Green) on plaster in poor condition in the Basement Room 003.

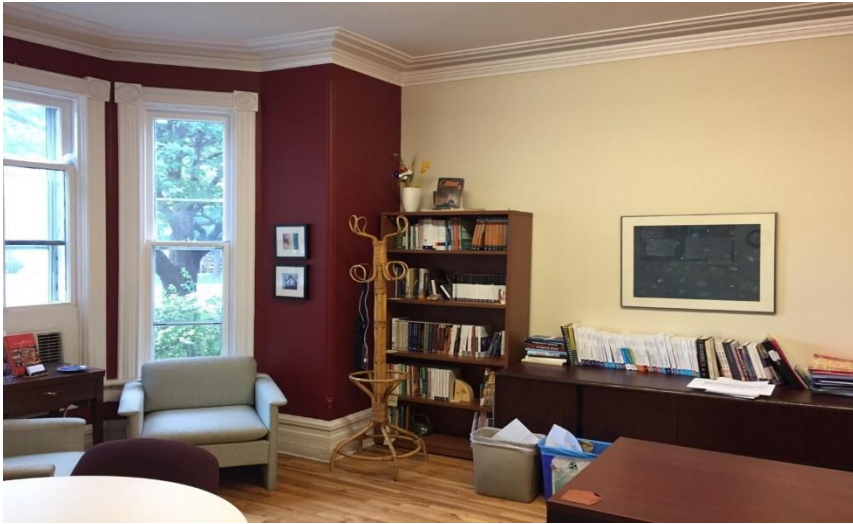
Photo 7: Representative view of non-asbestos finishes on the ground floor.

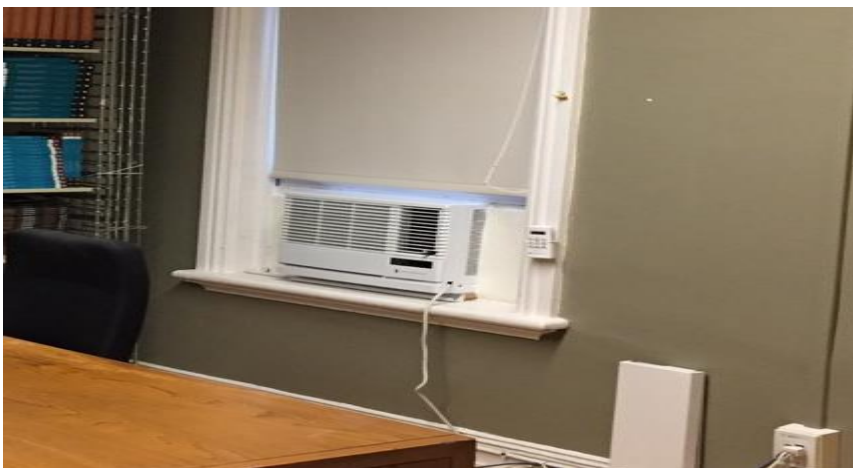
A visual assessment for equipment potentially containing ODSs and other halocarbons was conducted. Equipment containing ODSs or other halocarbons was observed in the subject building.

Photo 8: View of typical window air-conditioning unit observed to contain ODSs.

Please refer to Appendix F – Hazardous Materials Checklist for equipment conditions, approximate quantities (where applicable), and recommended actions.

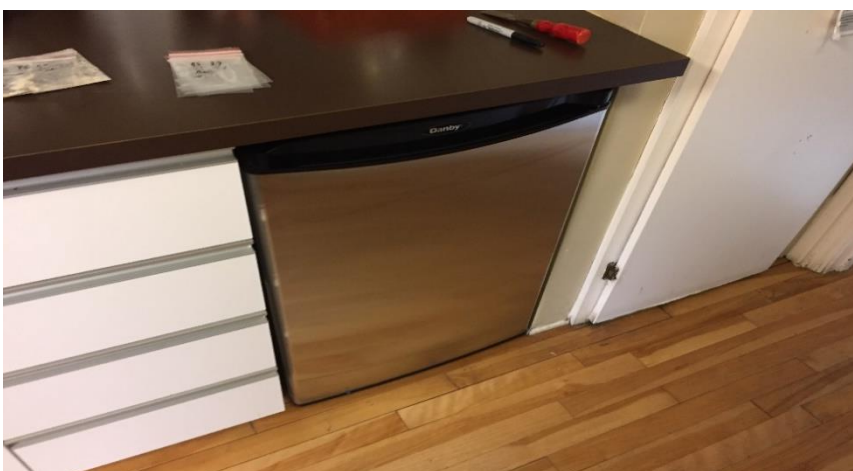
Photo 9: View of equipment observed to contain ODSs in Room 201.
