HAZARDOUS MATERIALS SURVEY AND 2023 REASSESSMENT 544 KING EDWARD AVENUE, OTTAWA, ON

Project No.: Z2021101HZ/ CCC-230252-00

University of Ottawa

McIntosh Perry Limited (MPL)

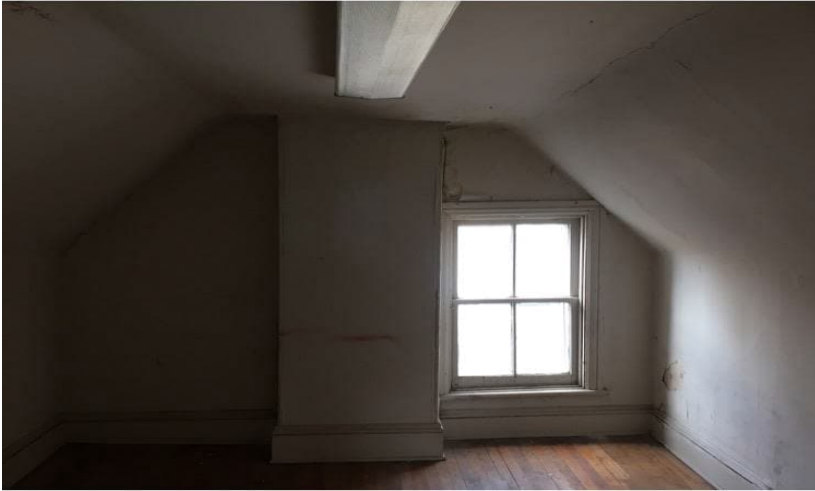
Photo 1: Typical view of building finishes observed within the subject building.

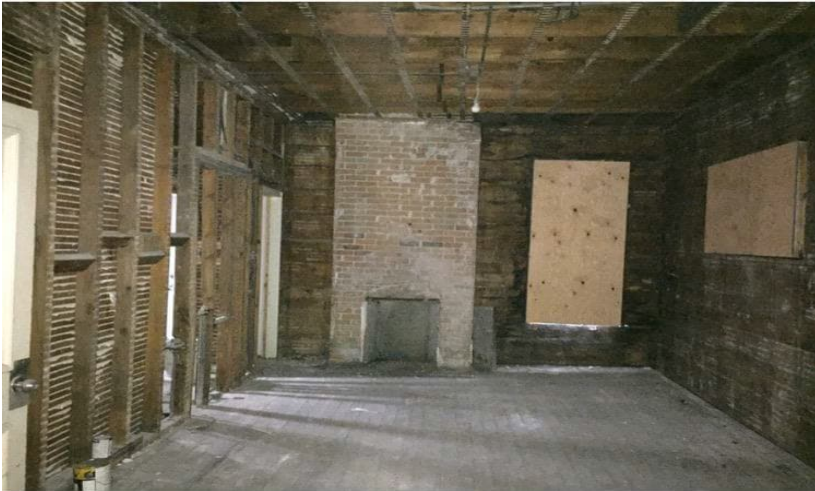
Photo 2: Typical view of building finishes observed within the subject building.

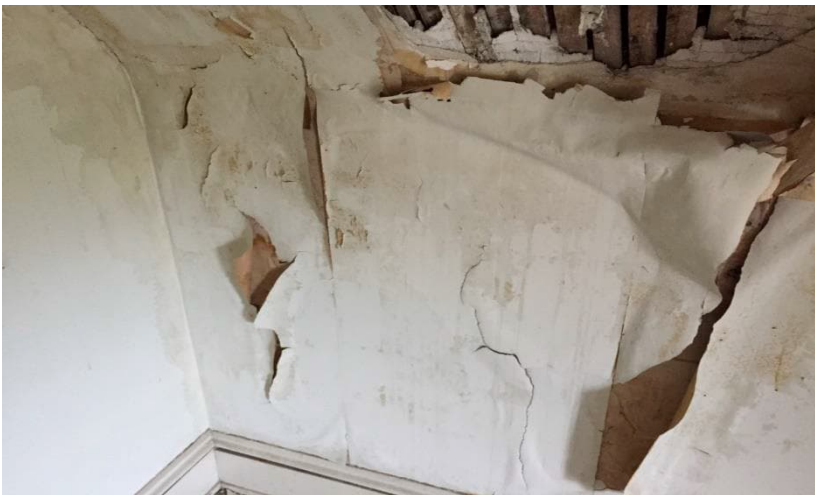
The paint finishes highlighted in blue in the above table was determined to contain low concentrations of lead, which are less than or equal to 0.1%. These paint finishes were observed to be in good condition, except for select areas that were observed in poor condition.

Photo 3: View of white low levels of paint observed to be damaged in Room 302.

Paints identified to contain lead that is in poor condition must be immediately repaired and/or stabilized following a minimum Type 1/2 lead abatement procedures as per OMOL “Lead on Construction Project” dated April 2011.

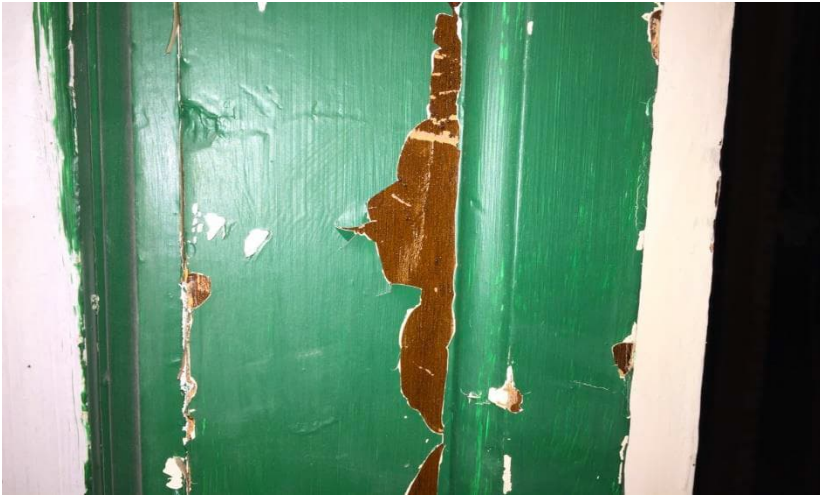
The paint finishes highlighted in pink in the above table are considered lead-containing paints or surface coatings with concentrations greater than 0.1% lead by weight. These paint finishes were observed to be in good condition, exception for select areas that were observed in poor condition.

Photo 4: View of green lead-containing paint observed to be damaged near the stairs to the 2nd floor.

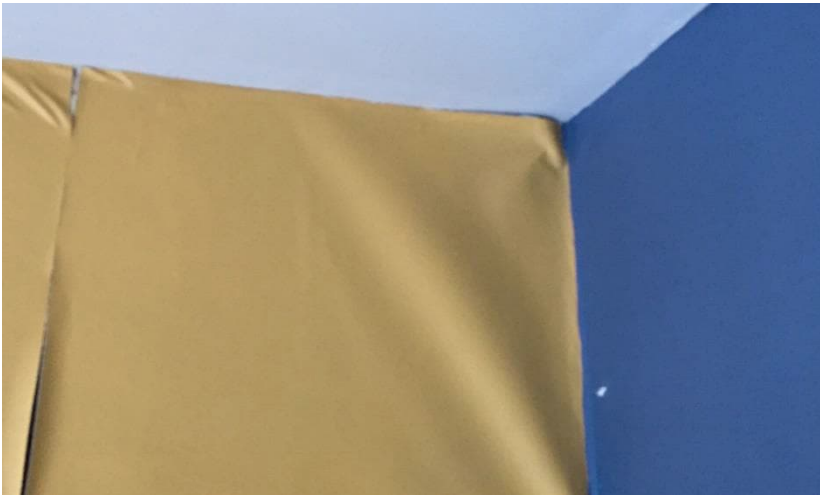
Photo 5: View of lead-containing yellow paint observed to be damaged in Room 203.

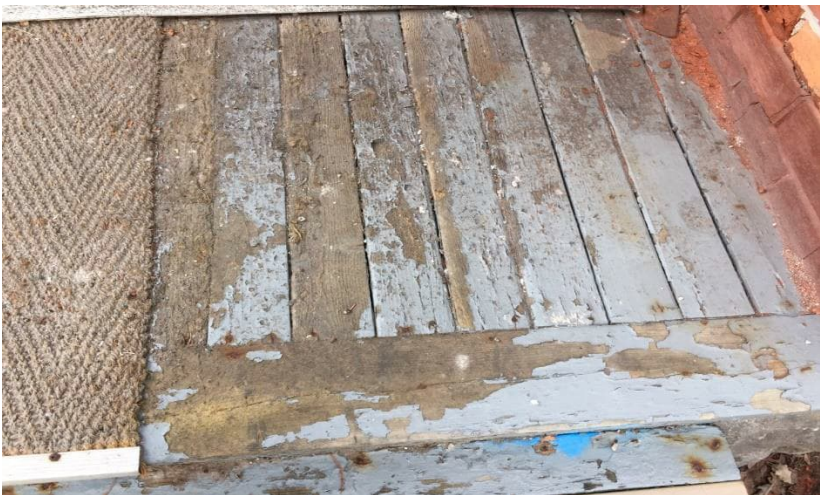
Photo 6: View of lead-containing grey/blue paint observed to be damaged on the exterior deck.

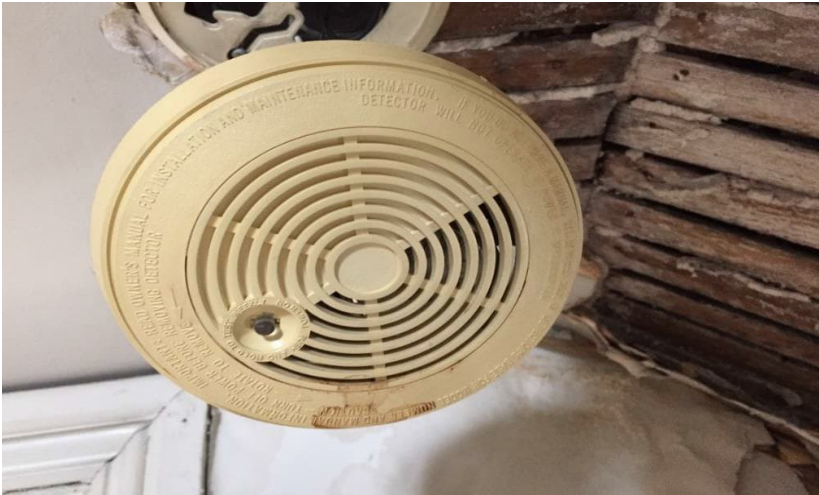
A visual assessment of the subject building was conducted to determine if any electrical components containing radioactive materials were present. Smoke detectors were observed throughout the subject building, which contained small quantities of radioactive material.

Photo 7: Typical view of radioactive smoke detectors observed within the subject building.

The radioactive sources in smoke alarms are sealed and contained within a metal case inside the smoke detector and must not be damaged or tampered with. These materials do not pose a hazard as long as they remain contained and properly disposed of at the time of removal or replacement.

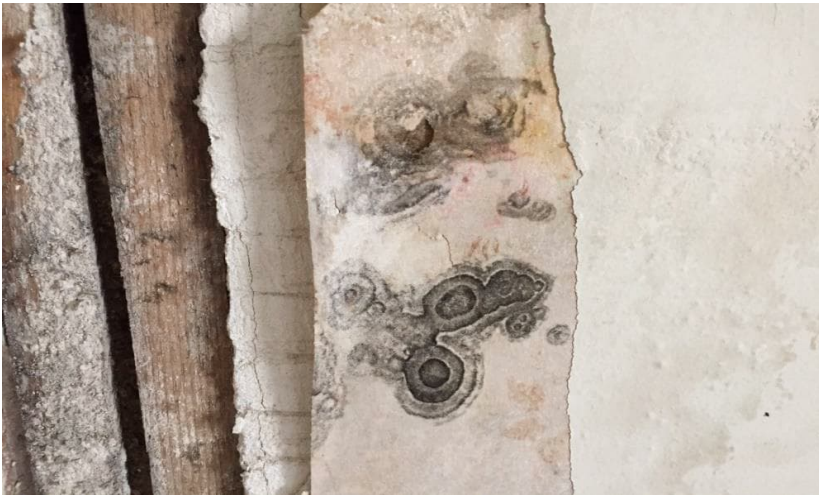
A visual survey of the subject building was conducted to determine if water damage was present. Select areas were identified throughout the subject building where materials were affected by water damage.

Photo 8: View of suspected mould growth observed on the plaster wall in Room 302.

Please refer to Appendix F – Hazardous Materials Checklist for equipment conditions, quantities (where applicable), and recommended actions.

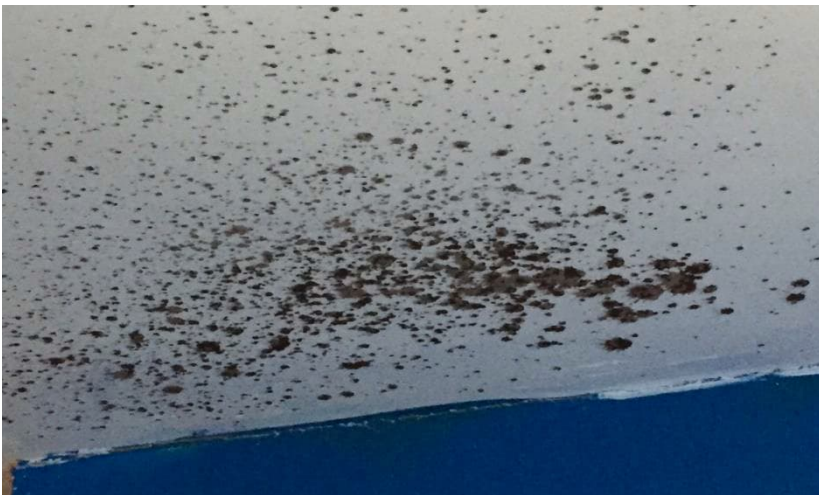
Photo 9: View of suspected mould growth observed on plaster ceiling in Room 202.
