HAZARDOUS MATERIALS SURVEY AND 2023 REASSESSMENT 548 KING EDWARD AVENUE, OTTAWA, ON

Project No.: Z2021102HZ/ CCC-230252-00

University of Ottawa

McIntosh Perry Limited (MPL)

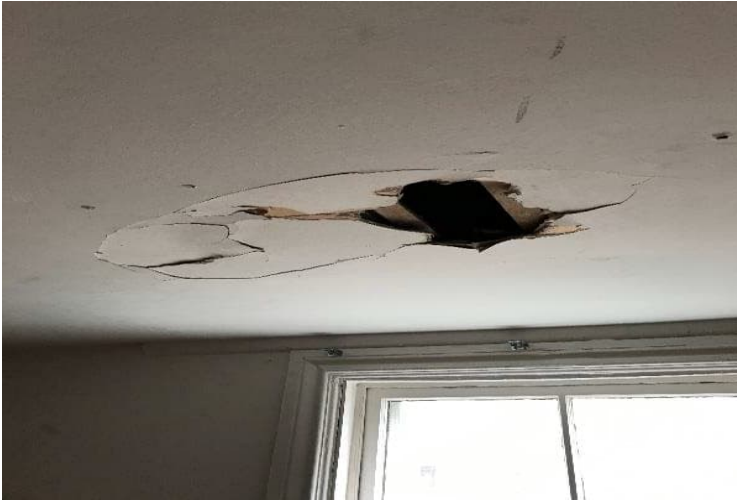
Drywall joint compounds were observed throughout the subject building. The laboratory analytical results of drywall joint compound samples collected indicate that this material **contains 2% Chrysotile asbestos**. Since drywall joint compound is a homogeneous material, all areas must be treated as asbestos-containing unless additional bulk sampling and analysis until proven otherwise. This material was observed to be in good condition.

Photo 1: View of asbestos-containing drywall joint observed to be damaged on the ceiling on the 1st floor of the subject building.

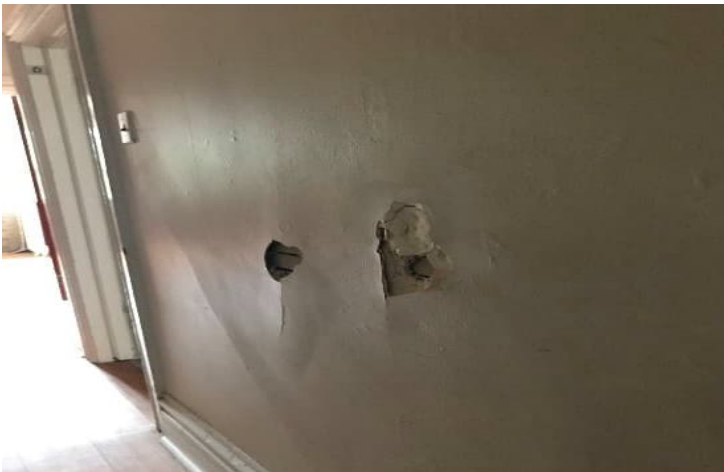
Photo 2: View of asbestos-containing drywall joint compound observed to be damaged in the hallway of the 2nd floor.

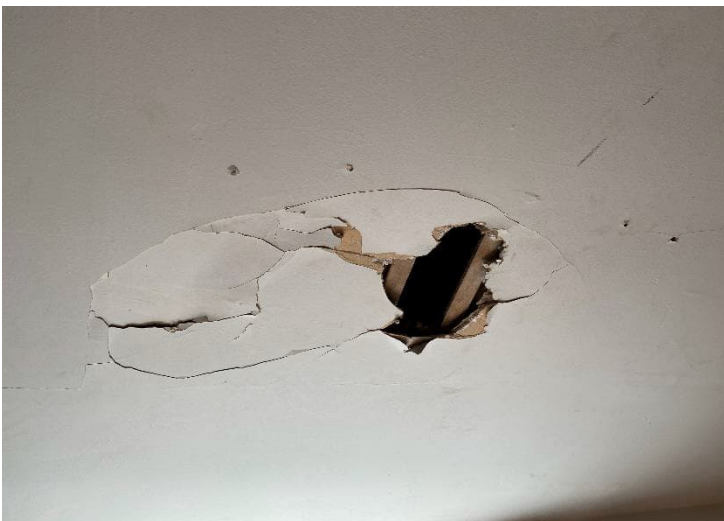
Photo 3: View of asbestos-containing drywall joint compound observed to be damaged on the ceiling on the 1st floor of the subject building.
