HAZARDOUS MATERIALS SURVEY AND 2023 REASSESSMENT 550 KING EDWARD AVENUE, OTTAWA, ON

Project No.: Z2021102HZ / CCC-230252-00

University of Ottawa

McIntosh Perry Limited (MPL)

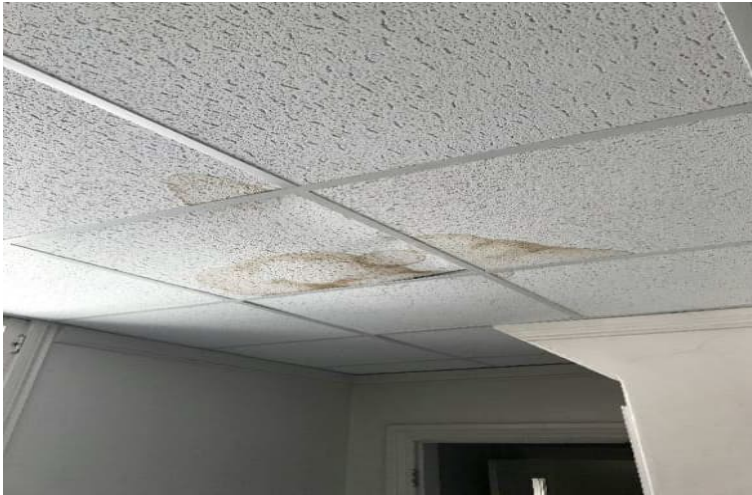
A visual survey of the subject building was conducted to determine if water damage was present. Select areas were identified throughout the subject building where materials were affected by water damage.

Photo 1: View of water-damaged suspended ceiling tiles (2'x2') observed at 550 King Edward Avenue.

Water-stained/damaged ceiling tiles observed throughout the subject building should be replaced as part of regular maintenance, and the underlying cause of the water leakage should be identified and repaired;

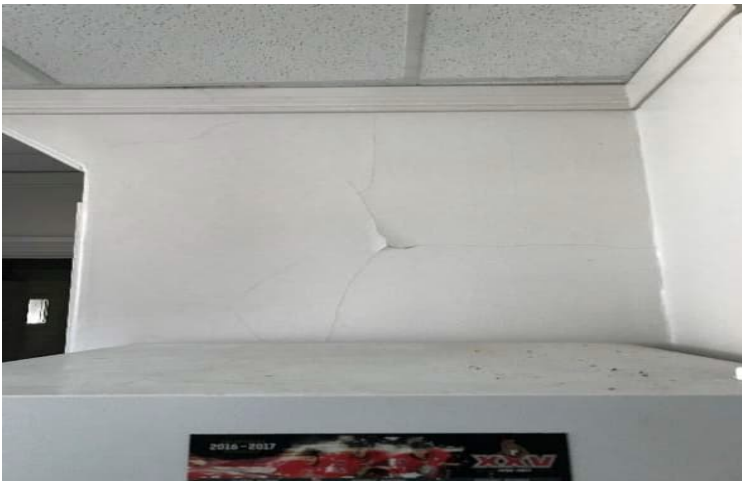
The paint finishes highlighted in pink in the above table are considered lead-containing paints or surface coatings with concentrations greater than 0.1% lead by weight. These paint finishes were observed to be in good condition, except for select areas, which were observed in fair condition.

Photo 2: View of lead-containing white paint observed to be in fair condition in the foyer of the subject building.

Paints identified to contain lead that are in fair condition should be either repaired (where possible) and/or closely monitored for signs of further deterioration.

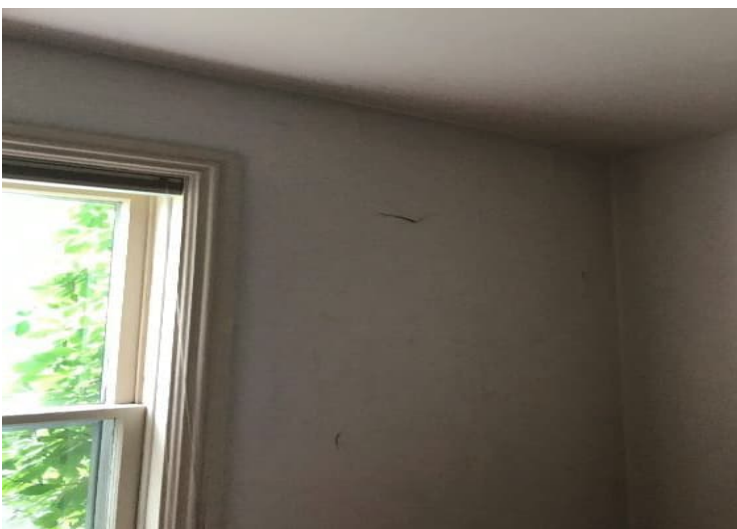
Photo 3: View of lead-containing beige paint observed to be in fair condition in the living room of the subject building.

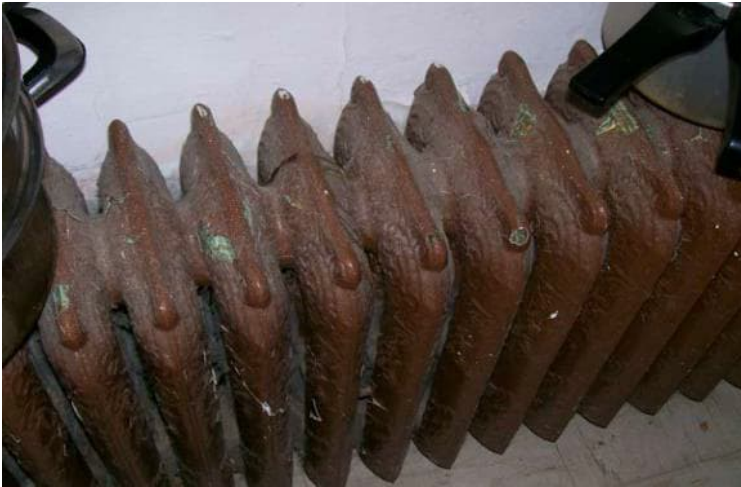
Photo 4: View of lead-containing brown paint observed to be in good condition in the dining room of the subject building.

Paints identified to contain lead that are in good condition and do not pose a risk to workers or occupants can be managed in place.

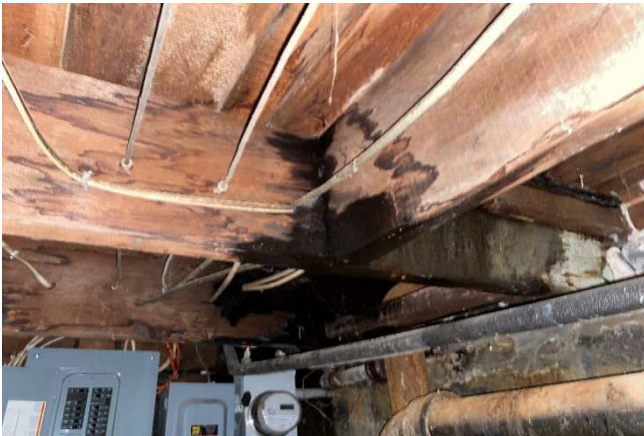
Photo 5: View of water-damaged wood decking observed in the basement of the subject building during 2022 Reassessment.

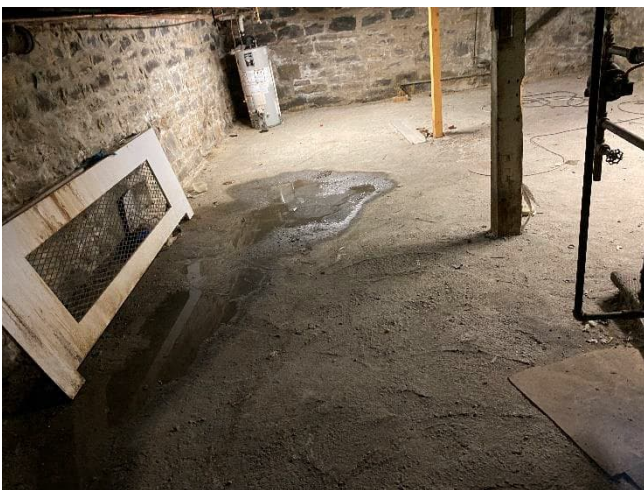
Photo 6: View of water damage (active pooling) observed in the basement of the subject building during 2022 Reassessment.
