HAZARDOUS MATERIALS SURVEY AND 2023 REASSESSMENT 558 KING EDWARD AVENUE, OTTAWA, ON

Project No.: Z2021101HZ/ CCC-230252-00

University of Ottawa

McIntosh Perry Limited (MPL)

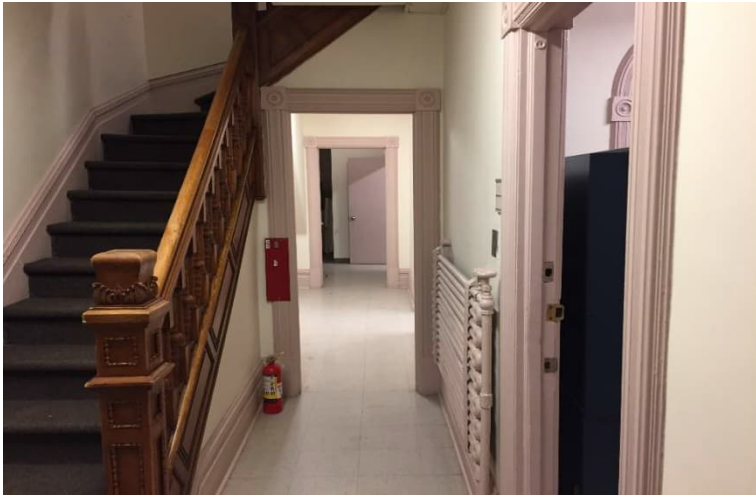
Photo 1: Typical view of finishes observed throughout the building located at 556 King Edward Avenue.

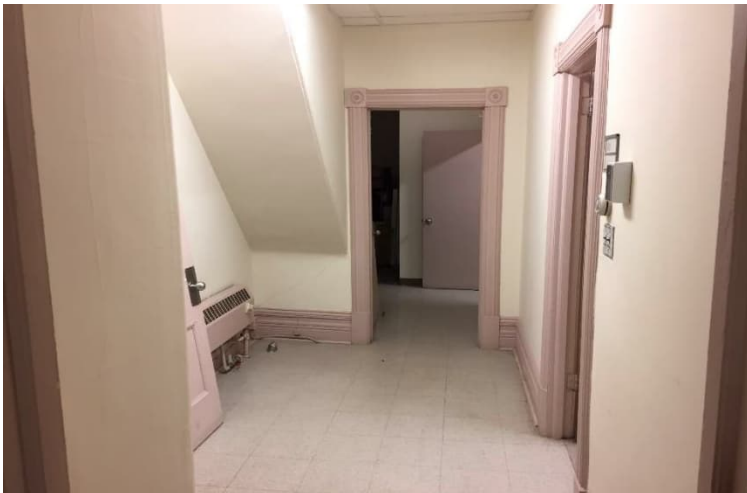
Drywall joint compounds were observed throughout the subject building. The laboratory analytical results of the samples collected indicate that this material **contains 2% Chrysotile asbestos**. Since drywall joint compound is a homogeneous material, all areas must be treated as asbestos-containing unless additional bulk sampling and analysis until proven otherwise. This material was observed to be in good condition.

Photo 2: Typical view of asbestos-containing drywall joint compound observed throughout the subject building.

- Materials identified to contain asbestos that are in good condition and do not pose a risk to workers or occupants can be managed in place. Prior to renovation/demolition activities that may disturb the ACMs, these materials must be removed following appropriate Type 1/2/3 asbestos abatement work procedures as detailed in O. Reg. 278/05 and disposed of as asbestos waste under O. Reg. 347;

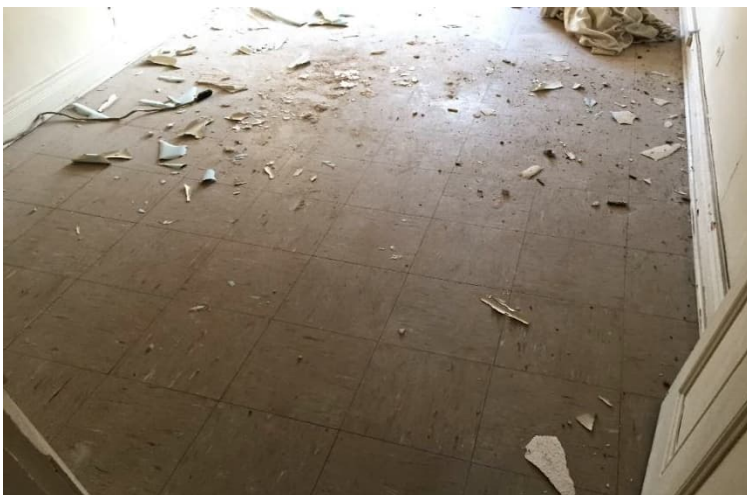
Photo 3: View of asbestos-containing vinyl floor tiles (12"x12"-grey with white and black streaks) observed in Room 302.

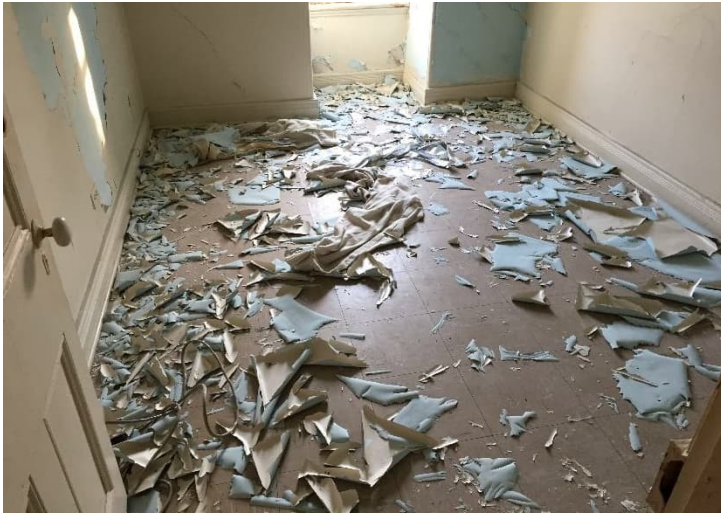
The paint finishes highlighted in pink in the above table are considered lead-containing paints or surface coatings with concentrations greater than 0.1% lead by weight. These paint finishes were observed to be in good condition, exception for select areas that were observed in poor condition.

Photo 4: View lead-containing light blue paint was observed to be in poor condition in Room 301.

Paints identified to contain lead that is in poor condition must be immediately repaired and/or stabilized following a minimum Type 1/2 lead abatement procedures as per OMOL “Lead on Construction Project” dated April 2011.

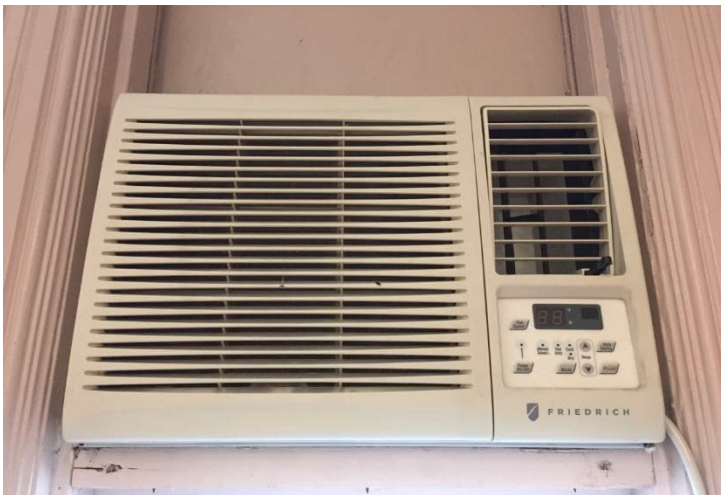
Photo 5: Typical view of ODS containing air-conditioning unit.

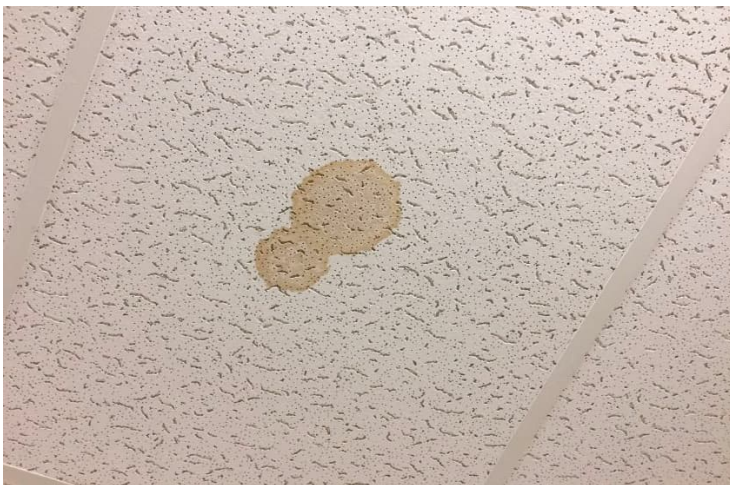
- Basement – Ceiling boards with slight water damage (approximately 2 SF)
- Room 101 – Ceiling tile with slight water damage (approximately <1 SF)
- Room 201 – Water damage at radiator (approximately 2 LF)
- Room 202 – Water damage at radiator (approximately 2 LF)

Photo 6: View of water-damaged suspended ceiling tile observed in Room 101.

Water-stained/damaged ceiling tiles observed throughout the subject building should be replaced as part of regular maintenance, and the underlying cause of the water leakage should be identified and repaired;
