HAZARDOUS MATERIALS SURVEY AND 2023 REASSESSMENT 562 KING EDWARD AVENUE, OTTAWA, ON

Project No.: Z2021101HZ / CCC-230252-00

University of Ottawa

McIntosh Perry Limited (MPL)

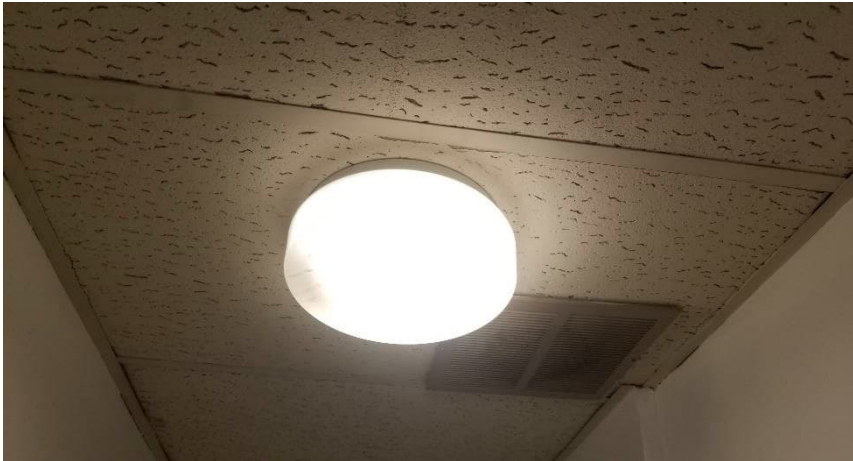
- Suspended ceiling tiles (2'x4' - Pinholes with Large Fissures) were observed in Room 108. The laboratory analytical results of ceiling tile samples collected from Room 108 indicate that this material **contains 3% Chrysotile asbestos**. This material was observed to be in fair condition.
- Suspended ceiling tiles (2'x4' Pinholes with Medium Fissures) were observed in Room 101. The laboratory analytical results of ceiling tile samples collected from Room 101 indicate that this material does not contain asbestos.

Photo 1: View of asbestos-containing suspended ceiling tiles (pinholes with large fissures) observed in Room 108.

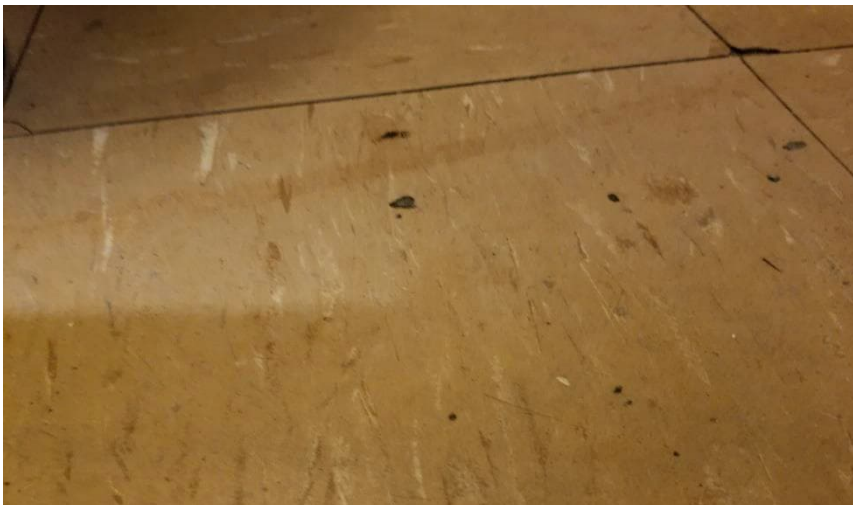
- Vinyl floor tiles (12"x12" – Brown w/ Brown and White) were observed in Room 106. The laboratory analytical results of vinyl floor tile samples collected from Room 106 indicate that this material **contains 2% Chrysotile asbestos**. This material is considered to be non-friable and was observed to be in good condition. The associated mastic (Black) was found not to contain asbestos.

Photo 2: View of asbestos-containing vinyl floor tiles (brown with brown and white) observed in Room 106.

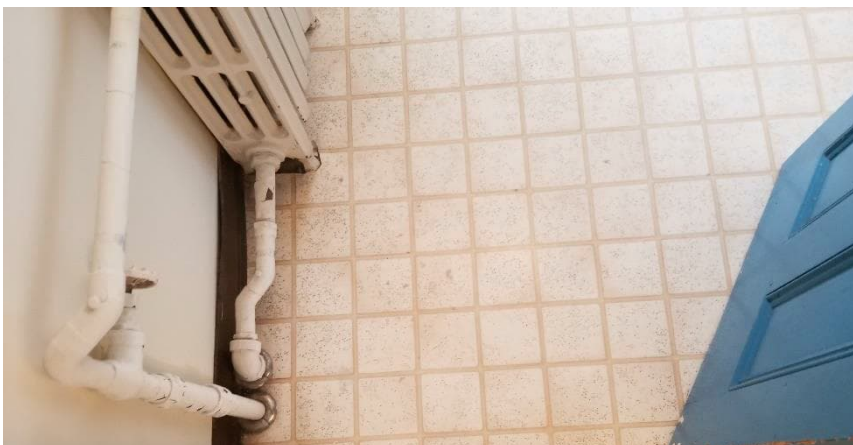
Previously identified Vinyl Sheet Flooring (Tan Squares) was observed in Room 209. The laboratory analytical results of the samples collected indicated that this material **contains 13.7% Chrysotile asbestos**. This material is considered to be friable and was observed to be in fair condition.

Photo 3: View of previously identified asbestos-containing vinyl sheet flooring (tan squares) observed in Room 209.

- ACMs identified as in fair condition should be either repaired (where possible) and/or closely monitored for signs of further deterioration. Depending on the type of material and location, these materials should be scheduled for removal if there is a potential risk of exposure to workers and/or occupants;

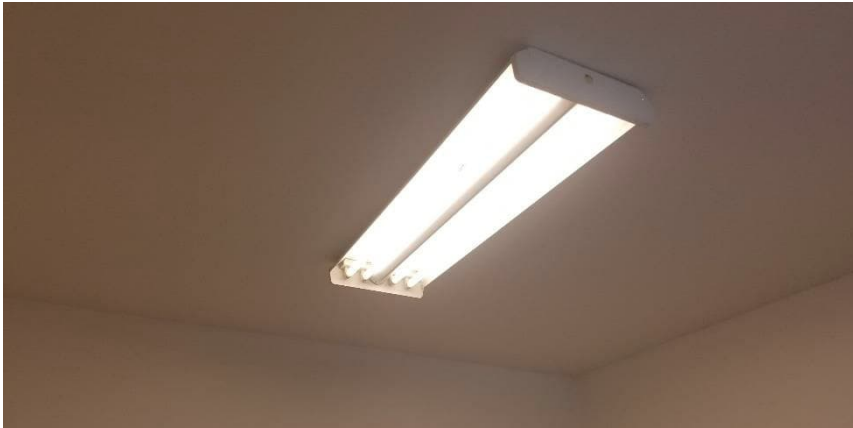
Photo 4: Typical fluorescent light fixtures observed throughout the subject building.

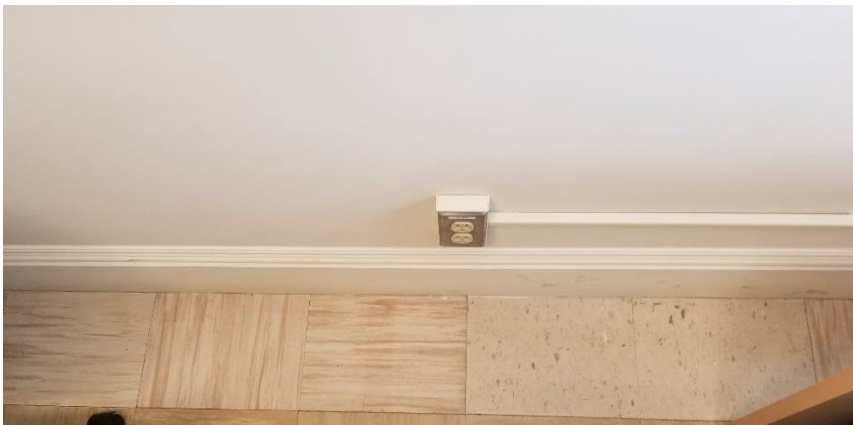
- Vinyl floor tiles (12"x12" – Off-White/Beige) were observed in Room 202. The laboratory analytical results of vinyl floor tile samples collected from Room 202 indicate that this material **contains 2.0% Chrysotile asbestos**. This material is considered to be non-friable and was observed to be in good condition.

Photo 5: View of asbestos-containing vinyl floor tiles (off-white/beige) observed in the upper left corner in Room 202.

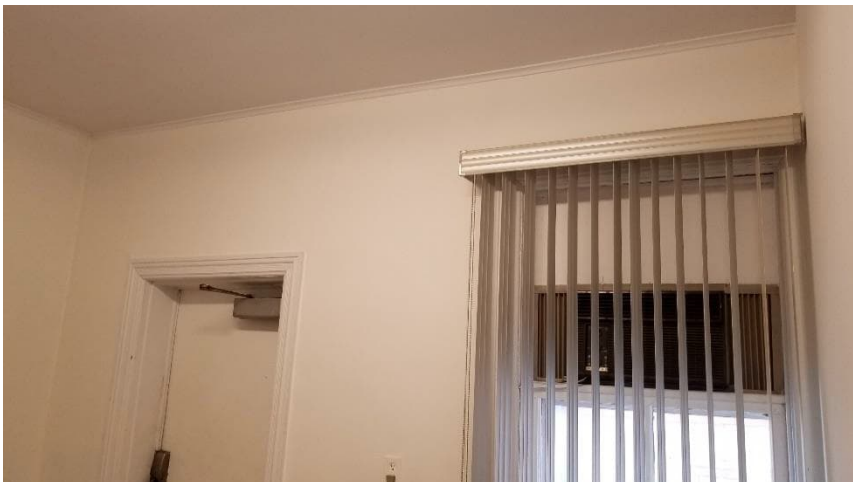
Ceiling/Wall plaster on wood lathe was observed throughout the building. The laboratory analytical results of ceiling/wall plaster samples collected throughout the building indicate that this material does not contain asbestos.

Photo 6: Typical wall and ceiling plaster finished observed in Room 110.
