HAZARDOUS MATERIALS SURVEY AND 2023 REASSESSMENT 599 KING EDWARD AVENUE, OTTAWA, ON

Project No.: Z2021102HZ / CCC-230252-00

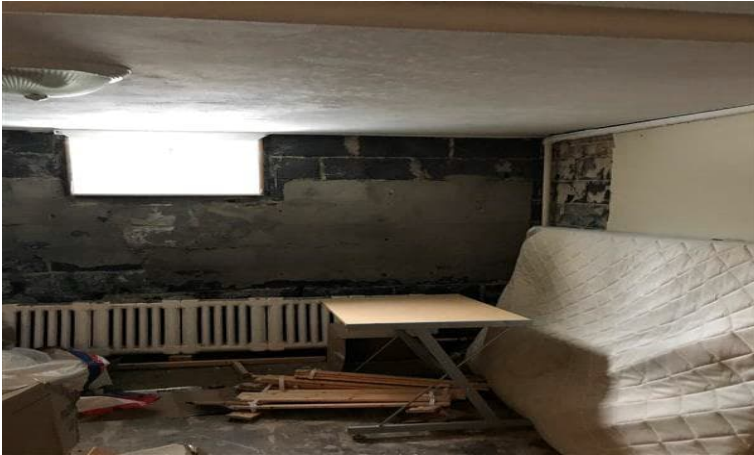
Photo 1: View of typical finishes observed at the building located at 599 King Edward Avenue.

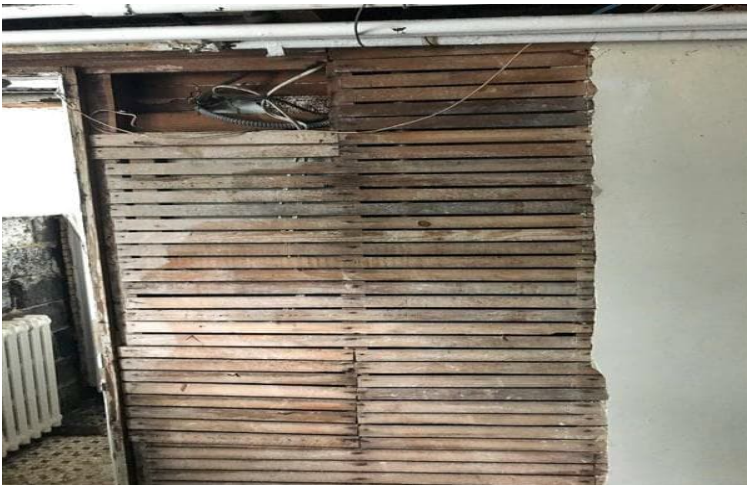
Photo 2: View of typical finishes observed at the building located at 599 King Edward Avenue.

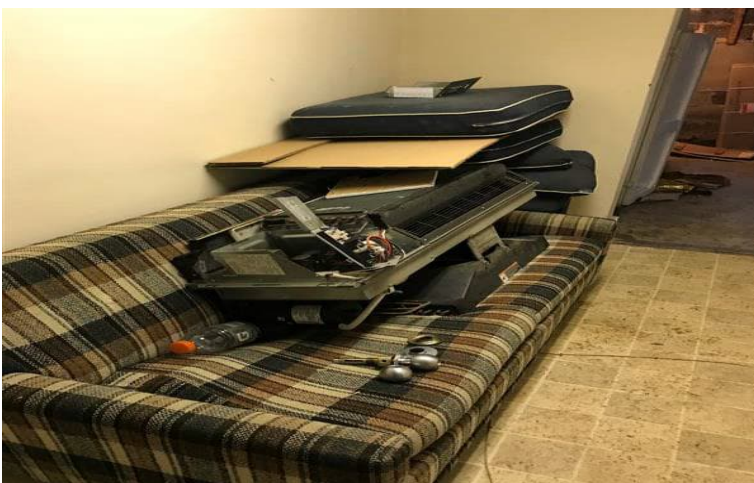
Photo 3: View of typical finishes observed at the building located at 599 King Edward Avenue.

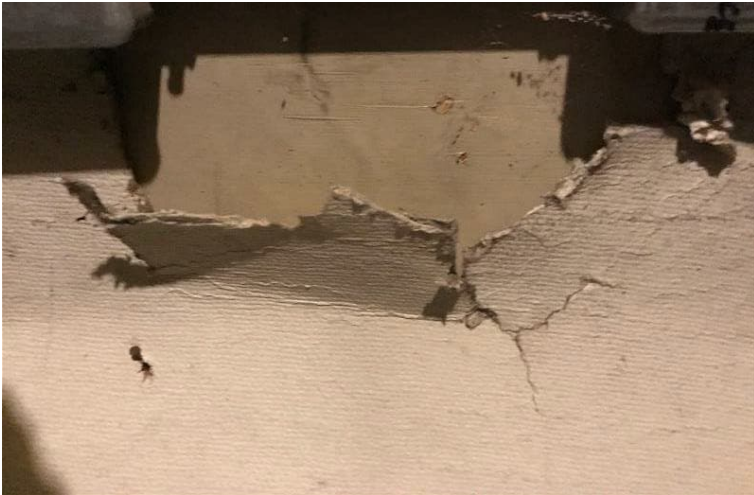
Photo 4: View of asbestos-containing thermal insulation observed to be in poor condition on the wall in the furnace room within the subject building.

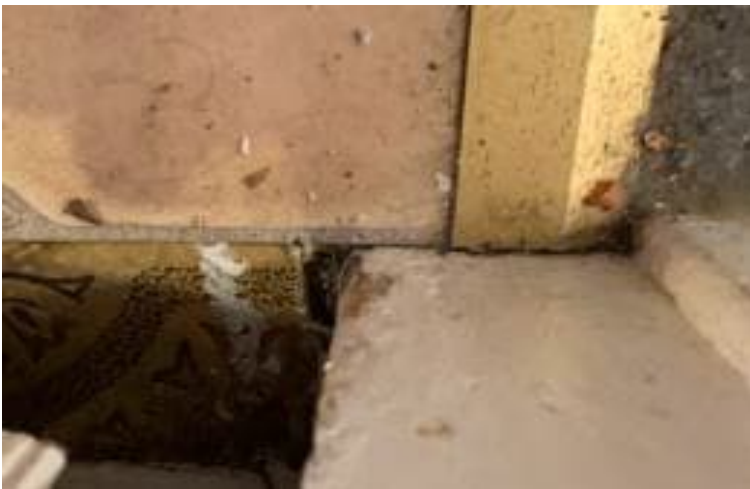
Photo 5: View of asbestos-containing vinyl floor tiles (12"x12"- beige) observed underneath vinyl sheet flooring in the kitchen of Apartment 1 within the subject building.

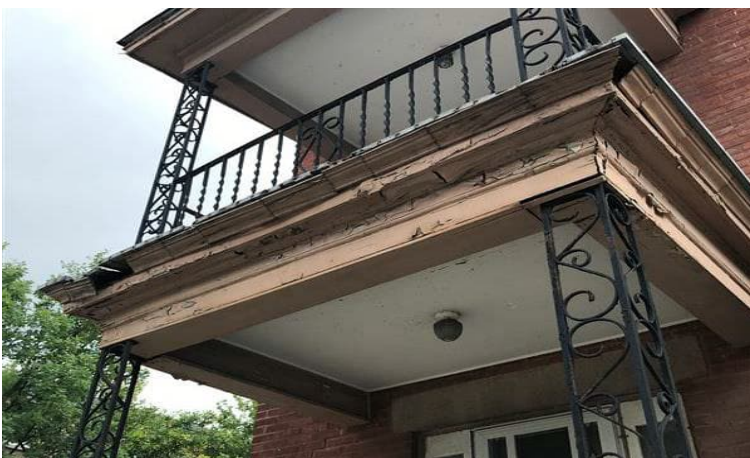
Photo 6: View of lead-containing beige paint observed to be in poor condition on the exterior patio.

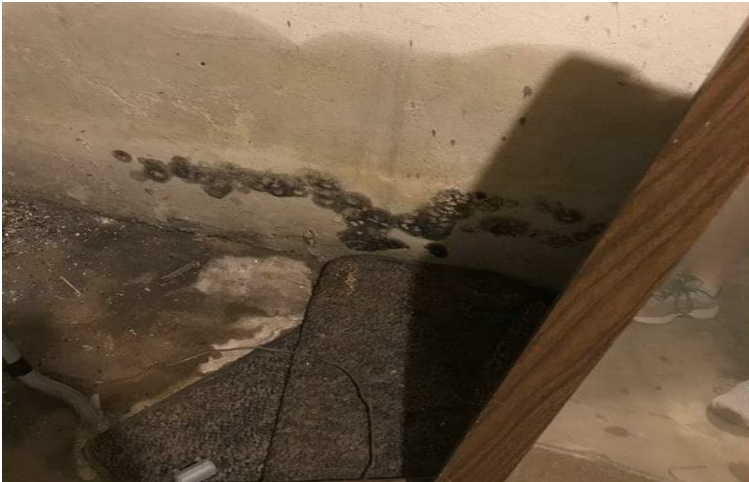
Photo 7: View of mould growth observed in the furnace room within the subject building.

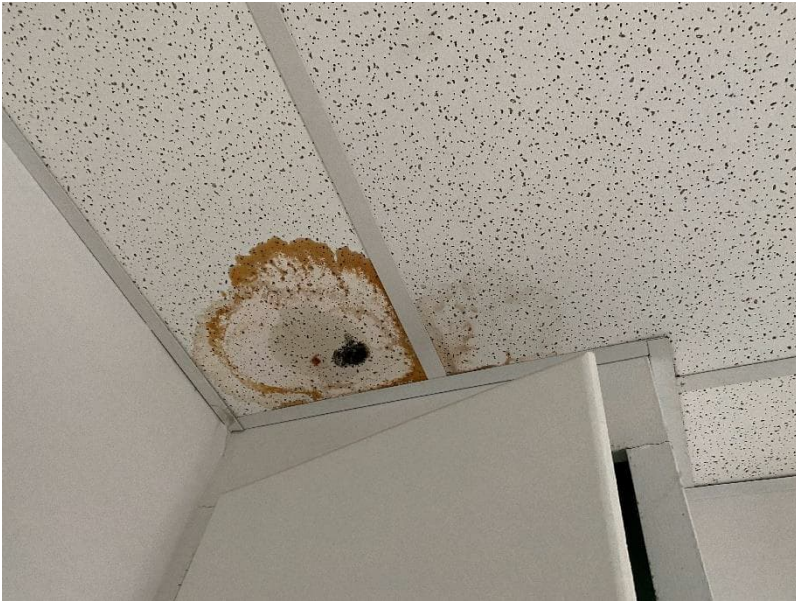
Photo 8: View of water damage observed on ceiling tiles in Room 101 within the subject building during the 2022 Reassessment.
