# HAZARDOUS MATERIALS SURVEY AND 2023 REASSESSMENT 621 KING EDWARD AVENUE, OTTAWA, ON

Project No.: CCC-214244-00 / CCC-230252-00

University of Ottawa

McIntosh Perry Limited (MPL)

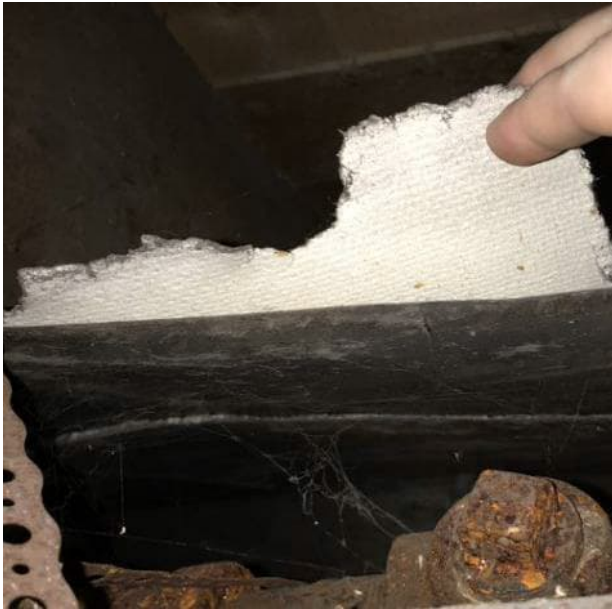
Grey Paper was sampled from Basement Ceiling above the furnace. Laboratory analytical results indicate that this material **contains 60% Chrysotile asbestos**. This material is considered to be friable and was observed to be in good condition.

**Photo 1:** Grey paper observed in the basement ceiling above furnace beneath sheet metal containing 60% Chrysotile asbestos.

- Materials identified to contain asbestos that are in good condition and do not pose a risk to workers or occupants can be managed in place. Prior to any renovation or demolition activities that may disturb the ACMs, these materials must be removed following appropriate Type 1/2/3 asbestos abatement work procedures as detailed in O. Reg. 278/05 and disposed of as asbestos waste under O. Reg. 347;

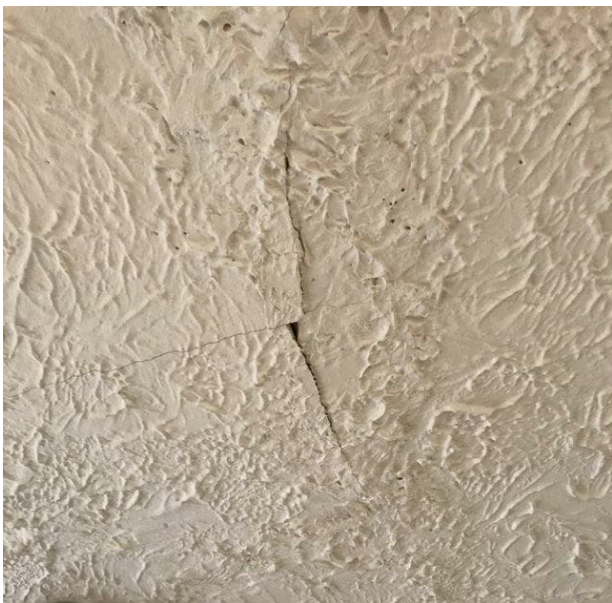
Ceiling texture coating (White) was observed in various locations of the subject building. The laboratory analytical results of ceiling texture coat (white) samples collected from various locations indicate that this material does not contain asbestos.

**Photo 2:** View of the non-asbestos containing ceiling texture finishes observed at various locations in the subject building.

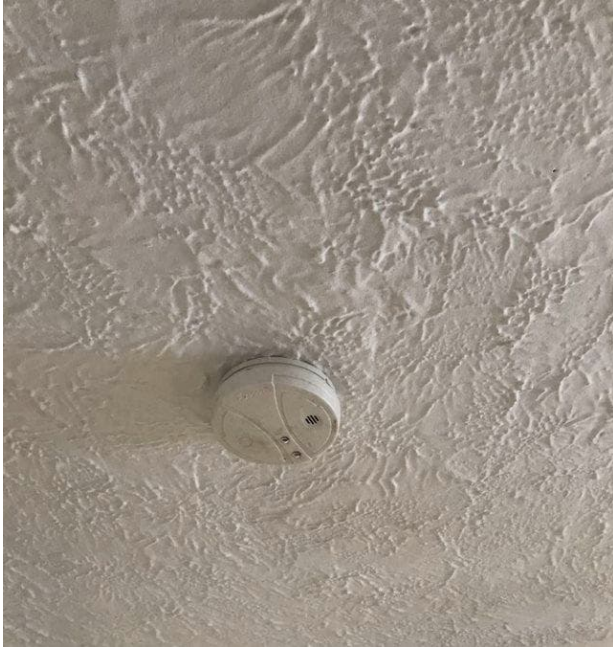
A visual assessment of the subject building was conducted to determine if any electrical components containing radioactive materials were present. Smoke detectors containing small quantities of radioactive material were observed at various locations of the subject building.

**Photo 3:** Representative view of the smoke detector containing Americim 241 observed at various locations of the subject building.

The radioactive sources in smoke alarms are sealed and contained within a metal case inside the smoke detector and must not be damaged or tampered with. These materials do not pose a hazard as long as they remain contained and properly disposed of at the time of removal or replacement.

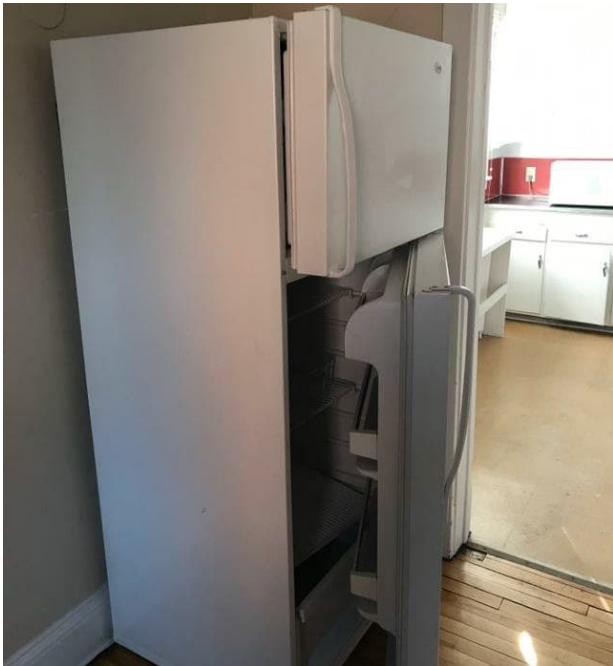
A visual assessment for equipment potentially containing ODSs and other halocarbons was conducted. MPL observed equipment such as refrigerators, water fountains, water coolers, freezers, etc. which contain or are suspected of containing ODSs or other halocarbons. One refrigerator was observed throughout the Kitchen of the subject building.

**Photo 4:** View of the refrigerator, suspected of containing ozone-depleting substance observed in the kitchen.

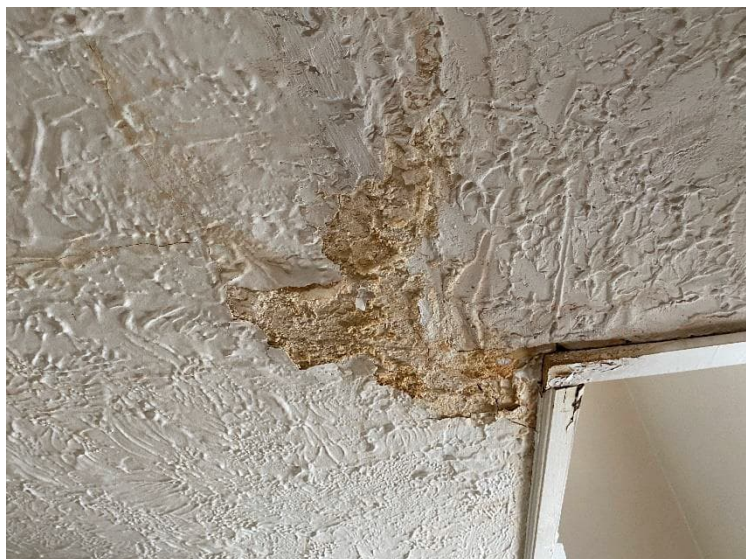
A visual survey of the subject building was conducted to determine if water damage was present. **Building materials affected by water damage were observed in select areas during the 2022 Reassessment.**

**Photo 5:** View of water-damaged texture coat on ceiling observed at the front entrance on the main floor of the subject building during the 2022 reassessment.
