# HAZARDOUS MATERIALS SURVEY AND 2023 REASSESSMENT 66 TEMPLETON STREET, OTTAWA, ON

Project No.: Z2021102HZ / CCC-230252-00

University of Ottawa

McIntosh Perry Limited (MPL)

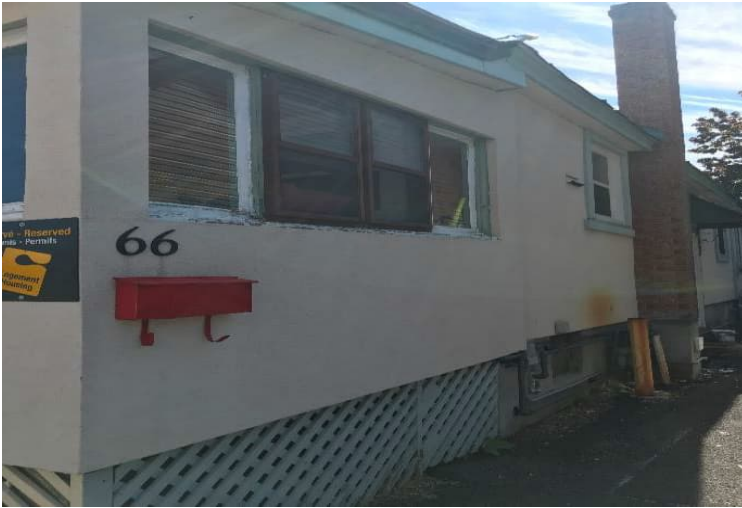
**Photo 1:** View of typical exterior finishes observed at the building located at 66 Templeton Street.

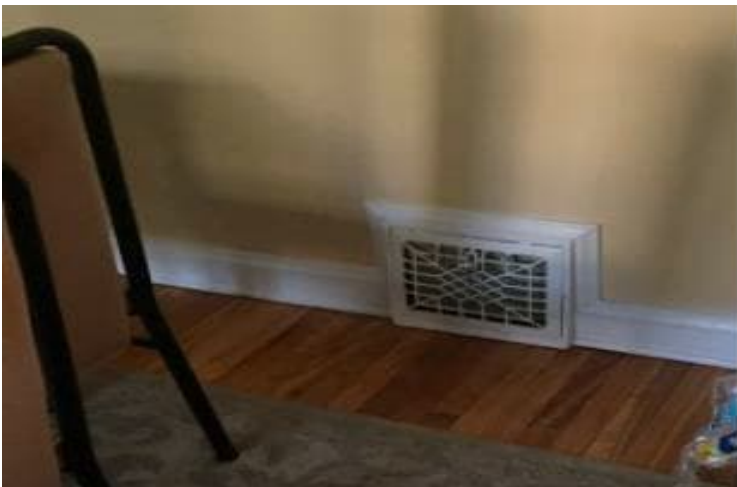
**Photo 2:** View of typical interior finishes observed at the building located at 66 Templeton Street.

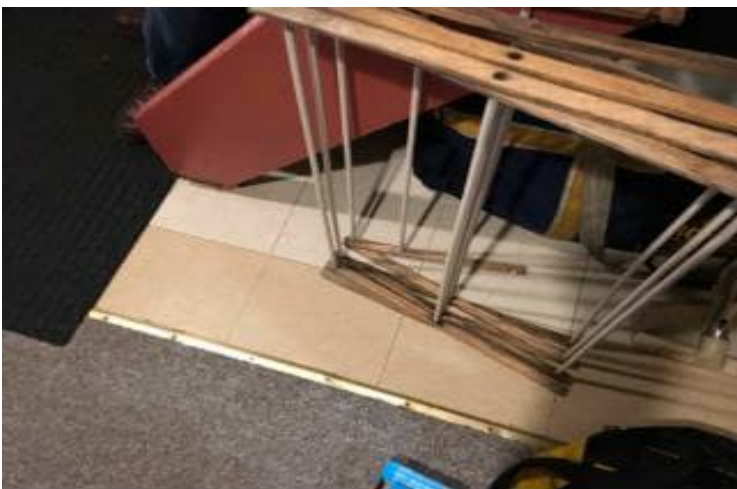
- Vinyl floor tiles (12"x12" – Beige) were observed throughout the basement of 66A. The laboratory analytical results of the vinyl floor tile samples collected indicate that this material does not contain asbestos. The associated mastic (black) does not contain asbestos.
- Vinyl floor tiles (12"x12" – Grey with beige) were observed throughout the basement of 66A. The laboratory analytical results of the vinyl floor tile samples collected indicate that this material does not contain asbestos. The associated mastic (black) does not contain asbestos.

**Photo 3:** View of non-asbestos-containing vinyl floor tiles (12"x12"-grey w/ beige) observed throughout the basement of the subject building.

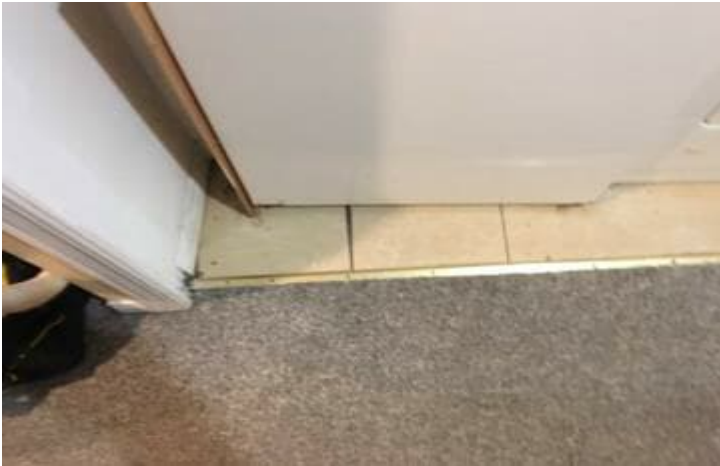
**Photo 4:** View of non-asbestos-containing vinyl floor tiles (12"x12"-beige) observed throughout the basement of the subject building.

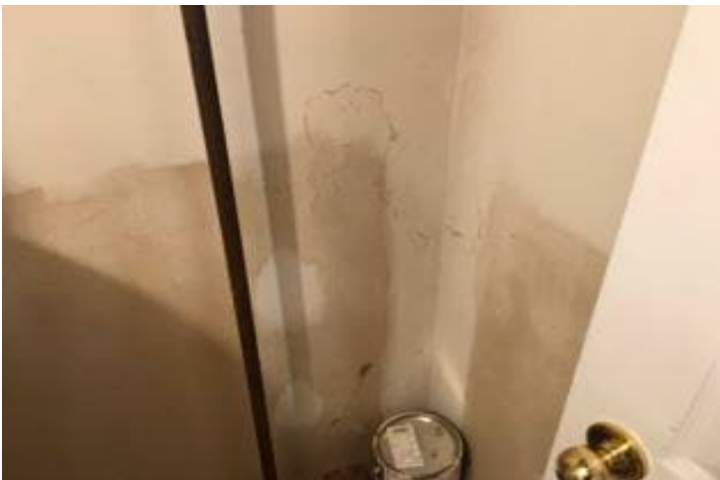
A drywall joint compound was observed throughout the subject building. The laboratory analytical results of the drywall joint compound samples collected indicate that this material does not contain asbestos.

**Photo 5:** Typical view of non-asbestos-containing drywall joint compound observed throughout the subject building.

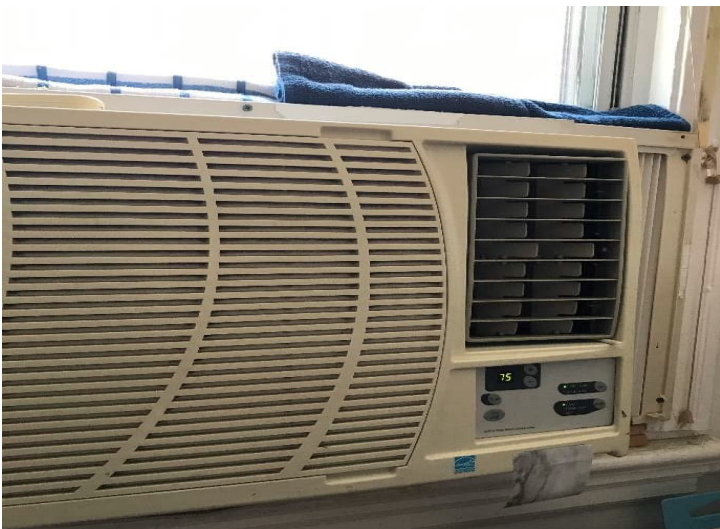
A visual assessment for equipment potentially containing ODSs and other halocarbons was conducted. MPL observed equipment such as refrigerators and air conditioners which contain or are suspected of containing ODSs or other halocarbons.

**Photo 6:** Typical view of the air-conditioning unit containing ozone-depleting substances.

Please refer to Appendix F – Hazardous Materials Checklist for equipment conditions, approximate quantities (where applicable), and recommended actions.
