HAZARDOUS MATERIALS SURVEY AND 2023 REASSESSMENT 70 TEMPLETON STREET, OTTAWA, ON

Project No.: Z2021102HZ / CCC-230252-00

University of Ottawa

McIntosh Perry Limited (MPL)

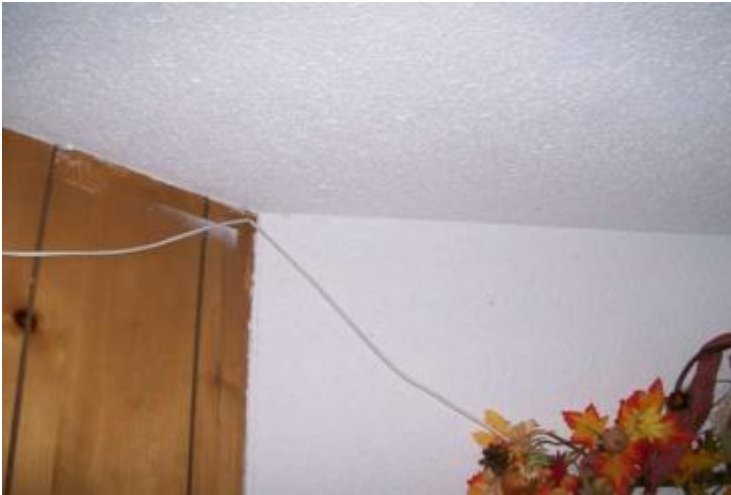
- Ceiling texture coat (stipple) was observed throughout the basement of the subject building. The laboratory analytical results of the texture coat samples collected indicate that this material **contains 2% Chrysotile asbestos**. This material is considered to be friable and was observed to be in good condition.

Photo 1: View of asbestos-containing texture coat (stipple) observed in the basement of the subject building.

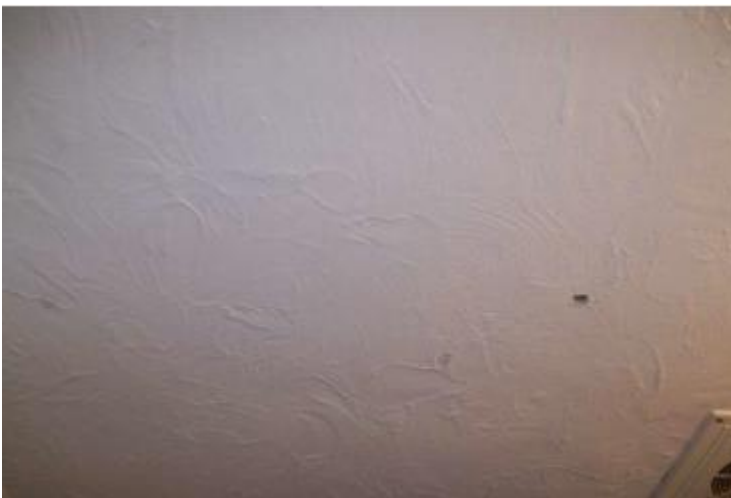
- Ceiling texture coat (random wavy) was observed throughout the bathroom (Room 104) on the 1st floor of the subject building. The laboratory analytical results of the texture coat samples collected indicate that this material **contains 2% Chrysotile asbestos**. This material is considered to be friable and was observed to be in good condition.

Photo 2: View of asbestos-containing texture coat (random wavy) observed in the bathroom of the subject building.

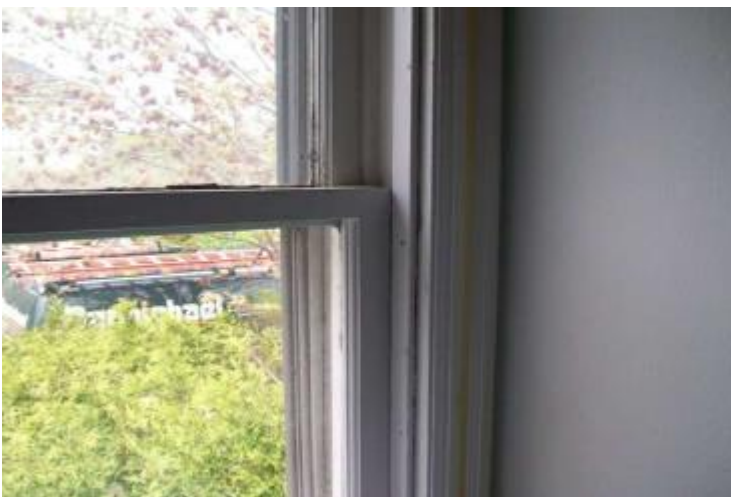
Photo 3: View of lead-containing white paint observed on the window frame in the living room within the subject building.

Paints identified to contain lead that are in good condition and do not pose a risk to workers or occupants can be managed in place.

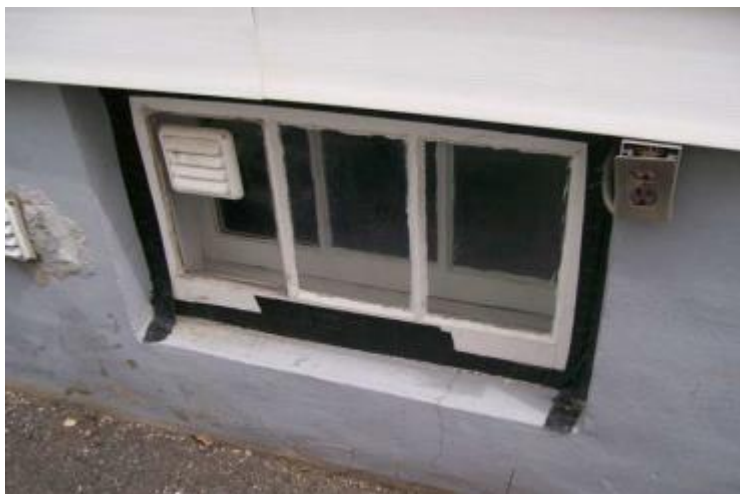
Photo 4: View of lead-containing white paint observed on the window frame on the exterior of the subject building.

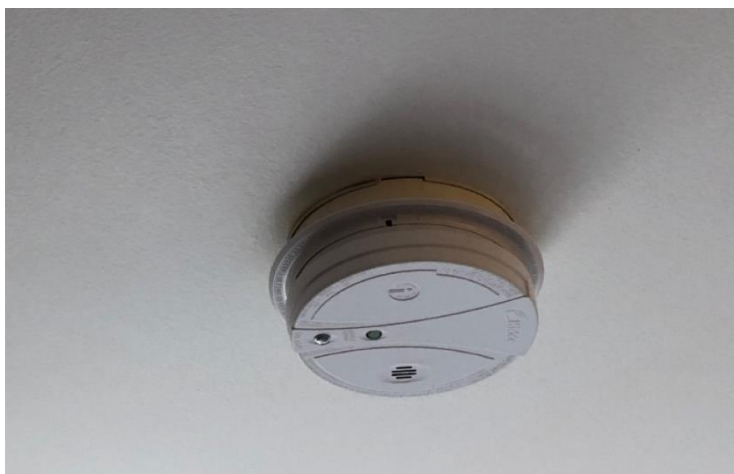
A visual assessment of the subject building was conducted to determine if any electrical components containing radioactive materials were present. Smoke detectors were observed throughout the subject building containing small quantities of radioactive material.

Photo 5: Typical view of smoke detectors containing radioactive materials.

The radioactive sources in smoke alarms are sealed and contained within a metal case inside the smoke detector and must not be damaged or tampered with. These materials do not pose a hazard if they remain contained and properly disposed of at the time of removal or replacement.

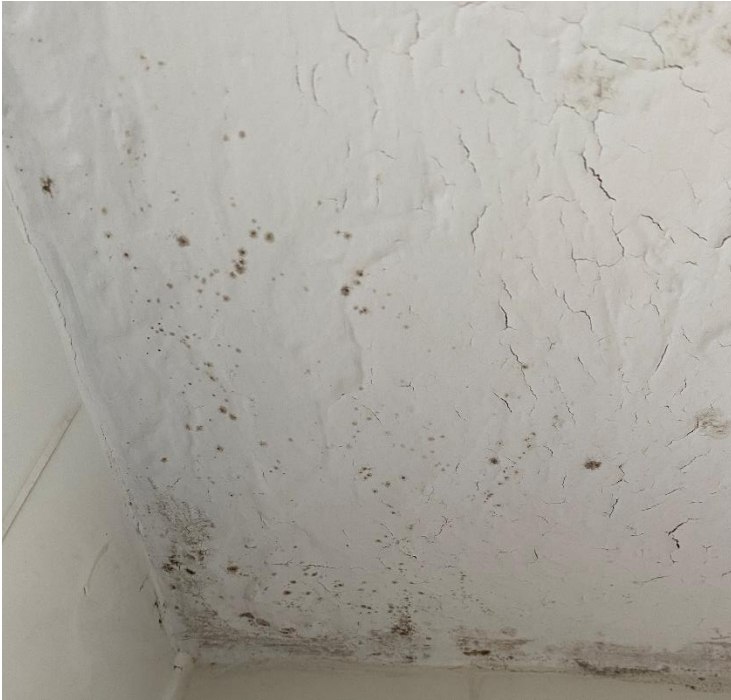
Photo 6: View of poor condition ceiling texture coat observed in Room 104 with mould.

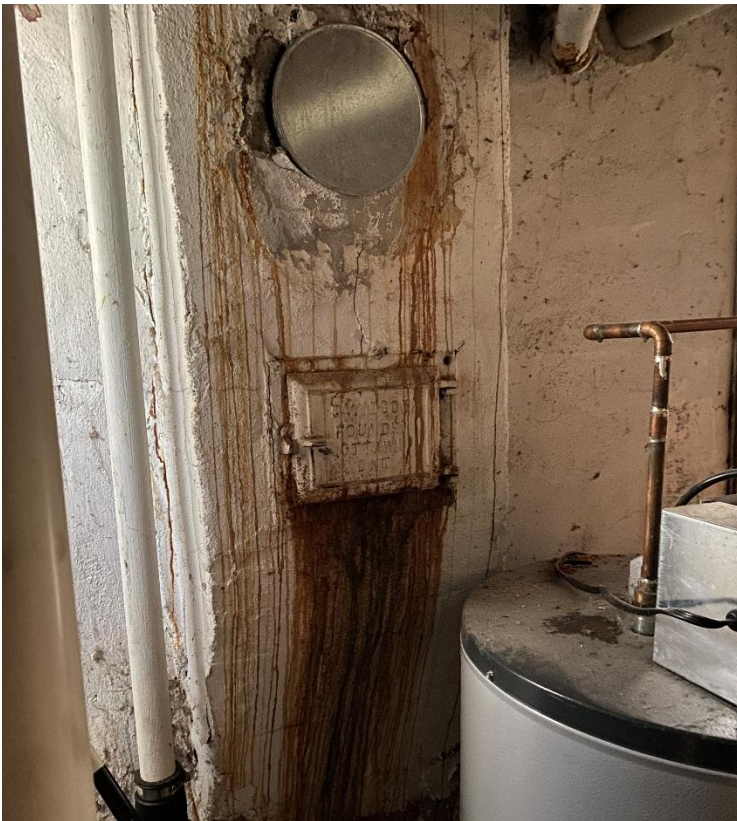
Photo 7: View of water damage observed in the basement laundry room
