# HAZARDOUS MATERIALS SURVEY AND 2023 REASSESSMENT 74 HENDERSON AVENUE, OTTAWA, ON

Project No.: Z2021102HZ/ CCC-230252-00

University of Ottawa

McIntosh Perry Limited (MPL)

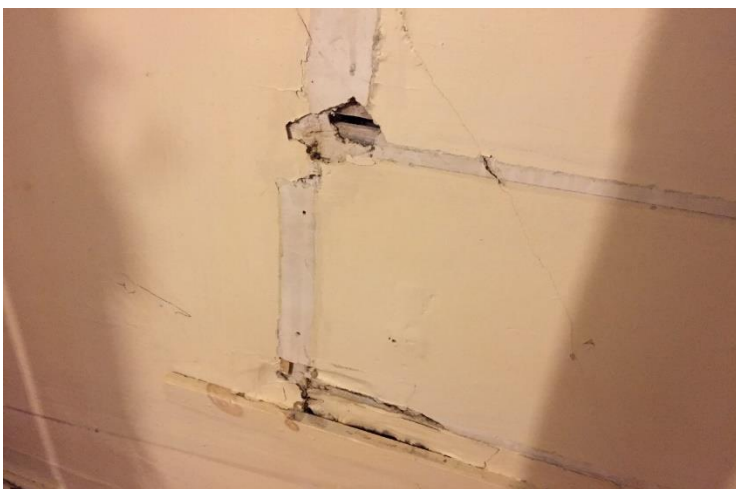
Plaster was observed throughout the subject building. The laboratory analytical results of the plaster samples collected indicate that this material **contains 1% Chrysotile asbestos**. Since plaster is a homogeneous material, all areas must be treated as asbestos-containing unless additional bulk sampling and analysis until proven otherwise. This material is considered friable and observed to be in good, fair and poor condition.

**Photo 6:** View of asbestos-containing plaster in Room 201 observed to be in poor condition.

- ACMs identified to be in poor condition must be repaired/removed immediately, following Type 1/2/3 asbestos abatement work procedures as detailed in O. Reg. 278/05 and disposed of as asbestos waste under O. Reg. 347;

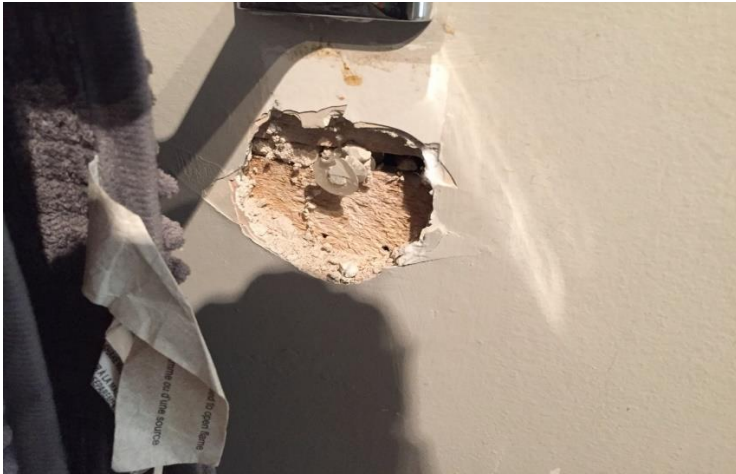
**Photo 7:** View of asbestos-containing plaster in Room 204 observed to be in poor condition.

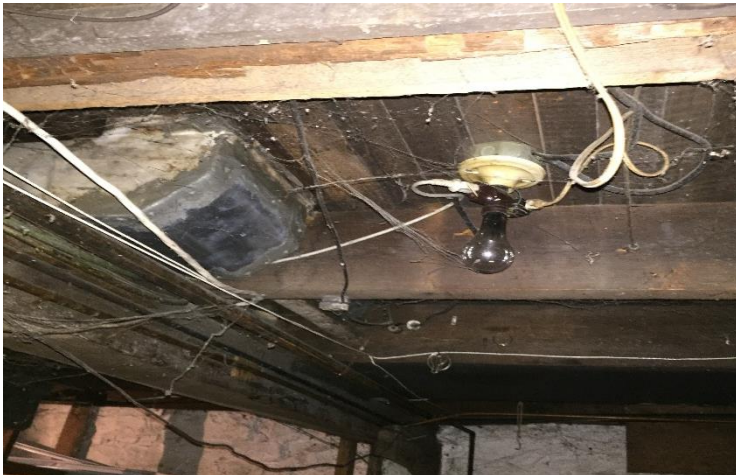
Previously identified HVAC duct insulation was observed in Room 01. The laboratory analytical results indicate that this material contains **60% Chrysotile asbestos**. This material is considered friable and was observed to be in good condition.

**Photo 8:** View of asbestos-containing duct insulation observed in Room 01.

- Materials identified to contain asbestos in good condition and not pose a risk to workers or occupants can be managed in place. Prior to renovation/demolition activities that may disturb the ACMs, these materials must be removed following appropriate Type 1/2/3 asbestos abatement work procedures as detailed in O. Reg. 278/05 and disposed of as asbestos waste under O. Reg. 347;

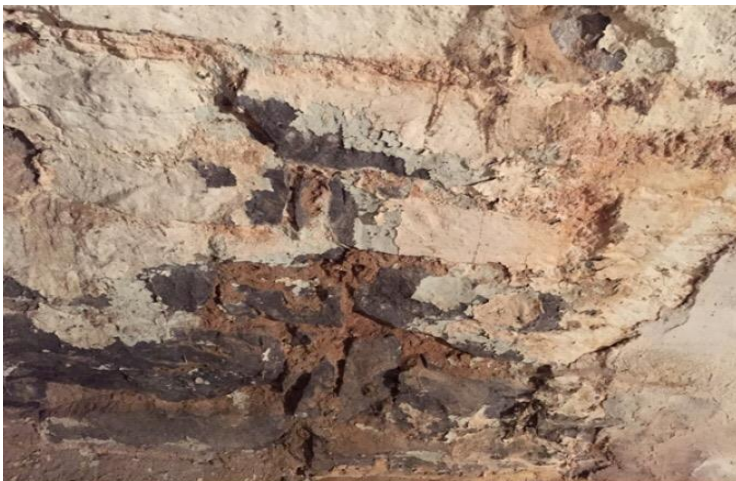
A wall texture coat was observed in Room 01. The laboratory analytical results of wall texture coat samples collected indicate that this material **contains 2% Chrysotile asbestos**. This material is considered friable and was observed to be in fair condition.

**Photo 9:** View of asbestos-containing wall texture coat observed to be in poor condition in Room 01.

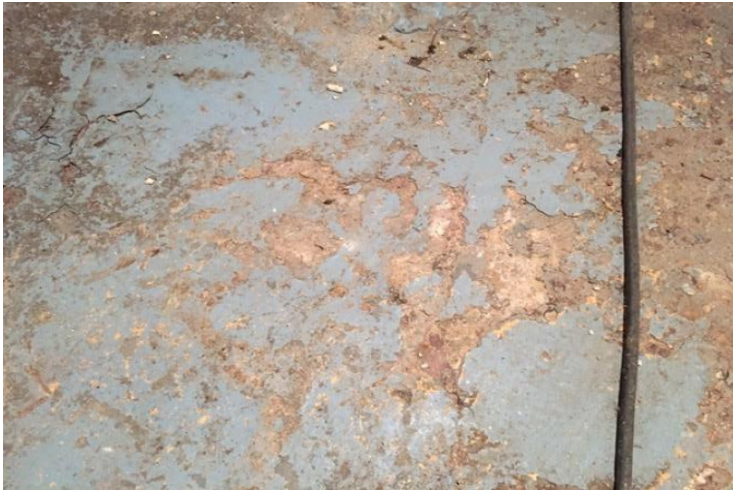
The paint finishes highlighted in pink in the above table are considered lead-containing paints or surface coatings with concentrations greater than 0.1% lead by weight. These paint finishes were observed to be in good condition, except for select areas that were observed in poor condition.

**Photo 10:** View of lead-containing blue floor paint observed to be in poor condition in Room 01.

Paints identified to contain lead that are in poor condition must be immediately repaired and/or stabilized following a minimum Type 1/2 lead abatement procedures as per OMOL “Lead on Construction Project” dated April 2011.

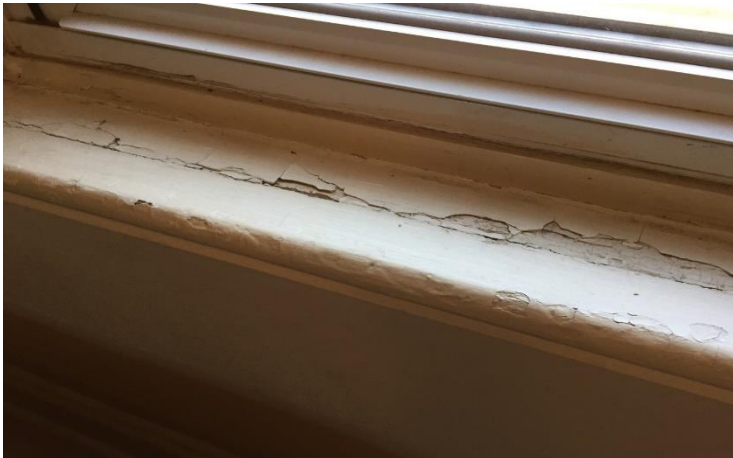
The paint finishes highlighted in blue in the above table was determined to contain low lead concentrations, less than or equal to 0.1%. These paint finishes were observed to be in good condition, except for select areas that were observed in poor condition.

**Photo 11:** View of low level lead white wall paint observed to be in poor condition in Room 202.

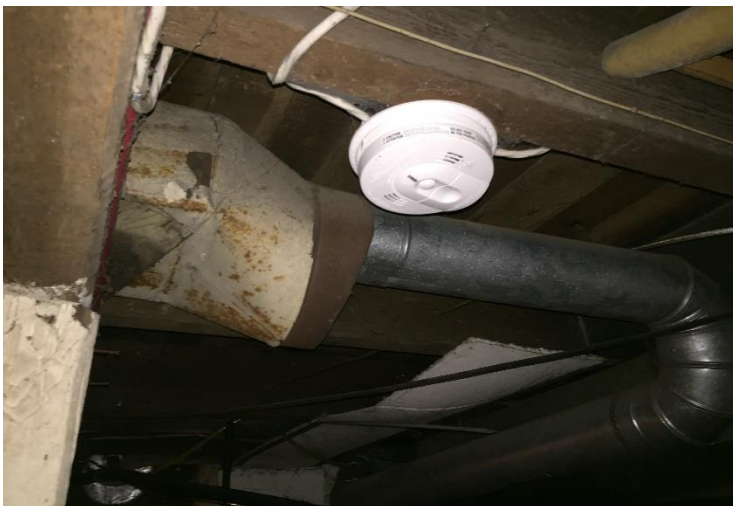
A visual assessment of the subject building was conducted to determine if any electrical components containing radioactive materials were present. Kidde brand smoke detectors were observed, which contain small quantities of radioactive material.

**Photo 12:** Typical view of smoke detectors containing radioactive materials.

The radioactive sources in smoke alarms are sealed and contained within a metal case inside the smoke detector and must not be damaged or tampered with. These materials are not hazardous if they remain contained and properly disposed of during removal or replacement.
