HAZARDOUS MATERIALS SURVEY AND 2023 REASSESSMENT 80 TEMPLETON STREET, OTTAWA, ON

Project No.: Z2021102HZ/ CCC-230252-00

University of Ottawa

McIntosh Perry Limited (MPL)

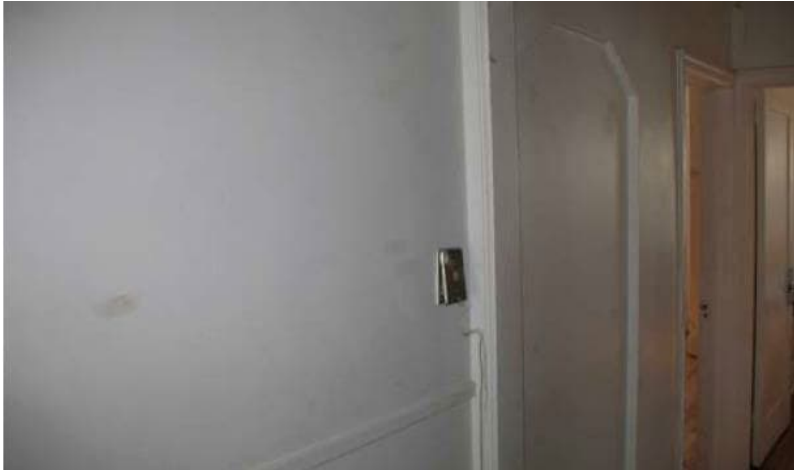
Photo 1: View of typical finishes observed at 80 Templeton Street.

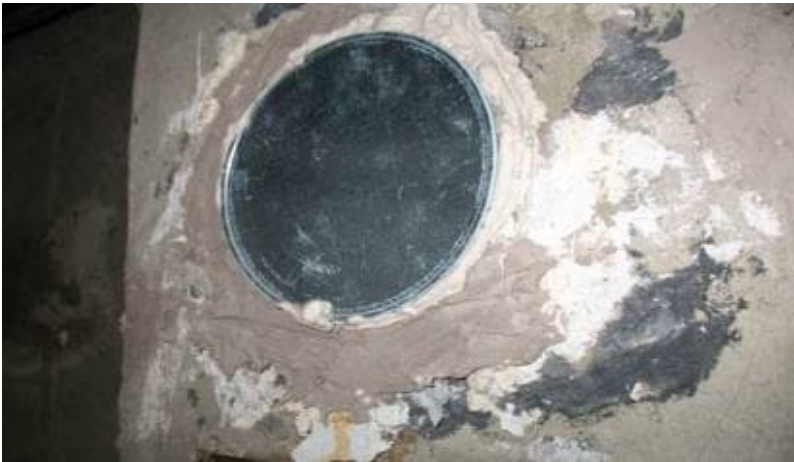
Previously identified chimney insulation associated with the boiler was observed and sampled in Room 002 in the subject building. The laboratory analytical results of chimney insulation samples collected indicate that this material **contains 60% Chrysotile asbestos**. This material is friable and was observed to be in poor condition.

Photo 2: View of asbestos-containing boiler insulation associated with the chimney observed in Room 002 in the basement of the subject building.

- ACMs identified to be in poor condition must be repaired/removed immediately, following Type 1/2/3 asbestos abatement work procedures as detailed in O. Reg. 278/05 and disposed of as asbestos waste under O. Reg. 347;

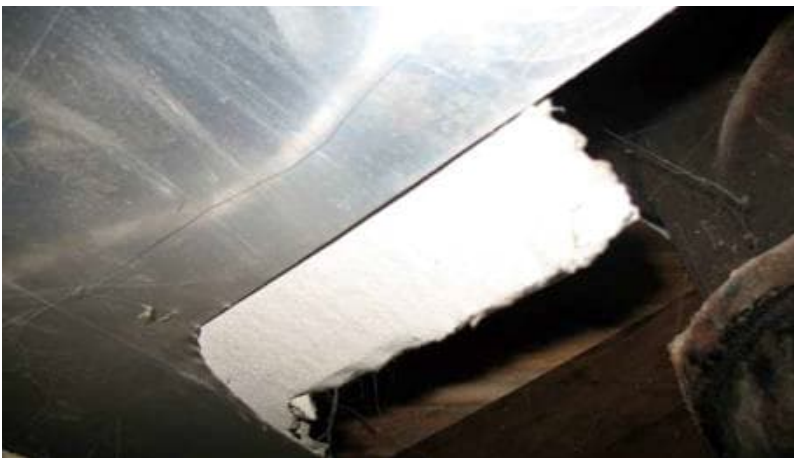
Previously identified aircell pipe insulation was observed and sampled in Room 002 in the subject building. The laboratory analytical results of aircell pipe insulation samples collected indicate that this material **contains 60% Chrysotile asbestos**. This material is friable and was observed to be in good condition.

Photo 3: View of asbestos-containing aircell pipe insulation observed in Room 002 in the basement of the subject building.

- Materials identified to contain asbestos that are in good condition and do not pose a risk to workers or occupants can be managed in place. Prior to renovation/demolition activities that may disturb the ACMs, these materials must be removed following appropriate Type 1/2/3 asbestos abatement work procedures as detailed in O. Reg. 278/05 and disposed of as asbestos waste under O. Reg. 347;

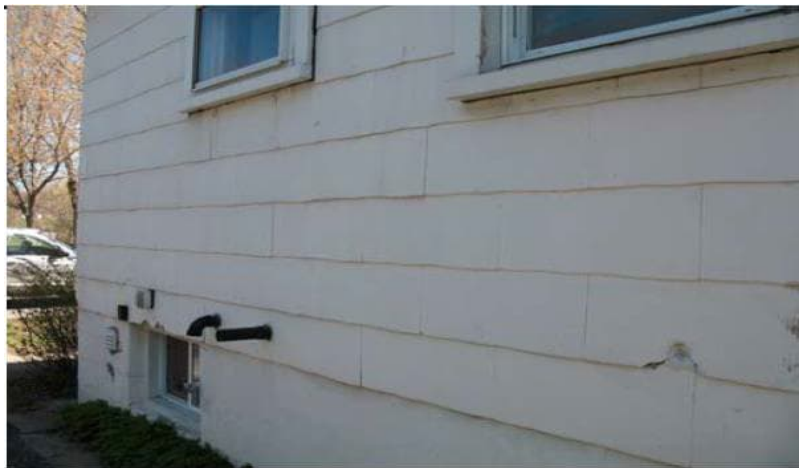
Previously identified transite siding was observed and sampled on the exterior of the subject building. This material was found to **contain 15% Chrysotile asbestos**. This material is considered to be non-friable and was observed to be in good condition.

Photo 4: View of asbestos-containing siding-transite observed on the exterior of the subject building.
