HAZARDOUS MATERIALS SURVEY AND 2022 REASSESSMENT ANNEX RESIDENCE, 265 LAURIER AVENUE EAST, OTTAWA, ON

Project No.: CCC-214260-00 / CCC-230252-00

University of Ottawa

January 19, 2023

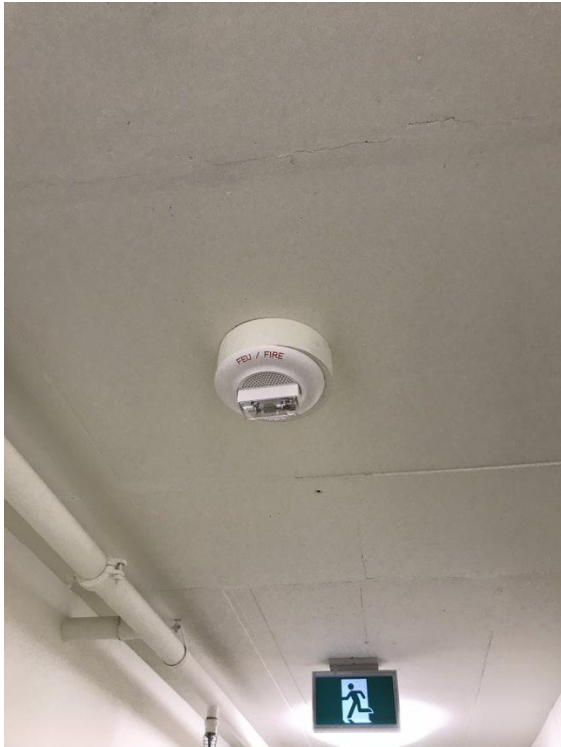
A visual assessment of the subject building was conducted to determine if any electrical components containing radioactive materials were present. MPL observed smoke detectors, which contains small quantities of radioactive material.

The radioactive sources in smoke alarms are sealed and contained within a metal case inside the smoke detector and must not be damaged or tampered with. These materials do not pose a hazard as long as they remain contained and properly disposed at the time of removal or replacement.

Photo 1: Representative view of the smoke detectors containing small amounts of isotope Americium 241, observed throughout the subject building.

Please refer to Appendix F – Hazardous Materials Checklist for equipment conditions, quantities (where applicable), and recommended actions.
