# HAZARDOUS MATERIALS SURVEY AND 2023 REASSESSMENT D'ORIO HALL, OTTAWA, ON

Project No.: Z2021101HZ / CCC-230252-00

University of Ottawa

October 31, 2023

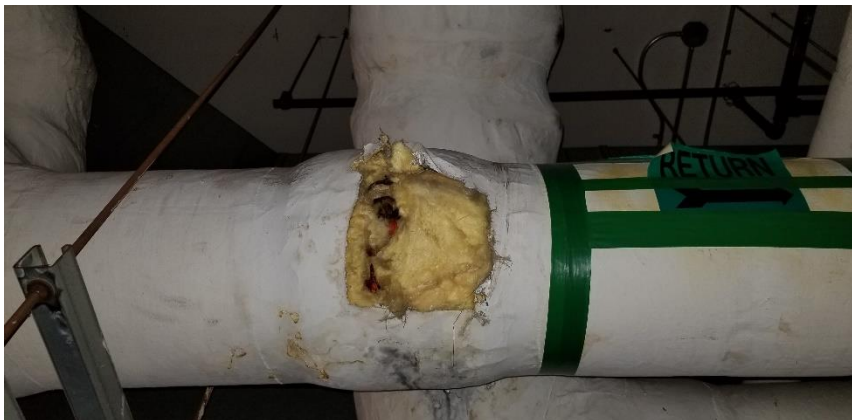
Mechanical pipe elbows/fittings insulation was observed throughout the subject building. MPL made several incisions throughout to investigate its composition, and it was visually identified as fibreglass and, therefore, not suspected of containing asbestos.

**Photo 2:** Representative view of the non-asbestos-containing mechanical insulation observed throughout the subject building.

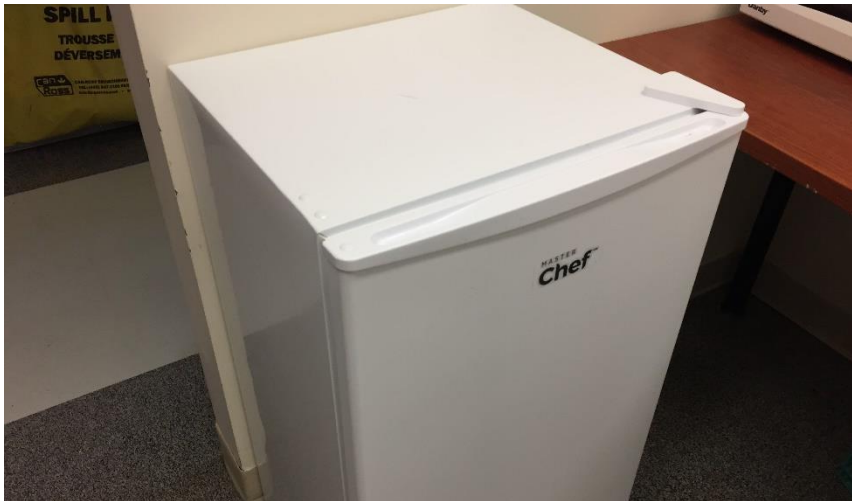
A visual assessment for equipment potentially containing ODSs and other halocarbons was conducted. Equipment containing ODSs or other halocarbons was observed throughout the subject building.

**Photo 4:** Representative view of the equipment containing ODSs observed throughout the subject building.

Please refer to Appendix F – Hazardous Materials Checklist for equipment conditions, approximate quantities (where applicable), and recommended actions.
