HAZARDOUS MATERIALS SURVEY AND 2023 REASSESSMENT 70 LAURIER AVENUE (HAMELIN HALL), OTTAWA, ON.

Project No.: Z2021101HZ / CCC-230252-00

University of Ottawa

McIntosh Perry Limited (MPL)

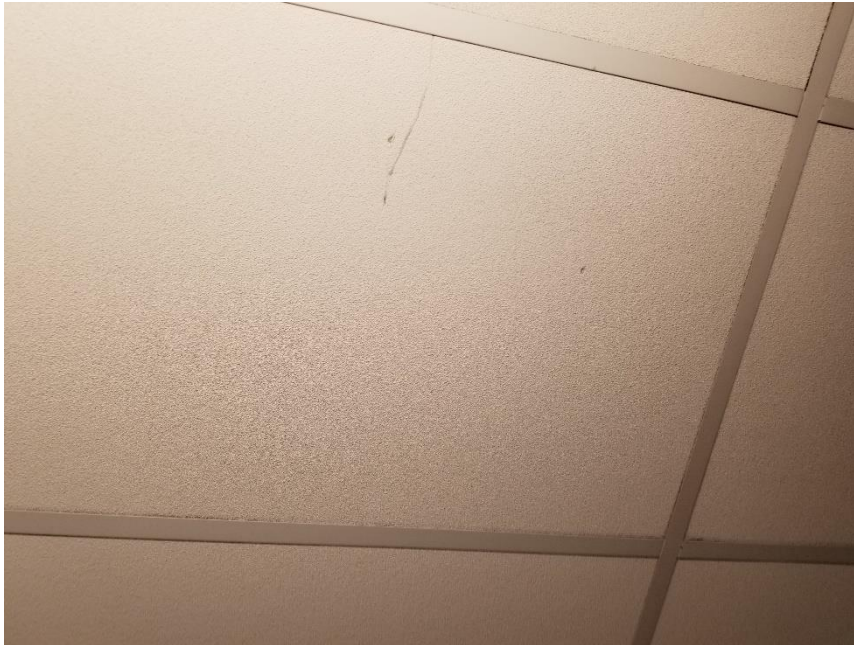
Photo 1: Typical view of non-asbestos-containing acoustical ceiling tiles observed in some areas of the subject building.

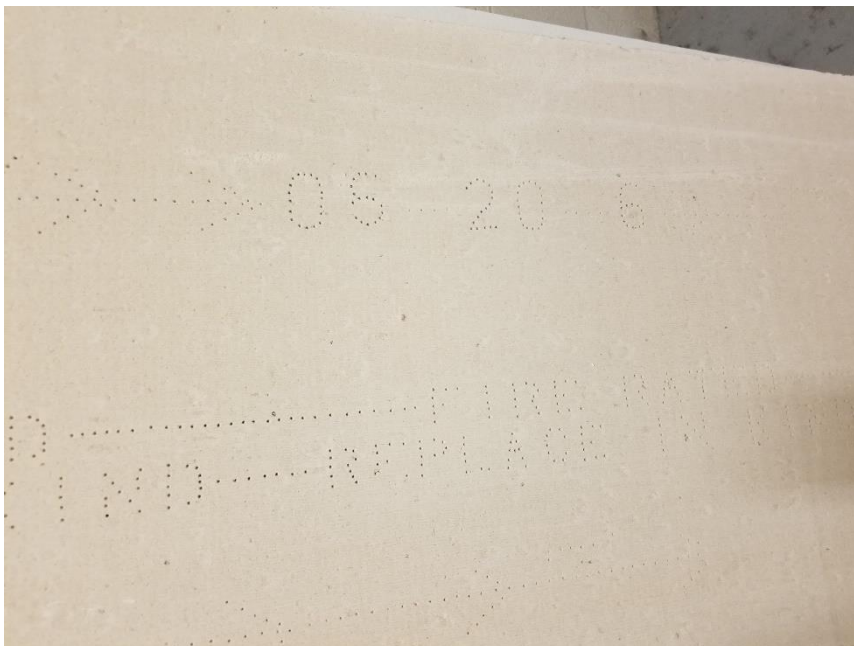
- Suspended ceiling tiles (2"x4"– Pinholes w/ Small Fissure) were observed in Room 019. Previous laboratory analytical results of the ceiling tiles samples collected from Room 019 indicate that this material does not contain asbestos.
- Suspended ceiling tiles (2"x4" – Pinholes w/ Large Fissure) were observed in Room 019. Previous laboratory analytical results of the ceiling tiles samples collected from Room 019 indicate that this material does not contain asbestos.
- Suspended ceiling tiles (Textured) were observed in Room 030. The date stamp on the back of these tiles indicated that they were manufactured in 2006. Therefore, this material is not considered to contain asbestos.

Photo 2: View of non-asbestos-containing suspended ceiling tiles with a date stamp that indicates that they were manufactured in 2006.

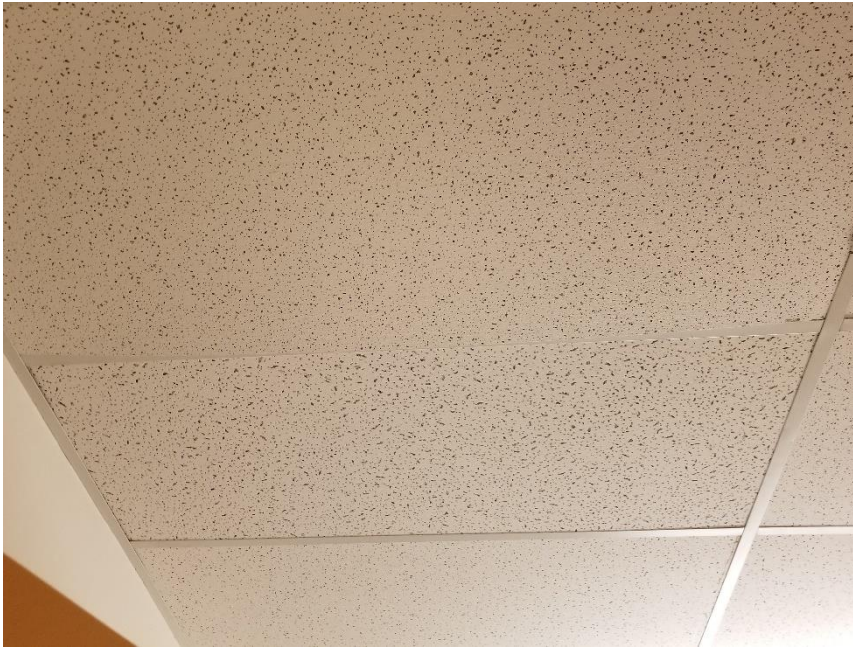
Photo 3: View of non-asbestos-containing suspended ceiling tiles (Pinholes w/ Large Fissure).

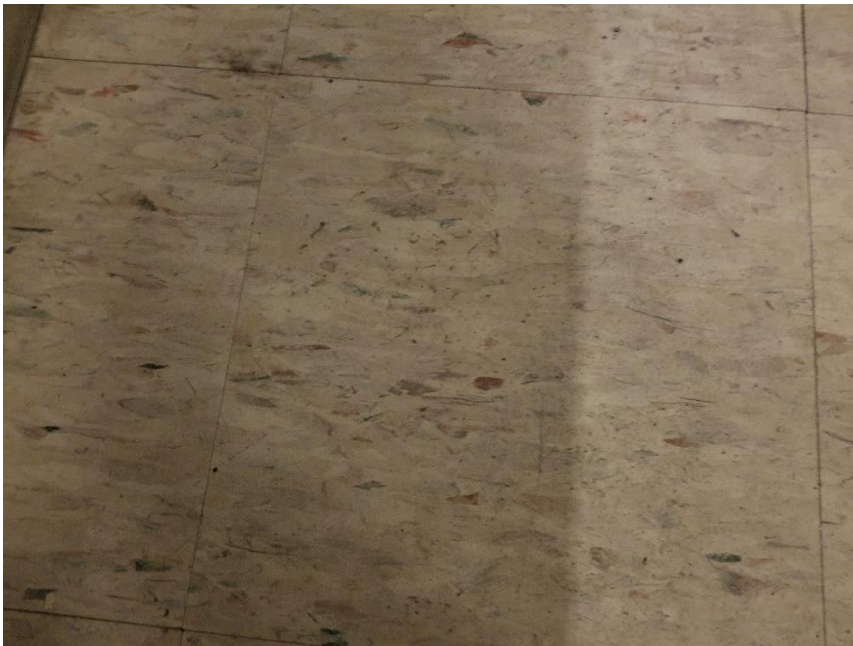
Photo 4: View on non-asbestos containing vinyl floor tiles (12"x12"-Beige w/ Brown Flakes)

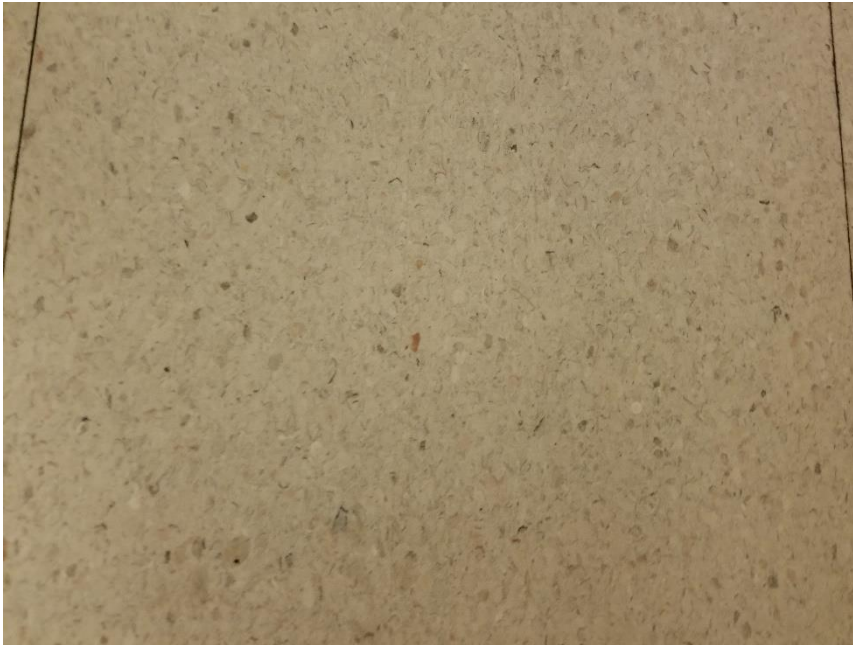
Photo 5: View on non-asbestos containing vinyl floor tiles (12"x12"- White, Brown & Grey Flakes)

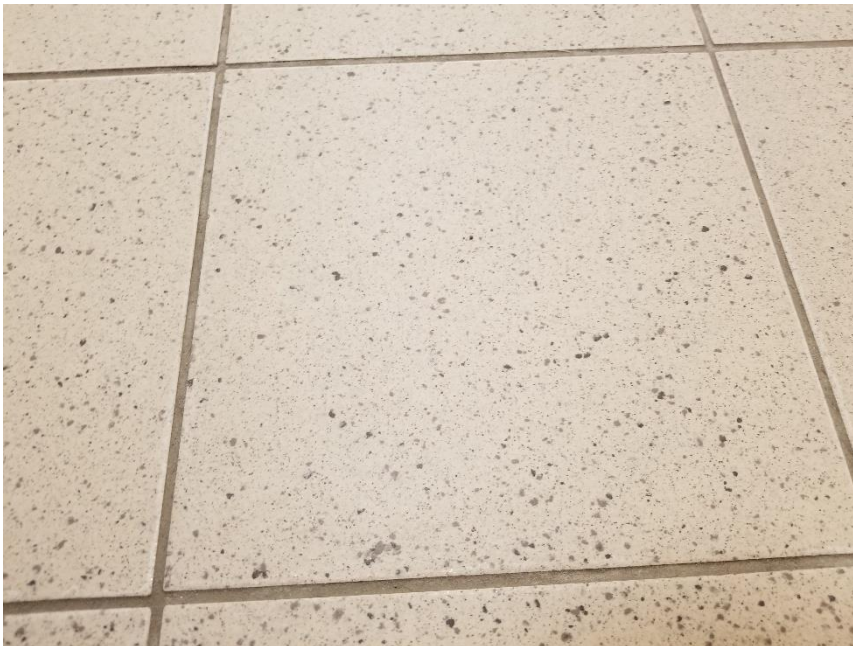
- Vinyl floor tiles (12"x12"- Grey w/ Dark Flakes) were observed in Room 109. Previous laboratory analytical results of the vinyl floor tile samples collected from Room 109 indicate that this material does not contain asbestos. The associated mastic (grey/yellow) did not contain asbestos.

Photo 6: View on non-asbestos containing vinyl floor tiles (12"x12"-Grey w/ Dark Flakes)

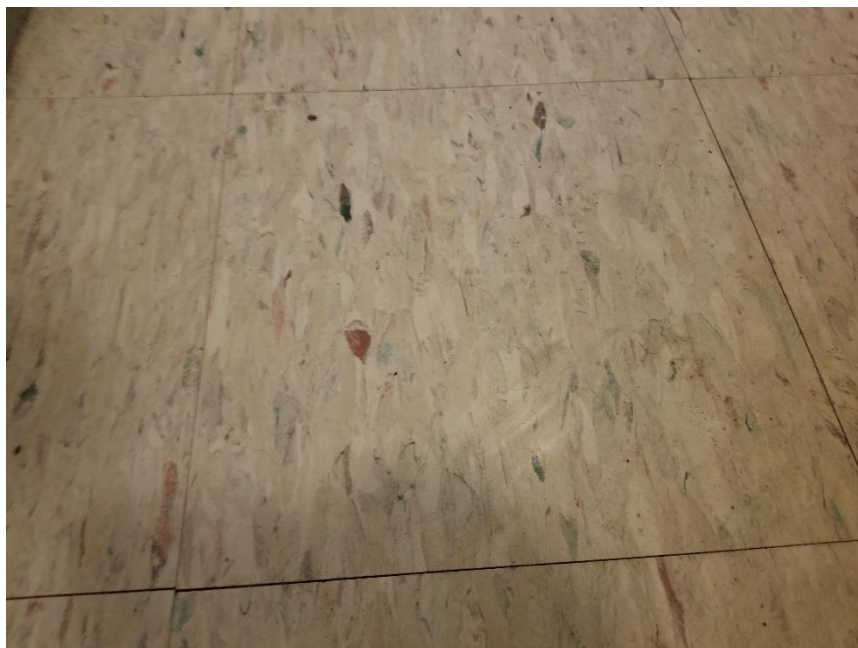
- Vinyl floor tiles (12"x12"- Beige w/ Red & Blue Specks) were observed in Room 007. Previous laboratory analytical results of the vinyl floor tile samples collected from room 007 indicate that this material does not contain asbestos. The associated mastic (black) was also found not to contain asbestos.

Photo 7: View on non-
asbestos containing
vinyl floor tiles
(12"x12" - Beige w/
Red & Blue Specks)
