HAZARDOUS MATERIALS SURVEY AND 2022 REASSESSMENT MARION HALL, OTTAWA, ON

Project No.: OZ2021101HZ / CCC-230252-00

University of Ottawa

January 6, 2023

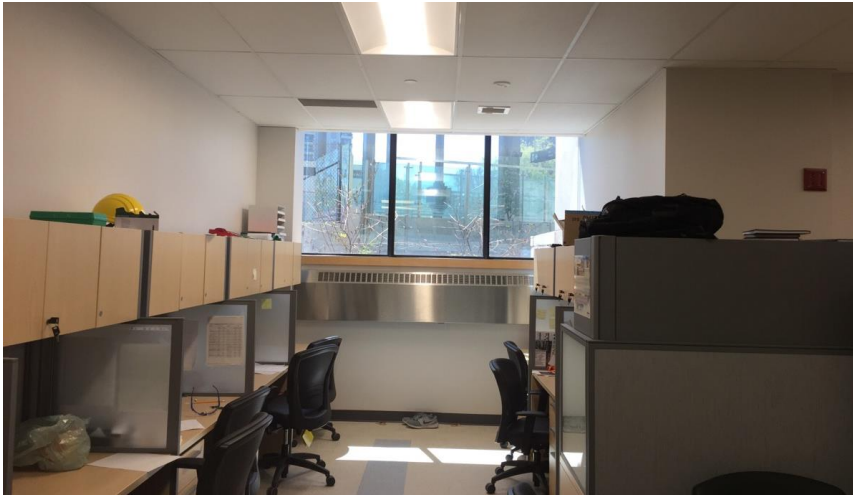
Photo 1: Representative view of the interior finishes observed throughout the subject building.

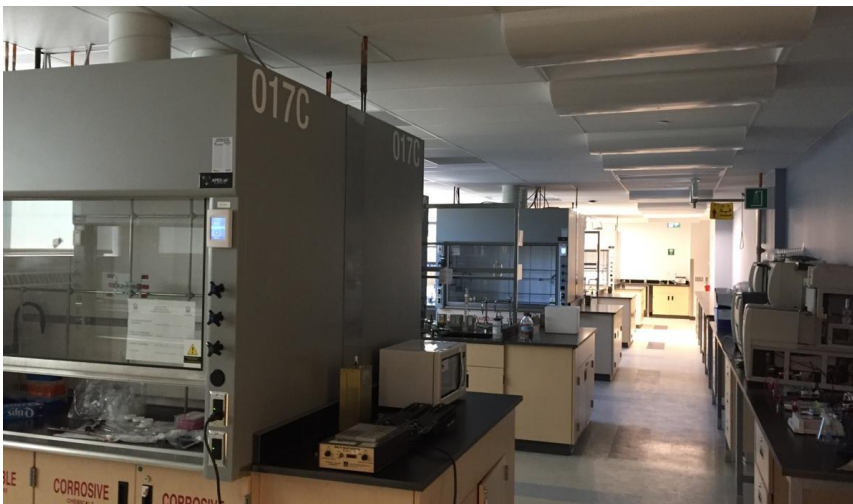
Photo 2: Representative view of the interior finishes observed throughout the subject building.

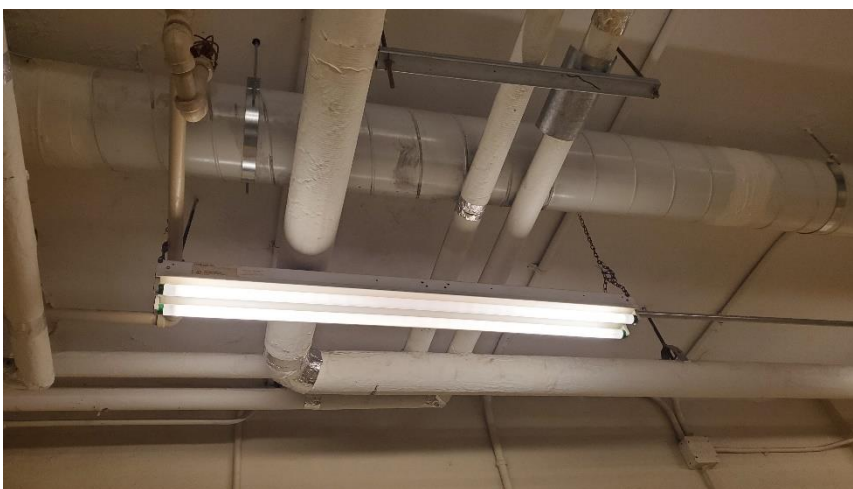
Photo 3: Representative view of the fluorescent light fixtures containing mercury vapour, observed throughout the subject building.

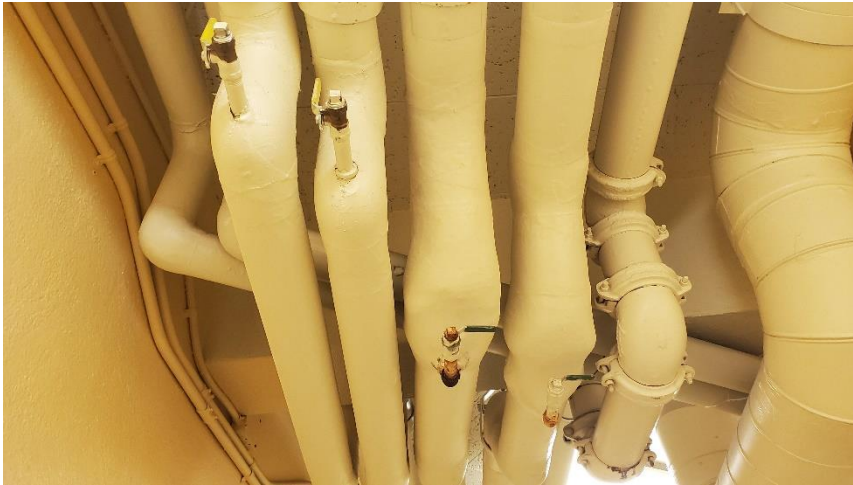
Previously identified asbestos-containing mechanical pipe elbows/fittings parging cement insulation was observed in Rooms 007, 007D, 014B, 028. This material contains 20% Chrysotile asbestos. This material is considered friable and was observed in good condition during the 2022 Reassessment.

Photo 4: View of the asbestos-containing parging cement pipe elbow/fitting insulation observed in good condition in Room 014B.

- Materials identified to contain asbestos that are in good condition and do not pose a risk to workers or occupants can be managed in place. Prior to renovation/demolition activities that may disturb the ACMs, these materials must be removed following appropriate Type 1/2/3 asbestos abatement work procedures as detailed in O. Reg. 278/05 and disposed of as asbestos waste under O. Reg. 347;

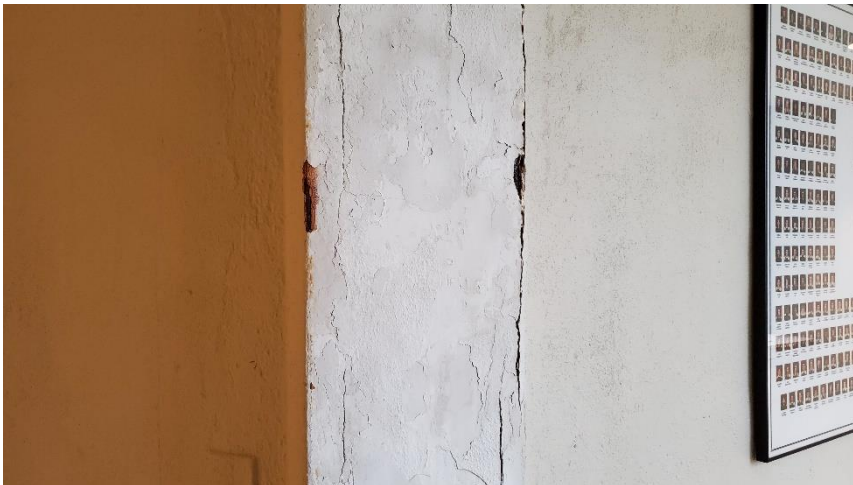
Photo 5: View of the non-asbestos containing wall plaster observed throughout the subject building.

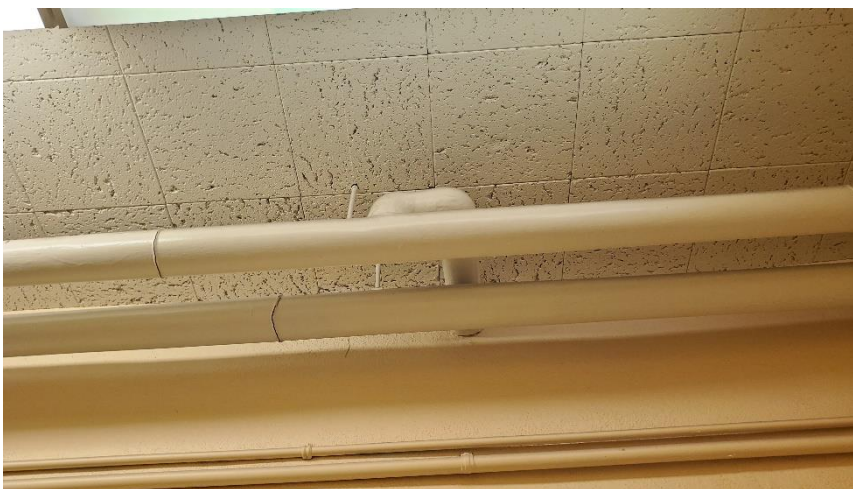
- Glue-on ceiling tiles (1'x1'- Pinholes & Large Fissures) were observed and sampled in Rooms 023A and 014B. The laboratory analytical results indicate that this material contains 4% Amosite asbestos. This material was observed in good condition during the 2022 Reassessment.
- Glue-on ceiling tiles (1'x1'- White) were previously sampled in Room 017, 020, 030A and 133. The laboratory analytical results indicated that this material does not contain asbestos.

Photo 6: Representative view of the asbestos containing ceiling tiles (1'x1' – Pinholes and Large Fissures) observed in good condition.

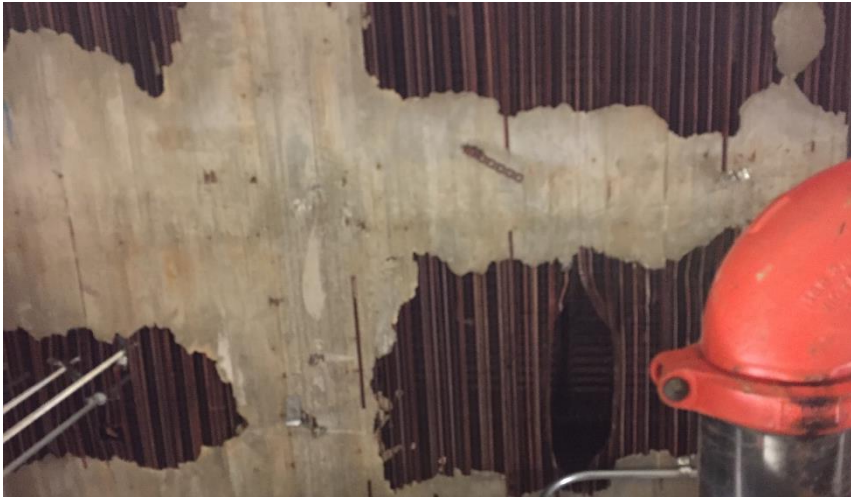
Photo 7: View of the non-asbestos containing ceiling plaster observed in Room 005.

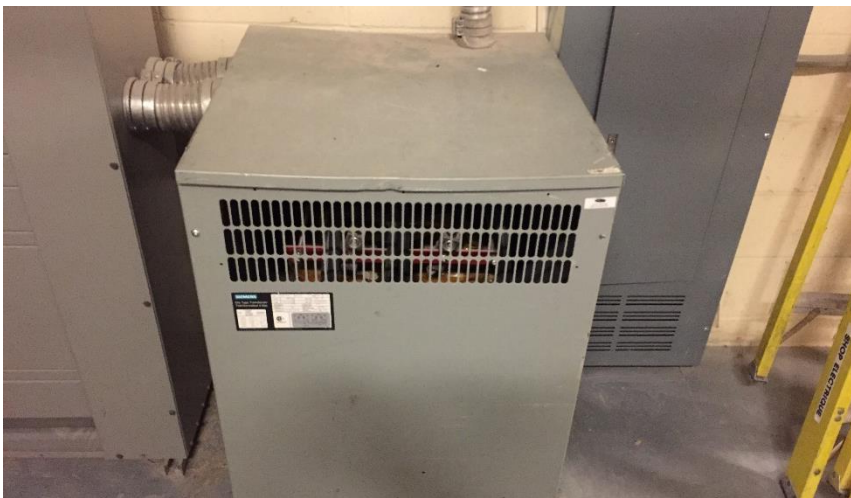
MPL did not observe any PCBs containing electrical transformers within the subject building. Transformers that could be assessed were observed to be dry-type and manufactured by Hammond Manufacturing.

Photo 8: View of the non-PCB dry-type transformers observed throughout the subject building.

Since no PCB containing equipment were observed or suspected to be present during the site survey, no further action is required.

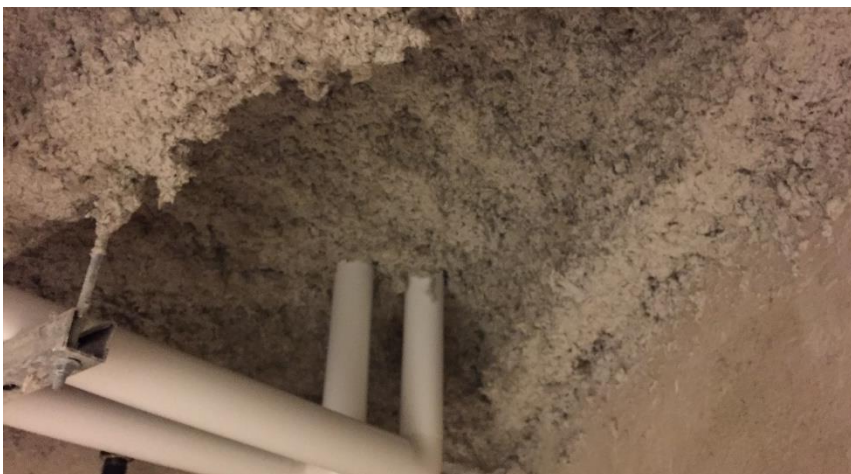
- Fireproofing (Grey) was observed and sampled in Room 07. The laboratory analytical results indicate that this material does not contain asbestos.
- Fireproofing (Grey) was previously sampled in Room 016 and 207. The laboratory analytical results indicated that this material does not contain asbestos.

Photo 9: View of the non-asbestos containing sprayed fireproofing (Grey) observed in Room 07.

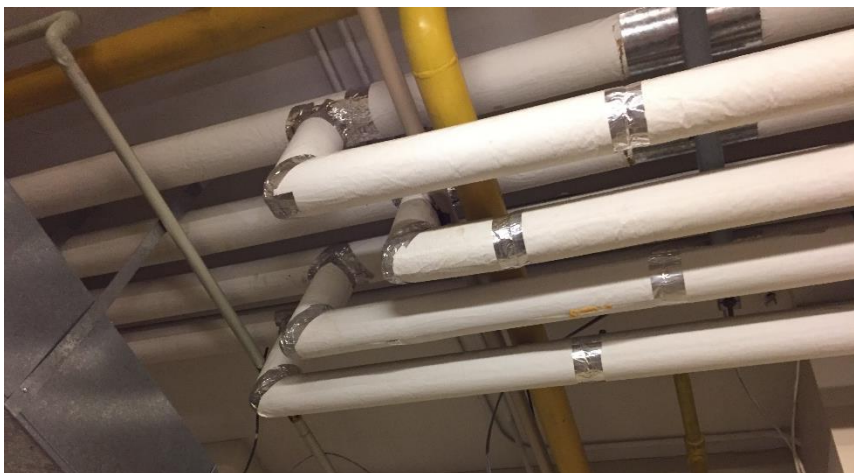
Photo 10: Representative view of the non-asbestos containing mechanical insulation observed in Room 0015.

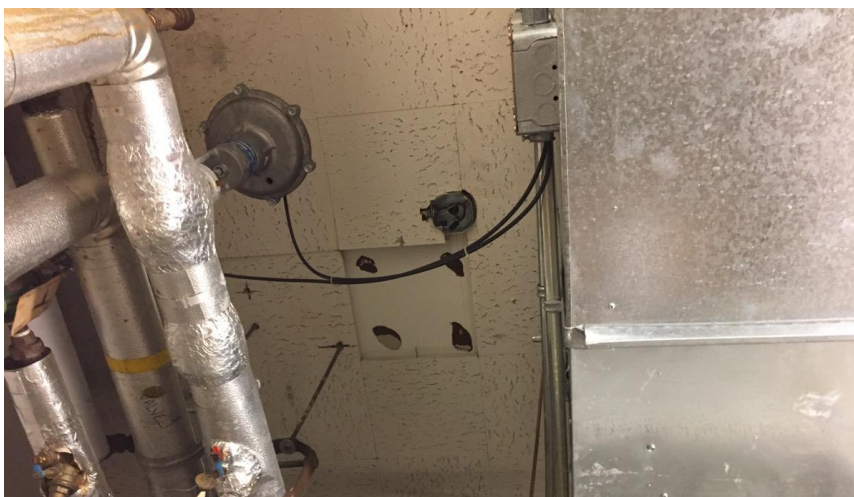
Photo 11: Representative view of the asbestos containing ceiling tiles (1'x1' – Pinholes and Large Fissures) observed in Room 023A.

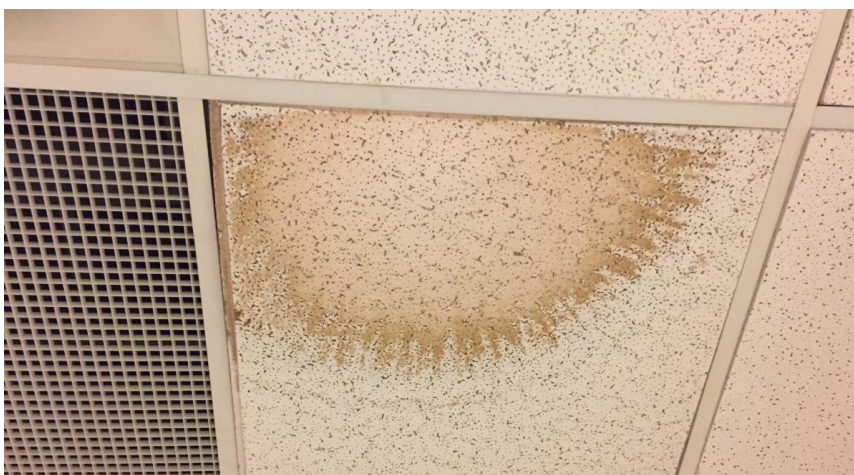
A visual survey of the subject building was conducted to determine if any water damaged was present. MPL identified ceiling tiles throughout the subject building which were affected by water damage.

Photo 12: View of the water damaged ceiling tiles observed in Room 0011A.

Water stained/damaged ceiling tiles observed throughout the subject building should be replaced as part of regular maintenance and the underlying cause of the water leakage should be identified and repaired.
