HAZARDOUS MATERIALS SURVEY AND 2023 REASSESSMENT MINTO SPORTS COMPLEX, OTTAWA, ON

Project No.: Z2021101HZ / CCC-230252-00

University of Ottawa

October 31, 2023

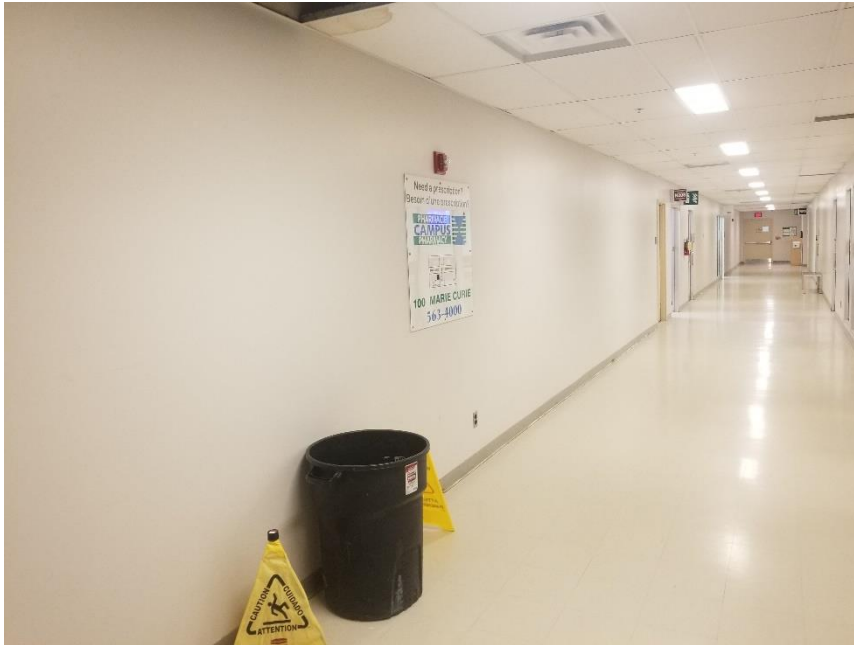
Photo 1: Typical view of finishes observed throughout the subject building.

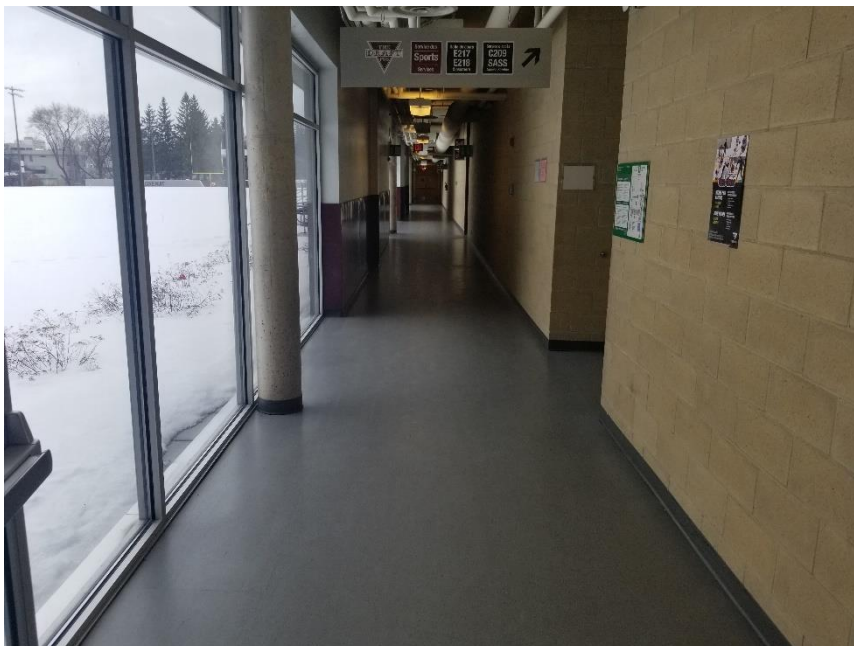
Photo 2: Typical view of finishes observed throughout the subject building.

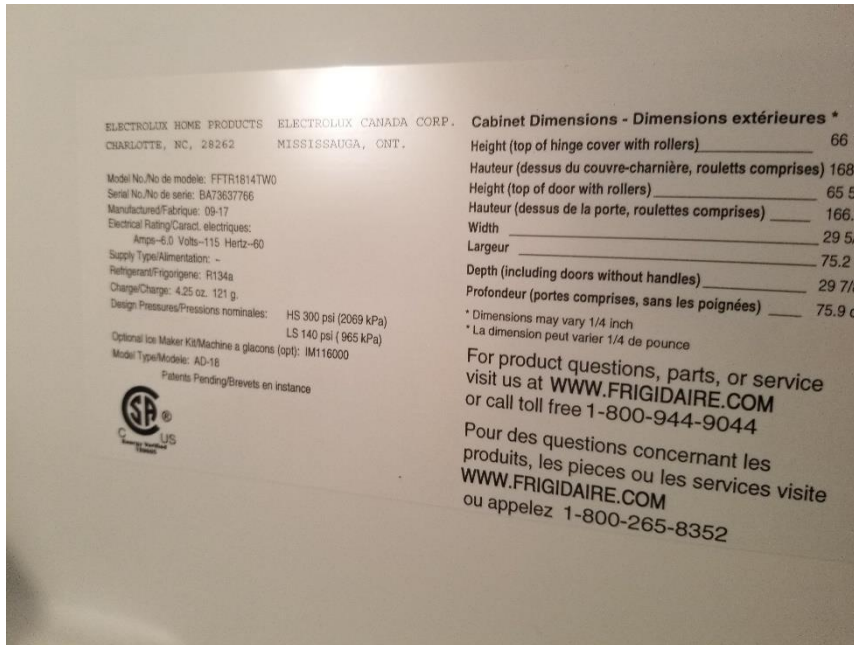
A visual assessment for equipment potentially containing ODSs and other halocarbons was conducted. Equipment containing ODSs or other halocarbons was observed throughout the subject building.

Photo 3: Typical refrigerators were observed to contain ODS.

Please refer to Appendix F – Hazardous Materials Checklist for equipment conditions, approximate quantities (where applicable), and recommended actions.
