# HAZARDOUS MATERIALS SURVEY AND 2022 REASSESSMENT ROGER GUINDON HALL, OTTAWA, ON

Project No.: Z1920014HZ / CCC-230252-00

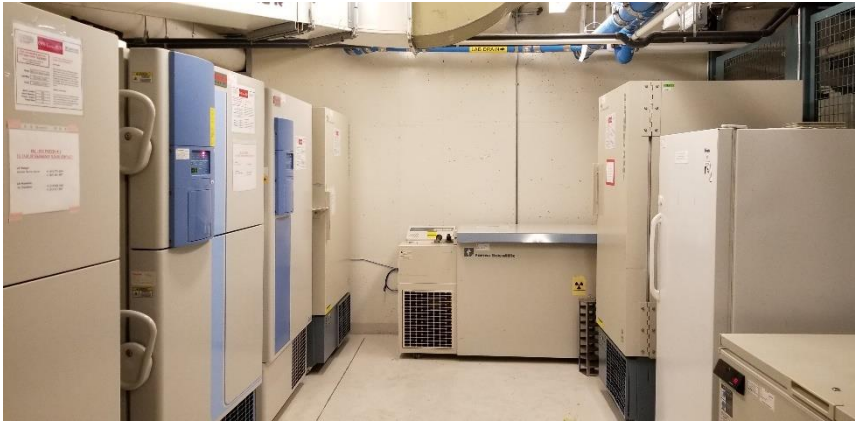
Photo 1: Representative view of refrigeration equipment observed in Room 0509, containing various ozone depleting substances.

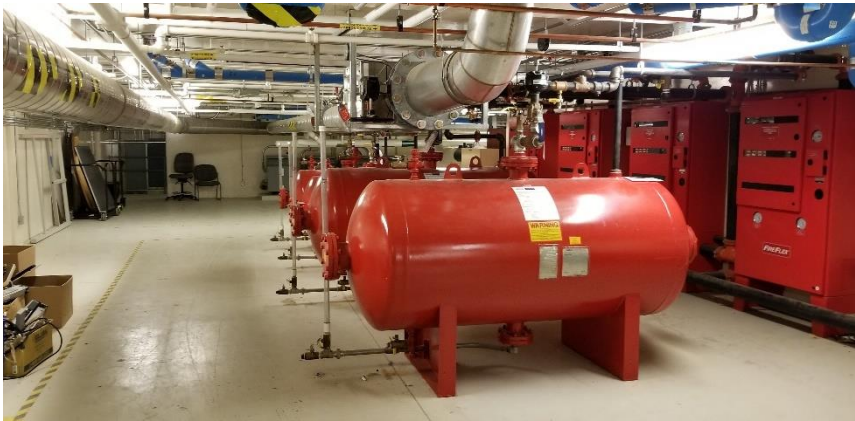
Photo 2: Representative view of the above ground foam tanks observed in Room 0507.

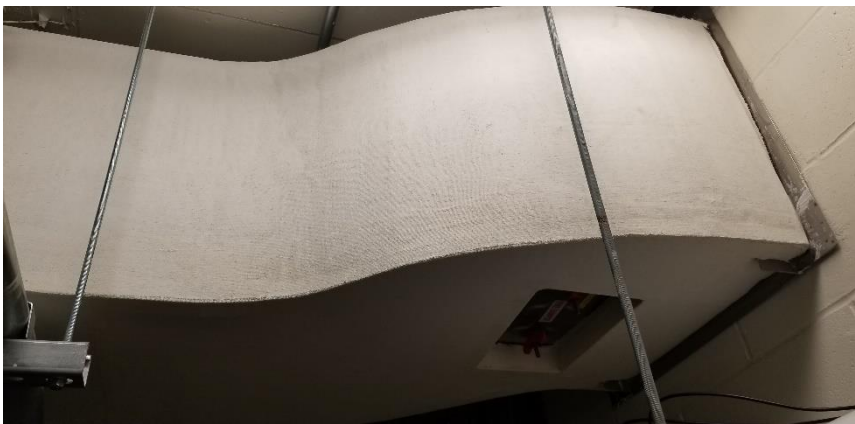
Photo 3: Representative view of the fiberglass insulation observed on HVAC ducts in Room 0515.

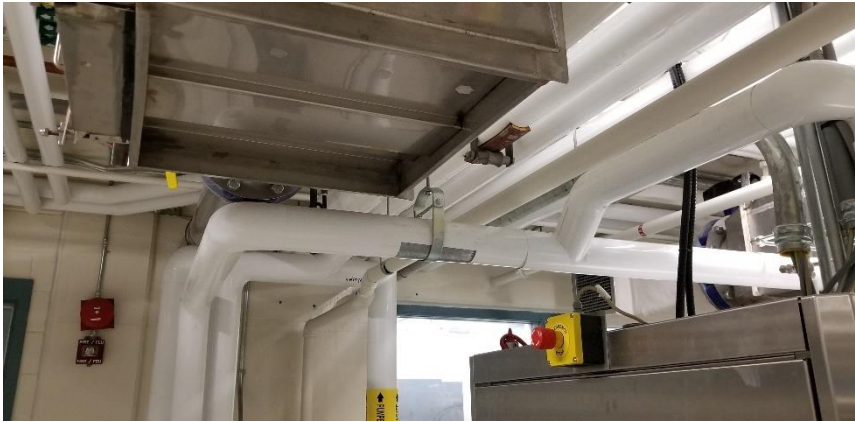
Photo 4: Representative view of the fiberglass insulation observed in Room 0516A/B.

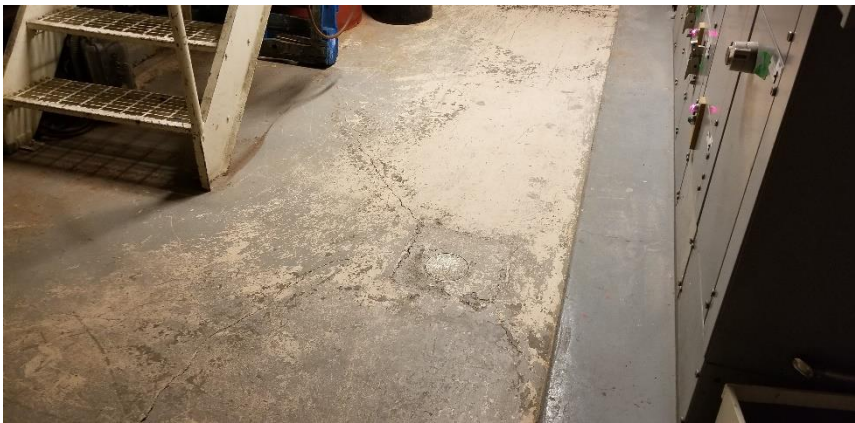
Photo 5: View of the poor condition lead floor paint (Grey) observed in Room 1138.

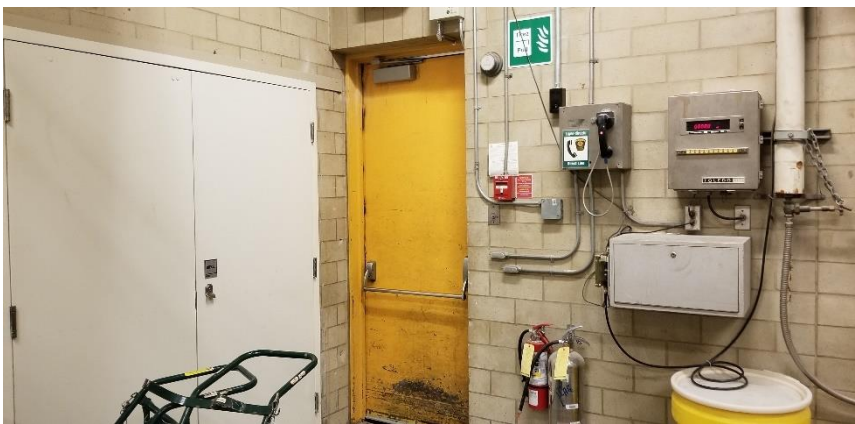
Photo 6: Representative view of the yellow lead paint observed in poor condition in Room 1129.

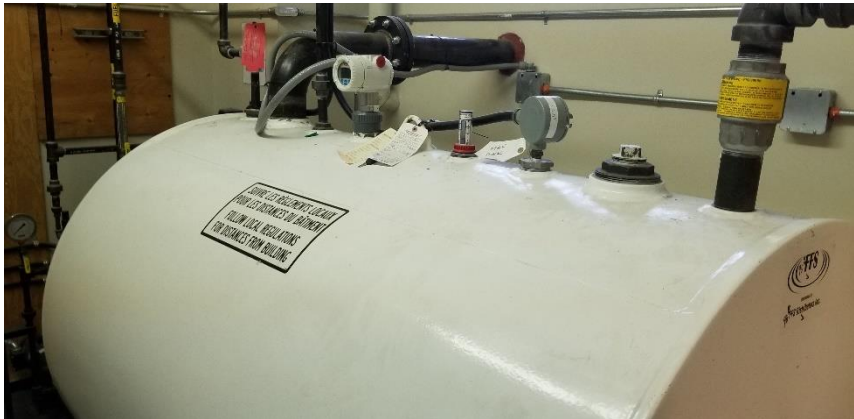
Photo 7: View of the above ground diesel storage tank observed in Room 1129C.

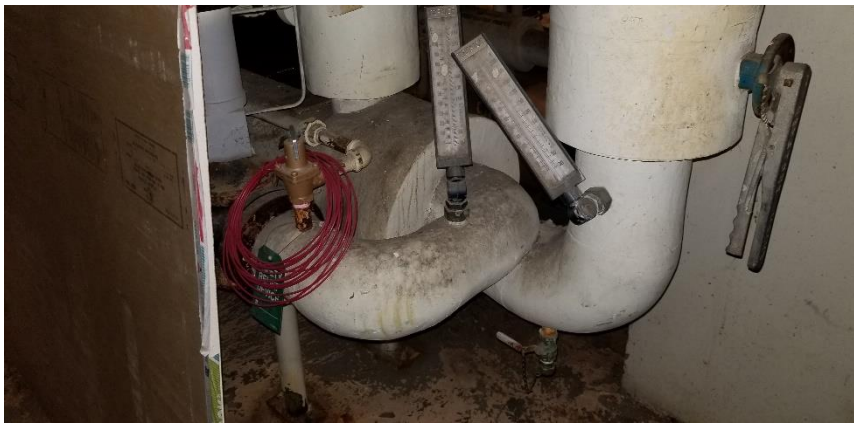
Photo 8: Representative view of the non-asbestos pipe elbow/fitting insulation observed in Room 1138.

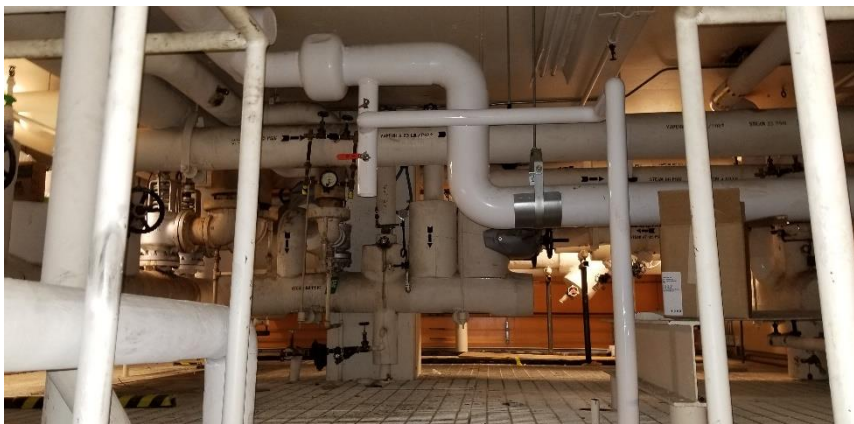
Photo 9: Representative view of the fiberglass insulation observed in Room 1138.

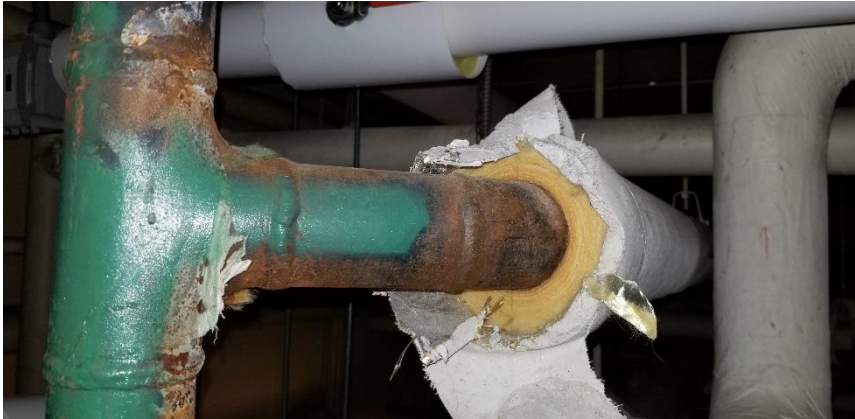
Photo 10: Representative view of the fiberglass insulation observed in Room 1138.

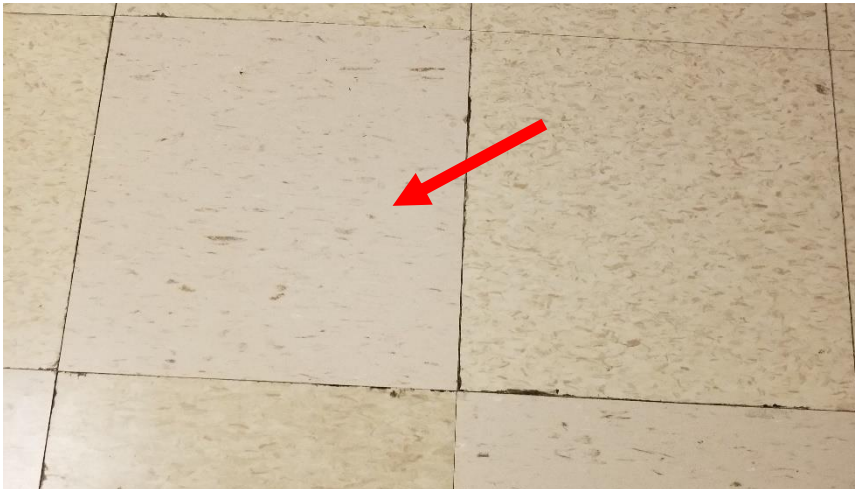
Photo 11: Representative view of the asbestos containing VFT (12"x12" Beige w/ Grey Flakes) observed throughout the subject building.

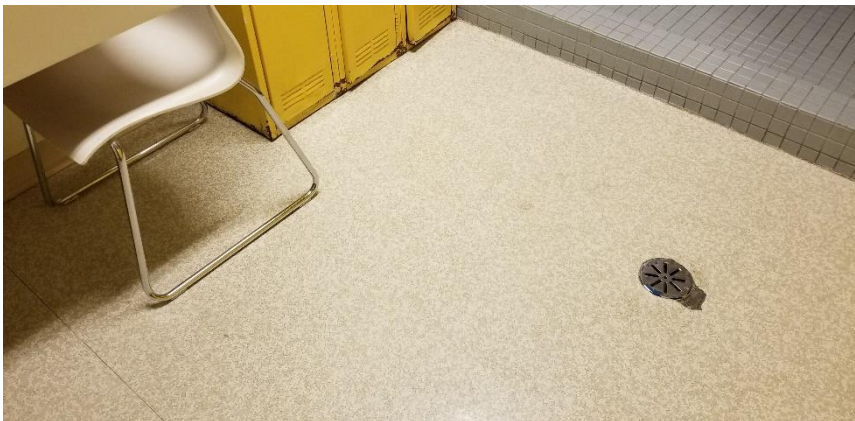
Photo 12: View of the non-asbestos vinyl sheet flooring (Beige Geometric Pattern) observed and sampled in Room 1113.

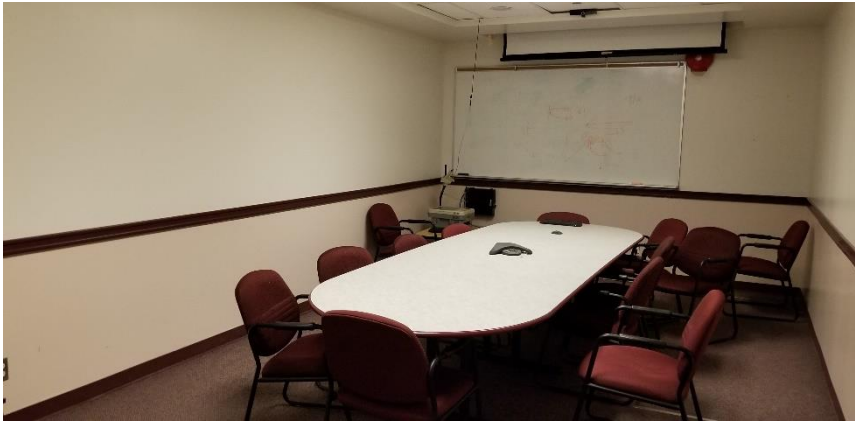
Photo 13: Representative view of the finishes observed in Room 1111.

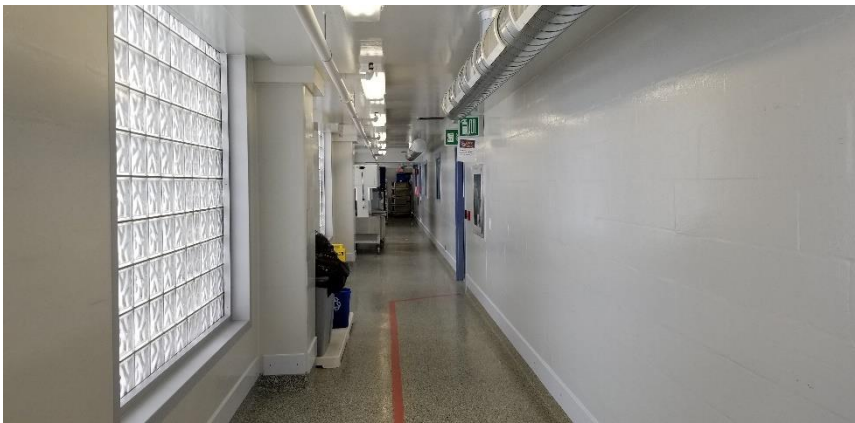
Photo 14: Representative view of the finishes observed in Room 1500K

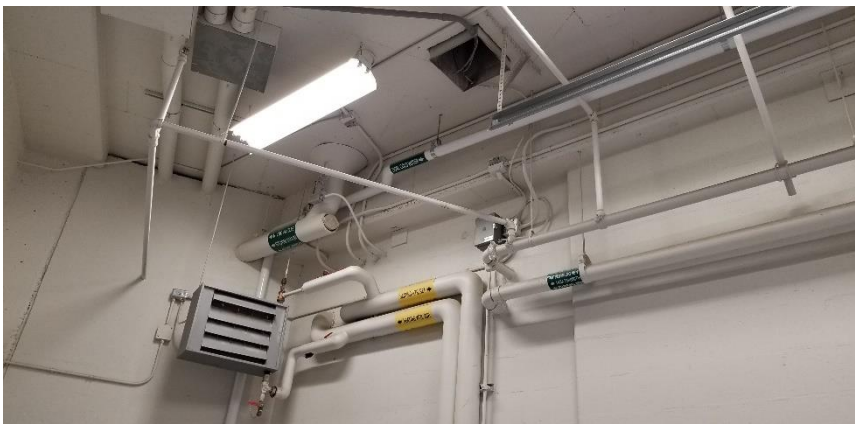
Photo 15: Representative view of the fiberglass insulation observed in Room 1506.

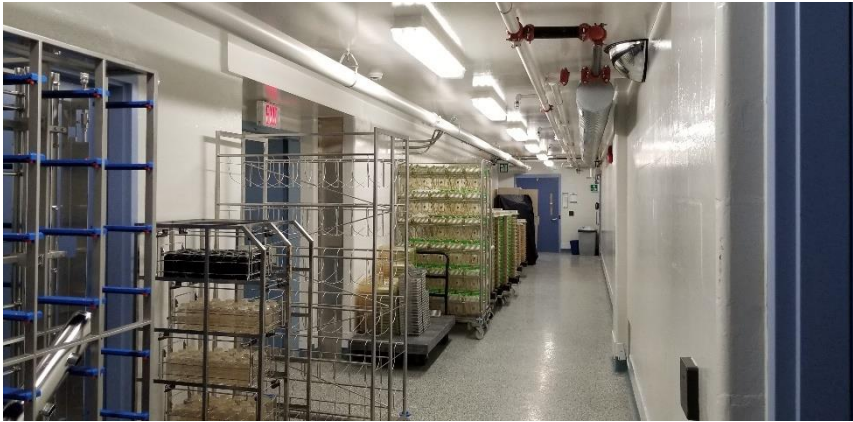
Photo 16: Representative view of the finishes observed in the hallway outside of Room 1500J.

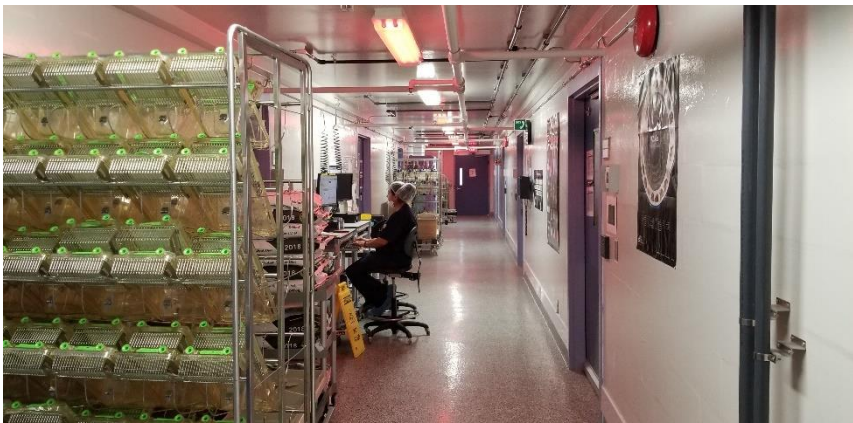
Photo 17: Representative view of the finishes observed in the hallway outside of Room 1500J.

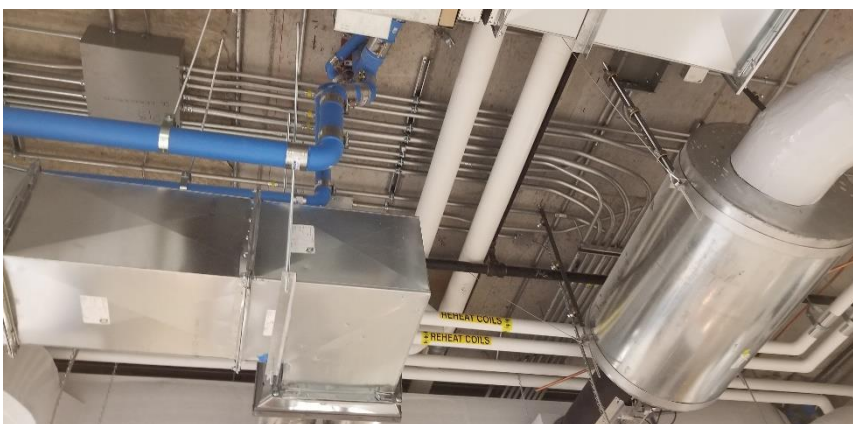
Photo 18: Representative view of the fiberglass insulation observed in Room 1500J.

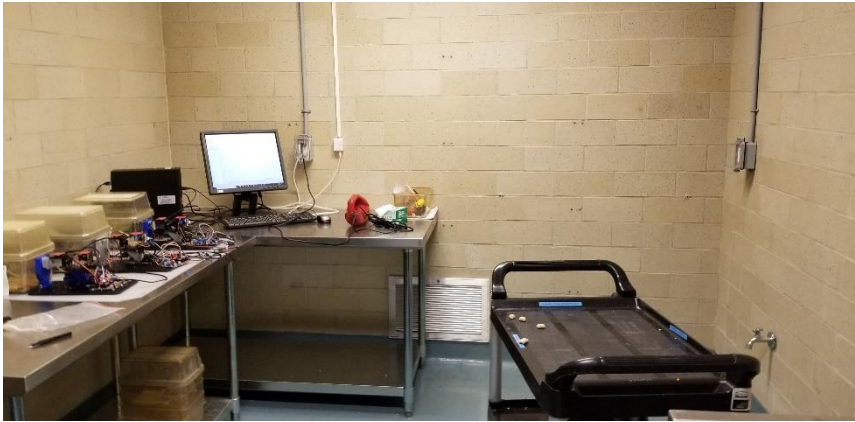
Photo 19: Representative view of the room finishes observed in Room 1201.

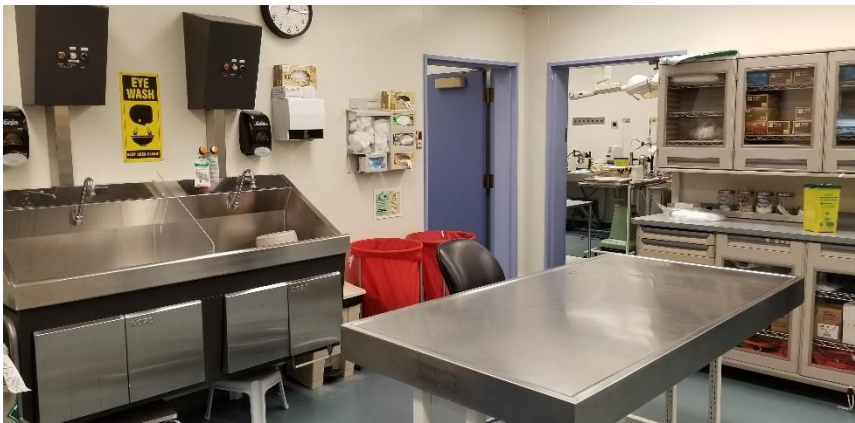
Photo 20: Representative view of the finishes observed throughout the first floor wet lab areas.

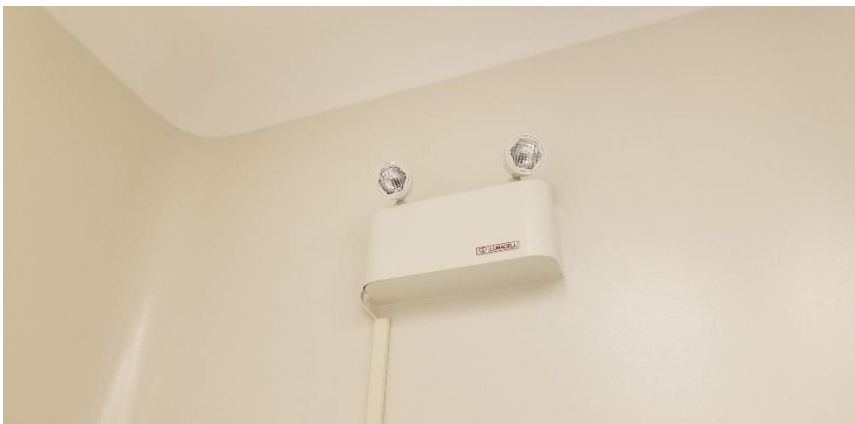
Photo 21: Representative view of the lead battery packs observed in Rooms 1326A & 1326C.

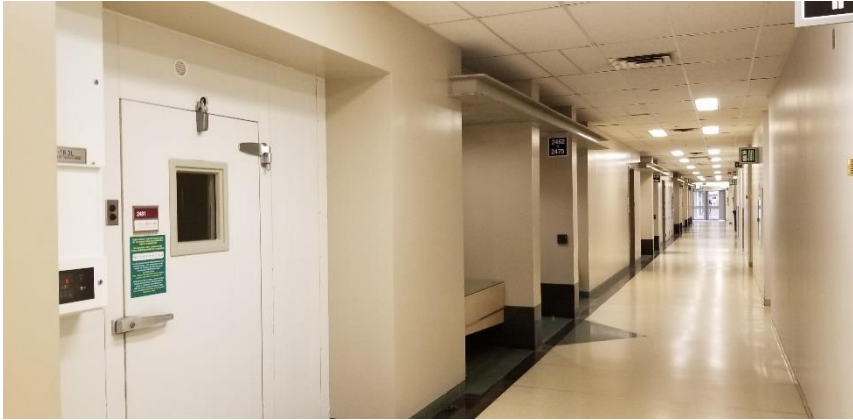
Photo 22: Representative view of the second level common area finishes.

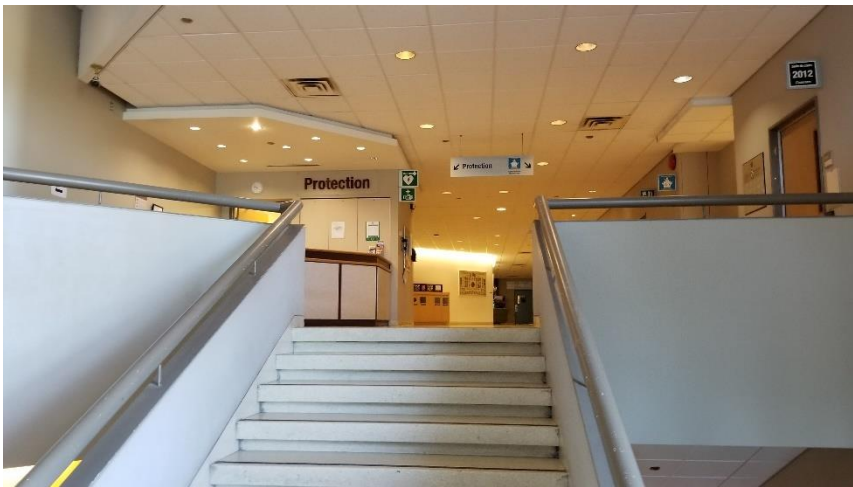
Photo 23: Representative view of the finishes observed throughout the second level.

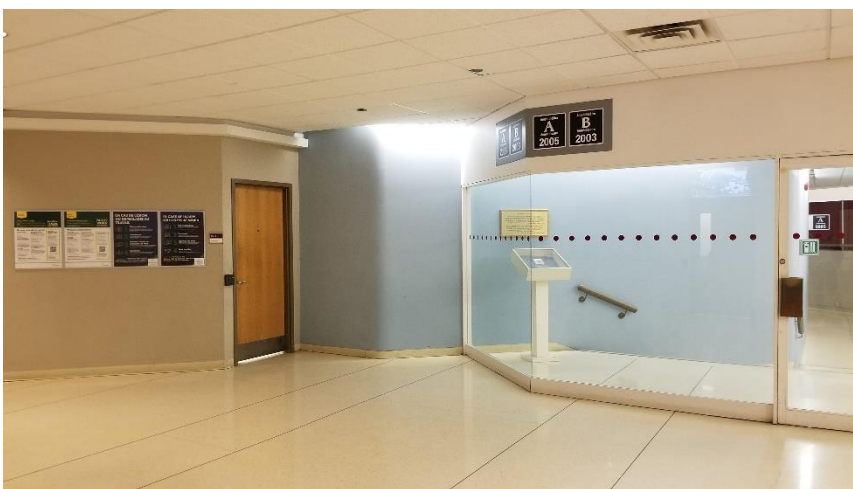
Photo 24: Representative view of the finishes throughout the second level.

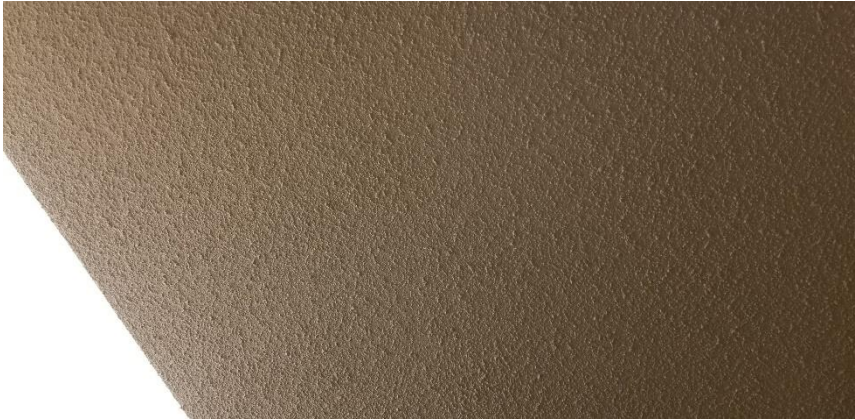
Photo 25: View of the non-asbestos containing ceiling texture coat observed in Room 2213B.

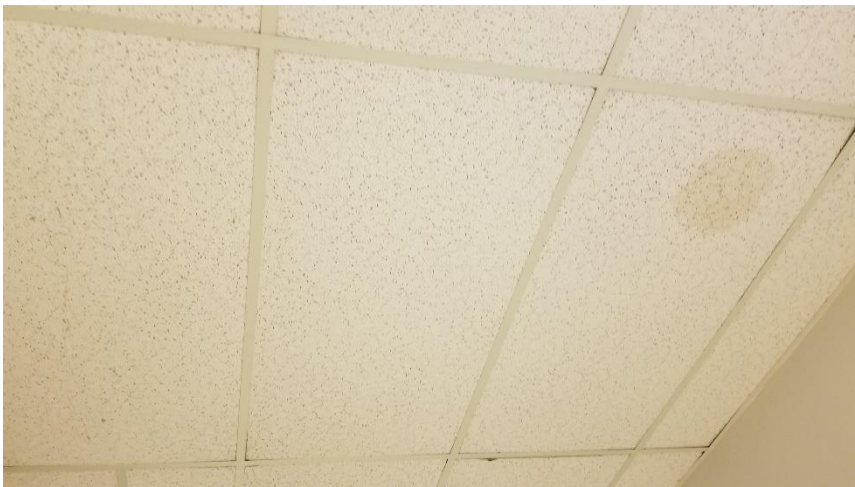
Photo 26: Representative view of water damaged ceiling tiles observed throughout the subject building.

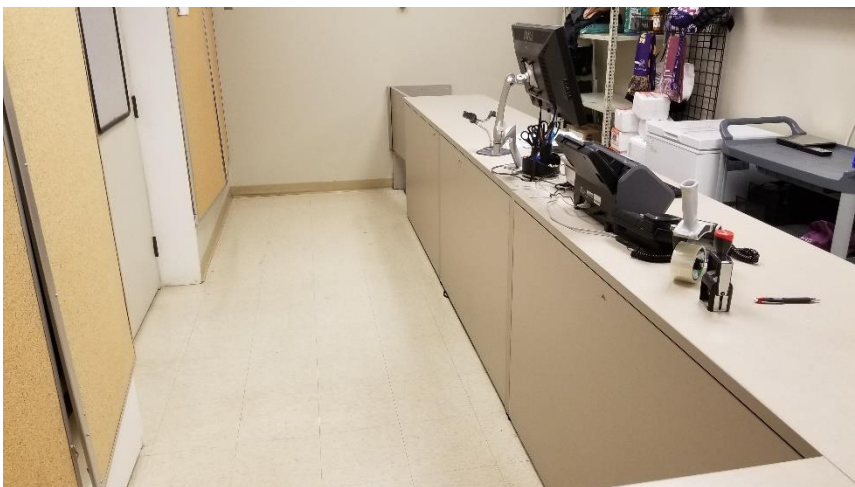
Photo 27: View of the non-asbestos VFT (12"x12" Beige w/ Brown Flakes) observed in Room 1129A.

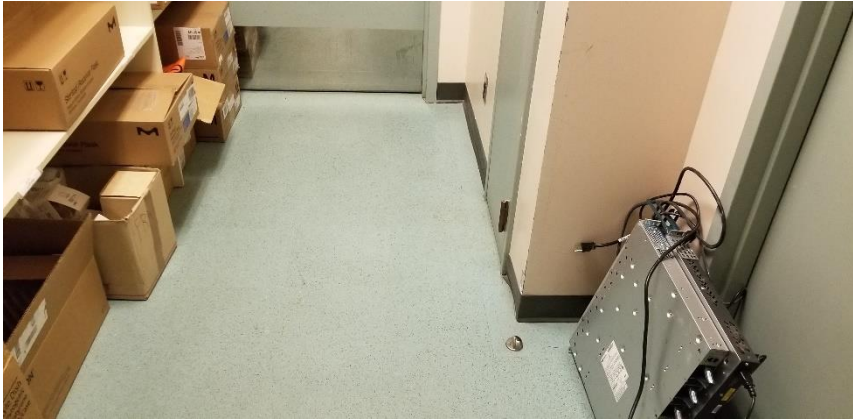
Photo 28: View of the non-asbestos VFT (12"x12" - Blue w/ Black Dots ) observed in Room 2482.

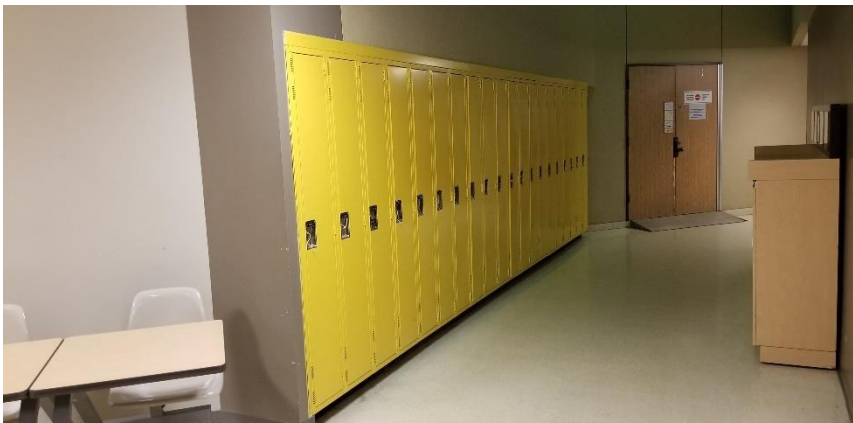
Photo 29: Representative view of the yellow lead paint observed on lockers throughout the subject building.

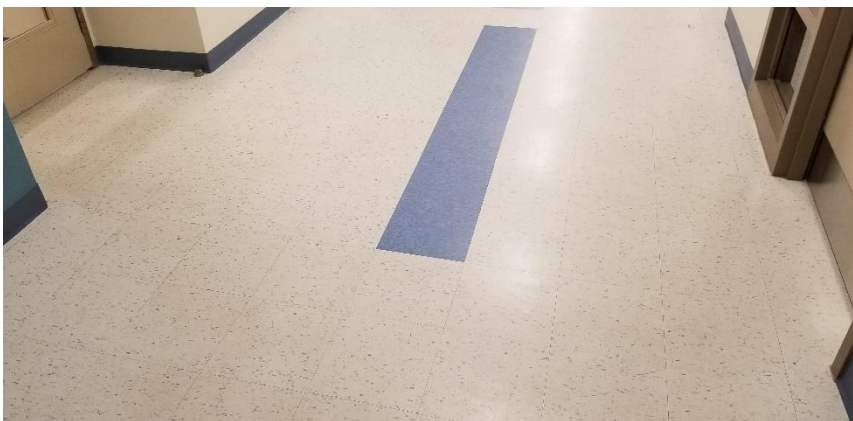
Photo 30: View of the non-asbestos containing vinyl floor tiles observed throughout the subject building.

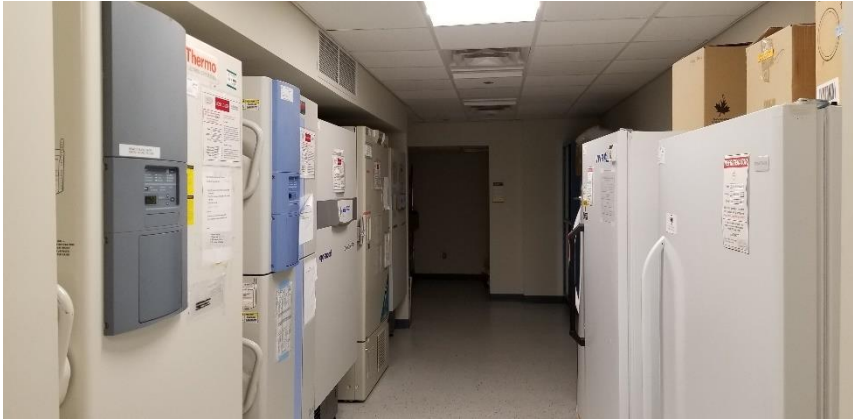
Photo 31: Representative view of the equipment observed throughout the third floor, containing ozone depleting substances.

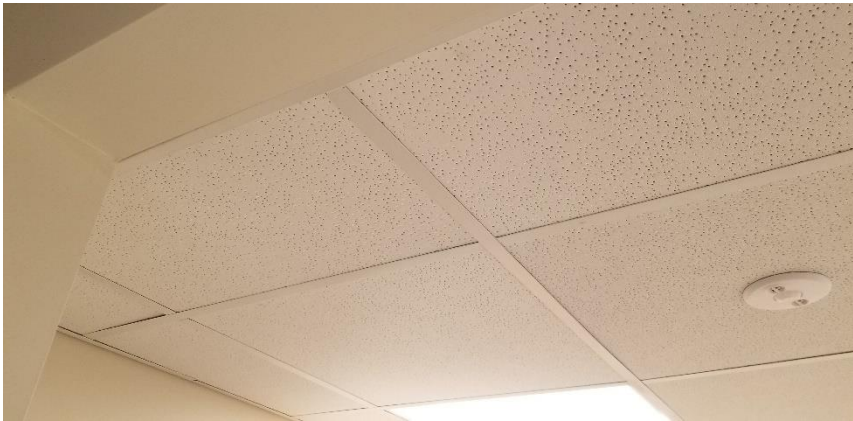
Photo 32: View of the non-asbestos containing ceiling tiles (2'x4' Mixed Pinholes) observed in 3105T and manufactured in 2016 and 2017.

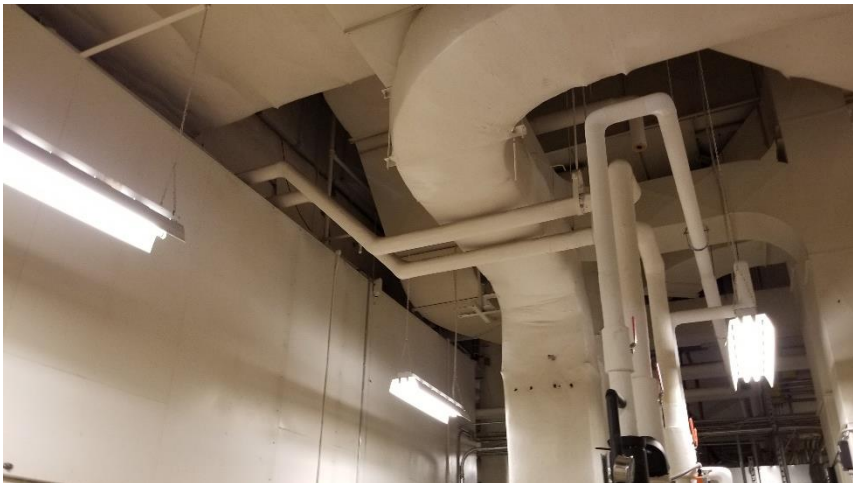
Photo 33: Representative view of the fiberglass mechanical insulation observed in Room 3003B.

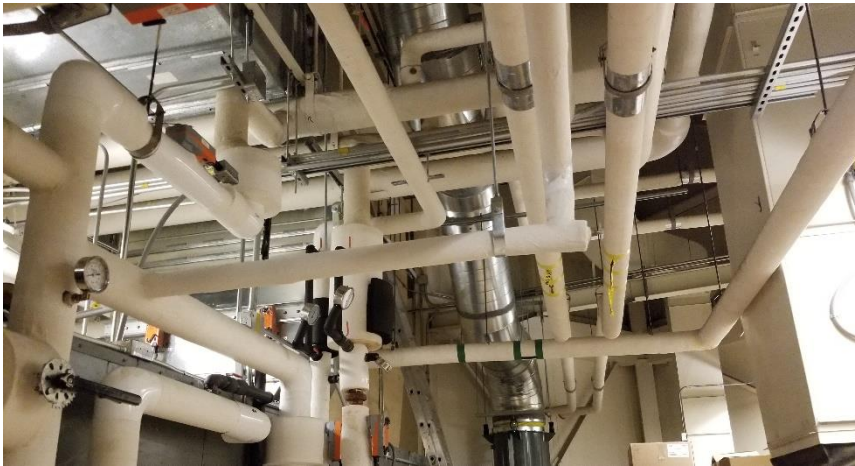
Photo 34: Representative view of the fiberglass mechanical insulation observed in Room 3003B.

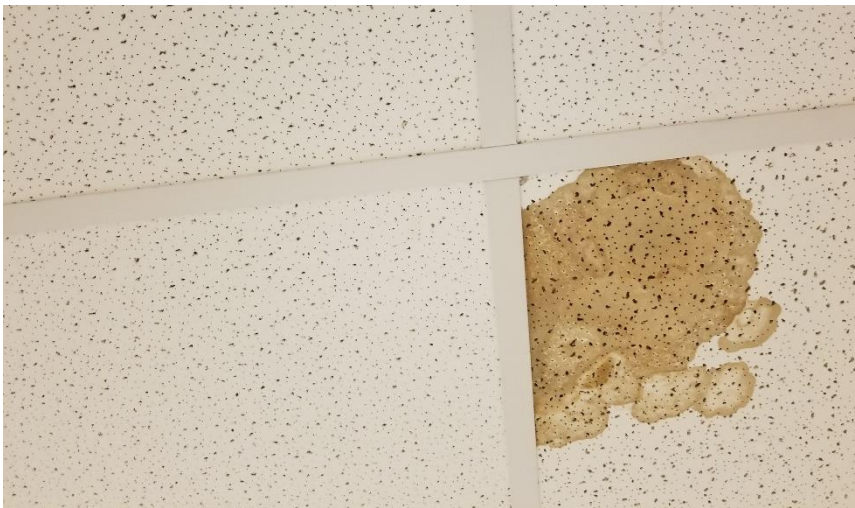
Photo 35: Representative view of water damaged ceiling tiles observed throughout the subject building.

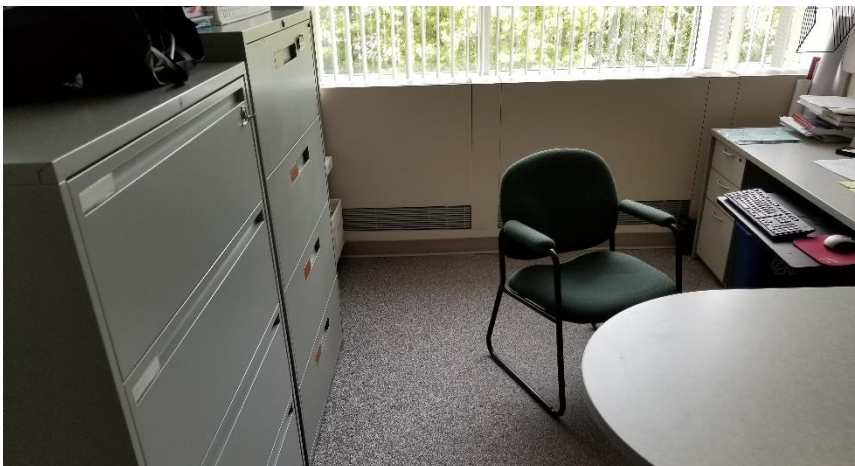
Photo 36: View of the typical office finishes observed throughout Room 3058.

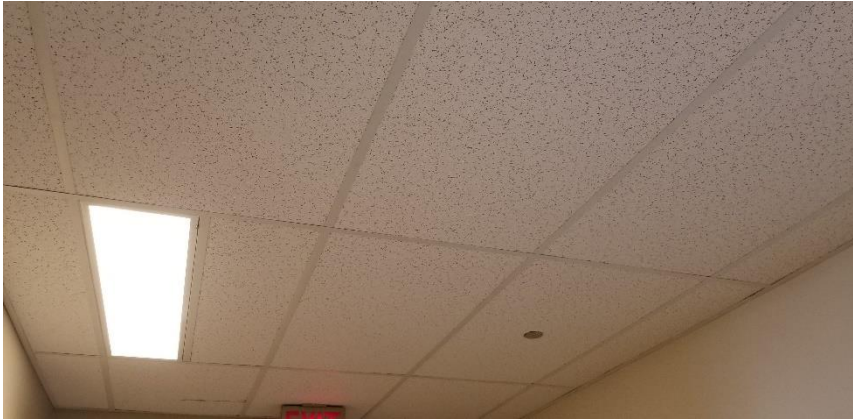
Photo 37: View of the non-asbestos ceiling tiles (2'x4' – Pinholes & Small Fissures) observed in Room 4200A.

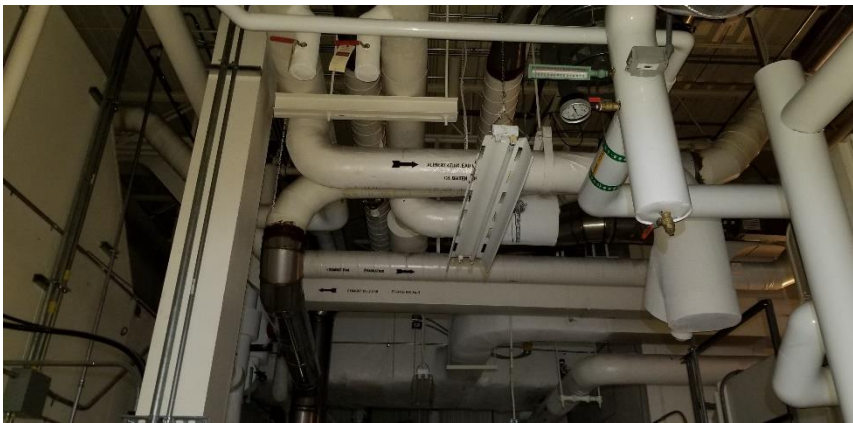
Photo 38: Representative view of the fiberglass mechanical insulation observed in Room 5004.

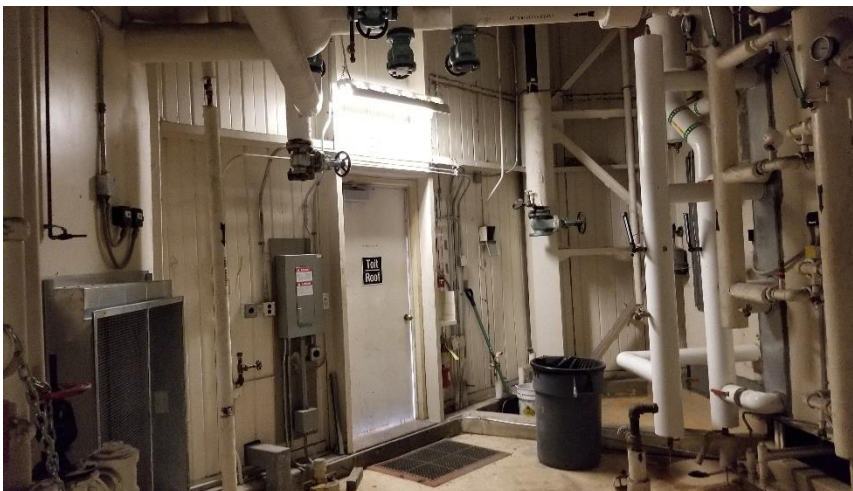
Photo 39: Representative view of the fiberglass mechanical insulation observed in Room 5004.

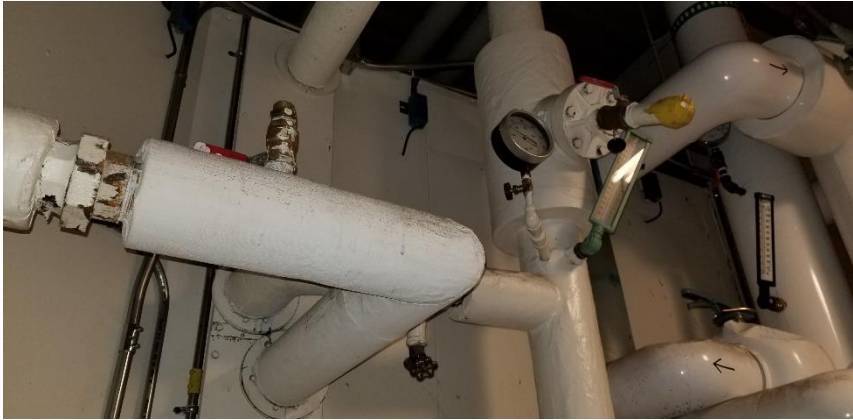
Photo 40: Representative view of the fiberglass mechanical insulation observed in Room 5002.
