HAZARDOUS MATERIALS SURVEY AND 2023 REASSESSMENT 800 KING EDWARD (SITE), OTTAWA, ON

Project No.:0Z2021101HZ / CCC-230252-00

University of Ottawa

McIntosh Perry Limited (MPL)

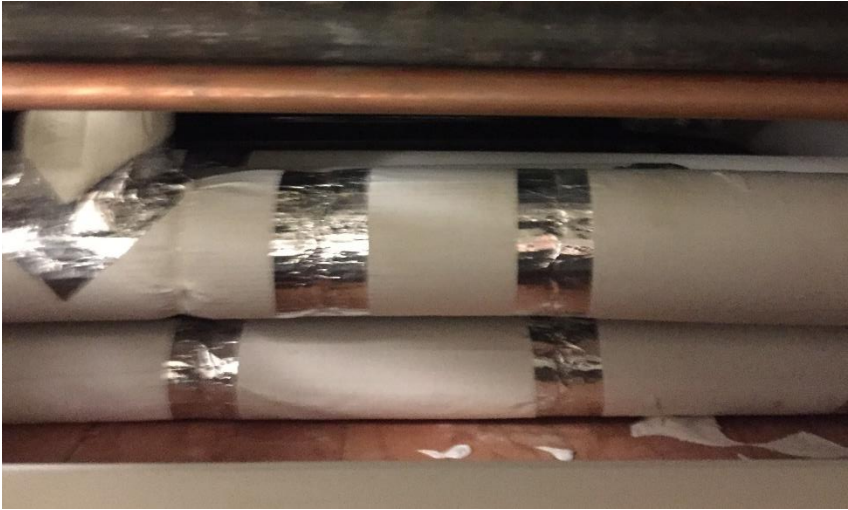
Mechanical pipe straight insulation was observed throughout the subject building. MPL previously made several incisions throughout to investigate its composition, and it was visually identified as fibreglass and, thus not suspected of containing asbestos.

Photo 1: Representative view of the non-asbestos-containing mechanical insulation observed throughout the subject building.

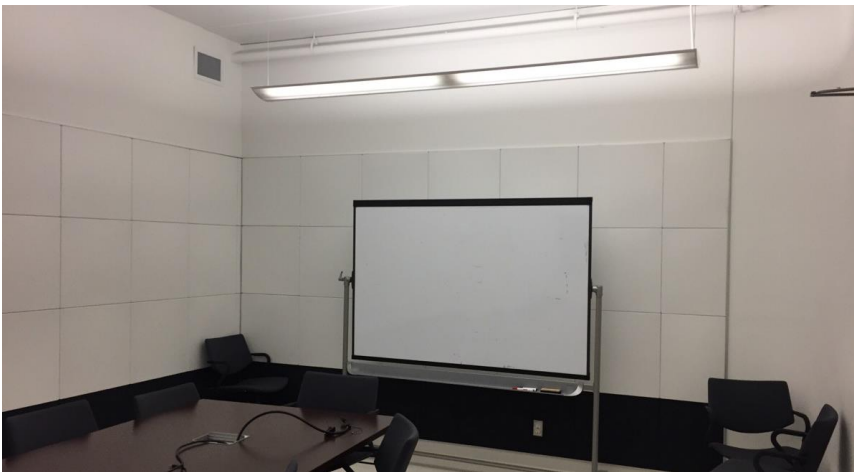
Photo 2: Representative view of the interior finishes observed throughout the subject building.

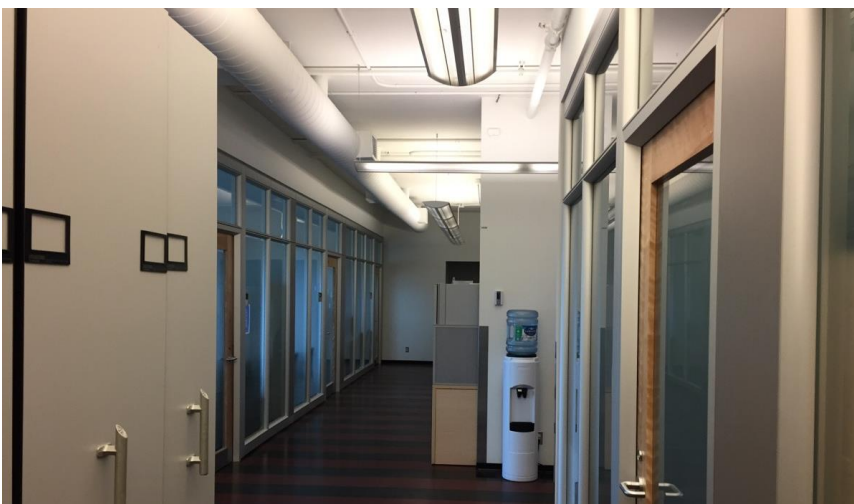
Photo 3: Representative view of the common area finishes observed throughout the subject building.

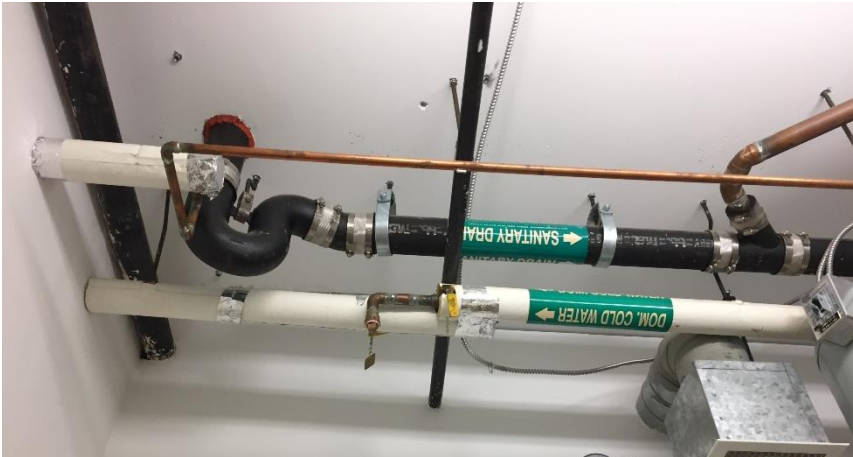
Mechanical pipe elbows/fittings insulation was observed throughout the subject building. MPL previously made several incisions throughout to investigate its composition, and it was visually identified as fibreglass and, thus not suspected of containing asbestos.

Photo 4: Representative view of the non-asbestos-containing mechanical insulation observed throughout the subject building.

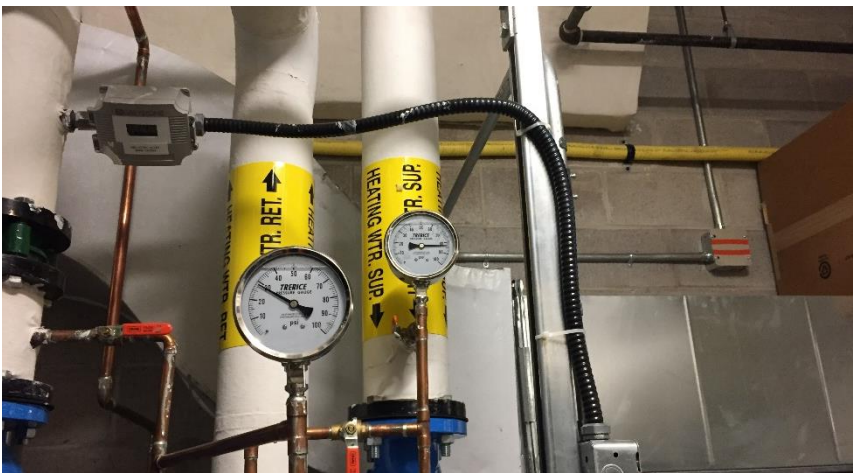
Pressure gauges suspected of containing mercury were observed in Rooms 0005 and 0004.

Photo 5: Representative view of the pressure gauges suspected of containing liquid mercury observed in Room 0004.

Please refer to Appendix F – Hazardous Materials Checklist for equipment conditions, quantities (where applicable), and recommended actions.

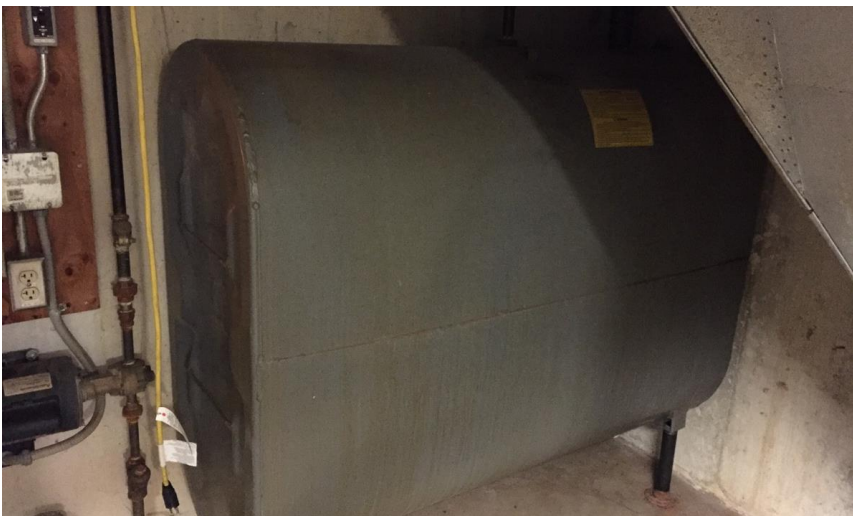
A visual survey of the subject building was conducted to determine if any USTs and ASTs were present. Three (3) above-ground storage tanks containing diesel fuel were observed in Rooms 0004 and 0005.

Photo 6: View of the above-ground storage tank containing diesel fuel in Room 0004.

Please refer to Appendix F – Hazardous Materials Checklist for equipment conditions, quantities (where applicable), and recommended actions.

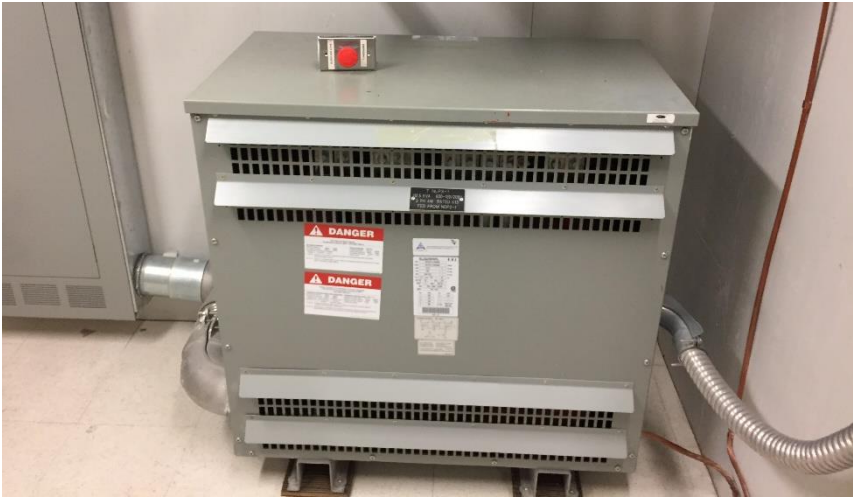
No PCBs containing electrical transformers were observed throughout the subject building. Transformers that could be assessed were observed to be dry-type and manufactured by Hammond Manufacturing throughout the subject building.

Photo 7: Representative view of the non-PCB containing dry-type transformers observed throughout the subject building.

Since no PCB-containing equipment was observed or suspected to be present during the site survey, no further action is required.

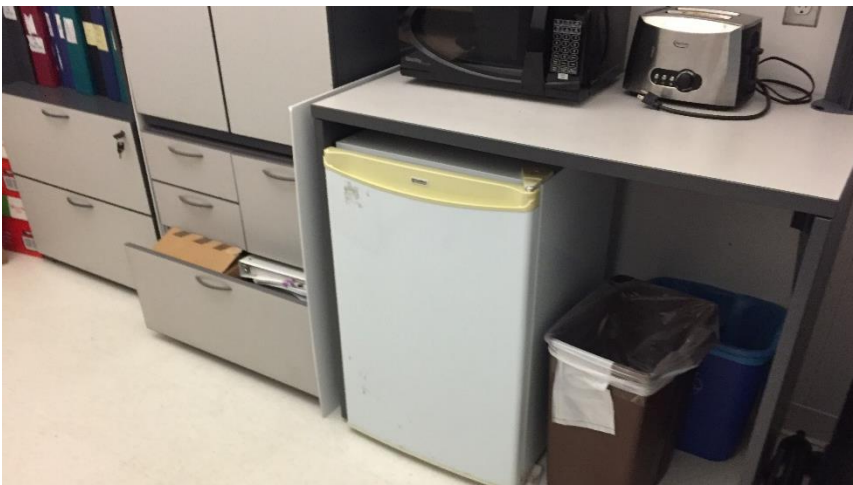
A visual assessment for equipment potentially containing ODSs and other halocarbons was conducted. Equipment containing ODSs or other halocarbons was observed throughout the subject building.

Photo 8: Representative view of the equipment containing ODSs observed throughout the subject building.

Please refer to Appendix F – Hazardous Materials Checklist for equipment conditions, approximate quantities (where applicable), and recommended actions.

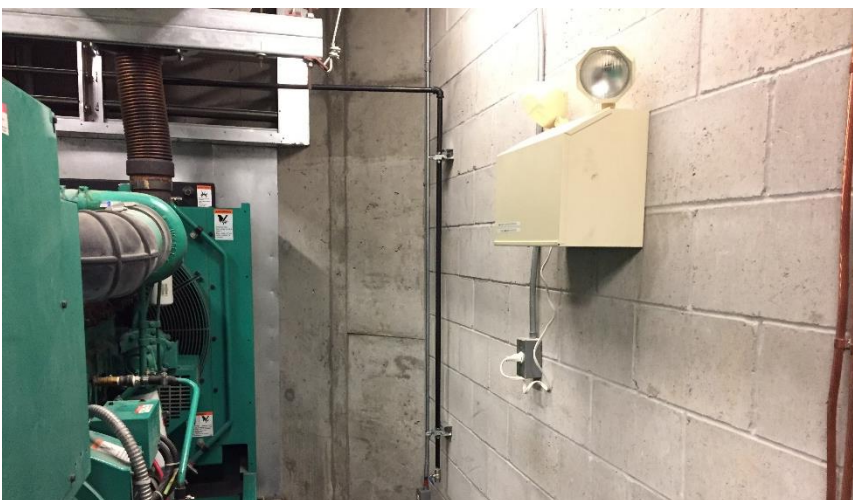
MPL observed two (2) lead-containing acid battery packs in Room 0005.

Photo 9: View of the lead-containing battery pack observed in Room 0005.

Please refer to Appendix F – Hazardous Materials Checklist for material conditions, quantities (where applicable), and recommended actions.

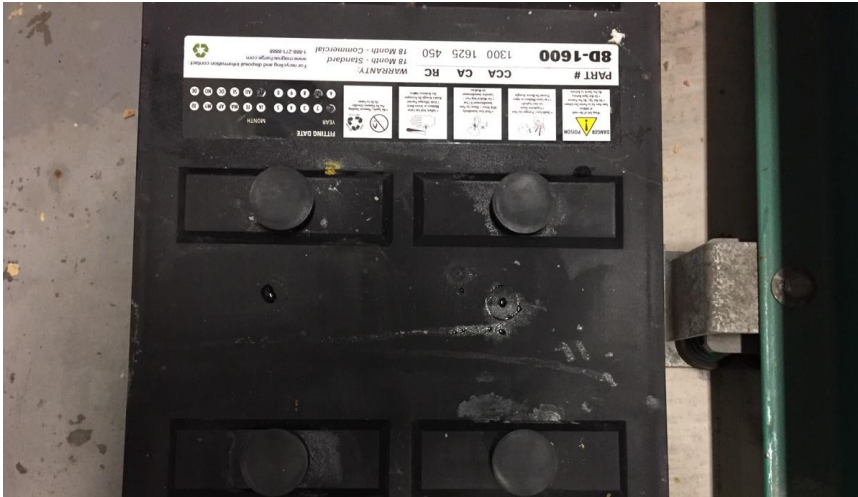
Photo 10: View of the lead-containing battery pack observed in Room 0005.

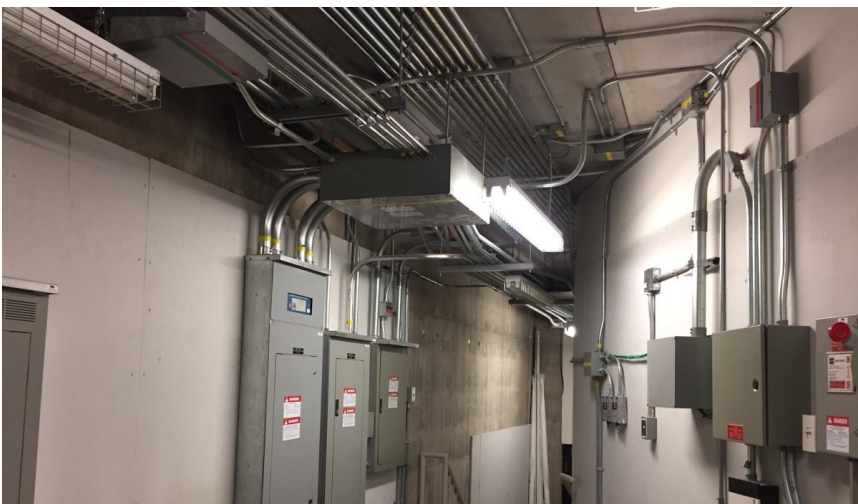
Fluorescent light fixtures were observed and identified throughout the subject building, containing 2 to 4 tubes per fixture. Mercury is confirmed to present in vapour form in fluorescent light tubes previously from Room 4051E.

Photo 11: Representative view of the fluorescent light fixtures containing mercury vapour observed throughout the subject building.
