HAZARDOUS MATERIALS SURVEY AND 2023 REASSESSMENT DESMARAIS HALL, 55 LAURIER AVENUE E, OTTAWA, ON

Project No.: Z2021101HZ / CCC-230252-00

University of Ottawa

McIntosh Perry Limited (MPL)

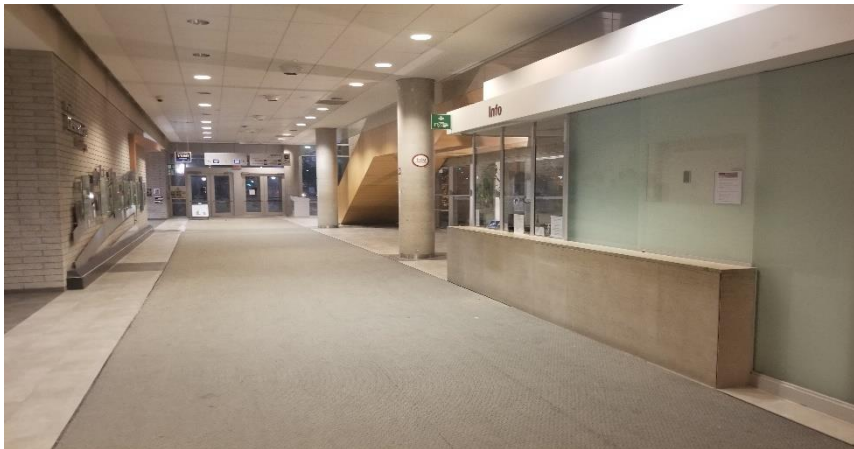
Photo 1: View of typical building finishes.

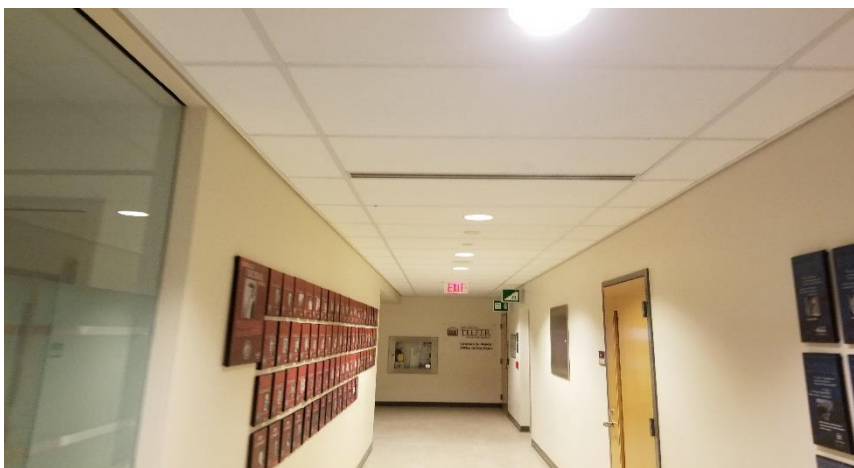
Photo 2: View of typical hallway finishes.

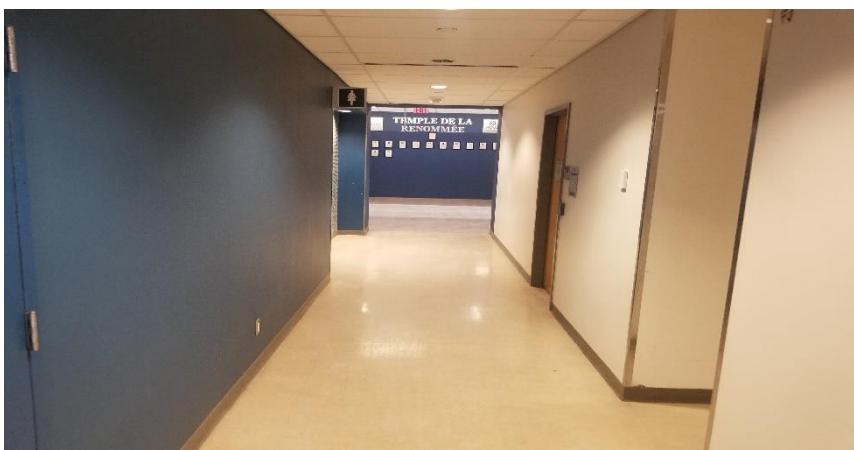
MPL identified lead-containing acid battery packs throughout the subject building. These battery packs were observed on walls and above exits throughout the surveyed building.

Photo 3: View of typical hallway finishes with lead-acid batteries present in emergency lights.

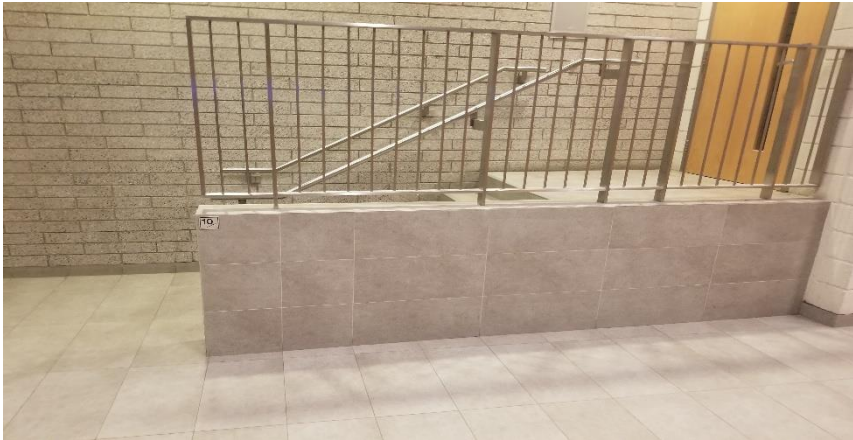
Silica is expected to be present in building materials such as concrete, brick, mortar and ceramic tiles throughout the structures. Free crystalline silica (α -Quartz) may be a component in ceiling tiles and gypsum boards. Silica (including free crystalline silica) may also be a component of concrete and brick surfaces noted in the building.

Photo 4: Typical silica contains brick, mortar, concrete, and ceramic tile finishes.

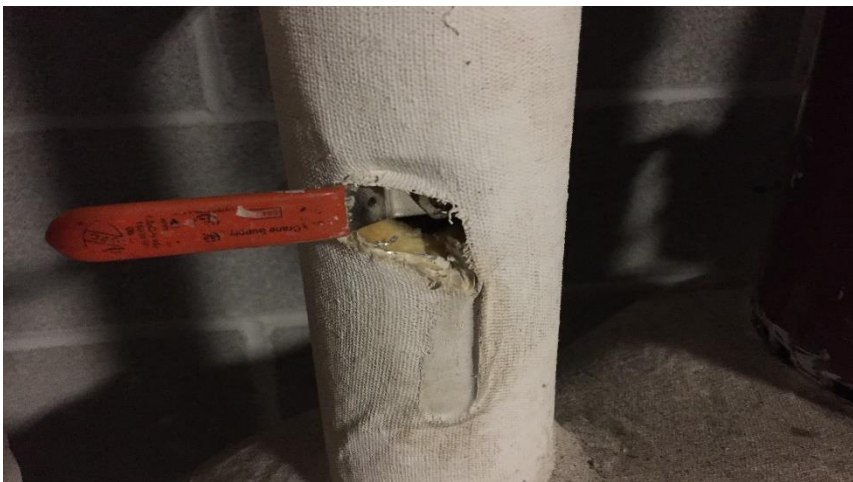
Photo 5: Typical view of fibreglass mechanical insulation.
