HAZARDOUS MATERIALS SURVEY AND 2022 REASSESSMENT SURVEY

161 LOUIS-PASTEUR PRIVATE, OTTAWA, ON

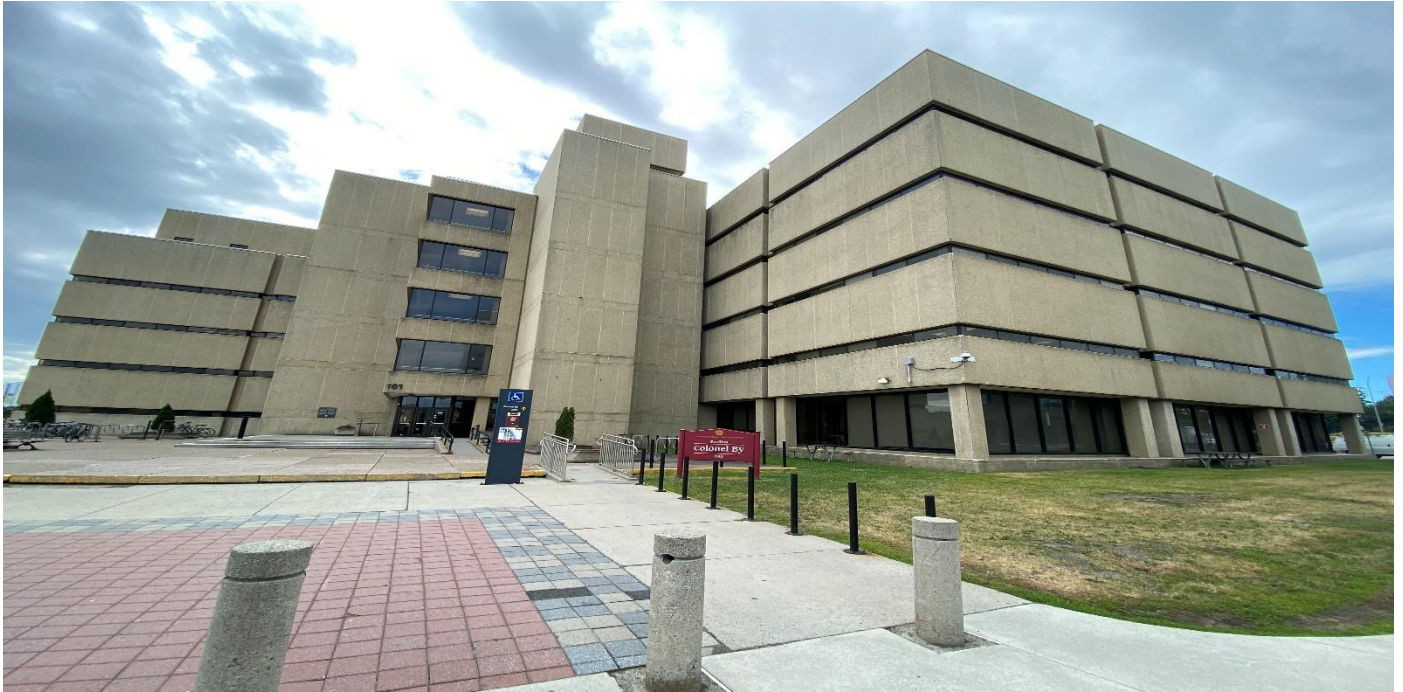
Project No.: Z1920014HZ / CCC-230252-00

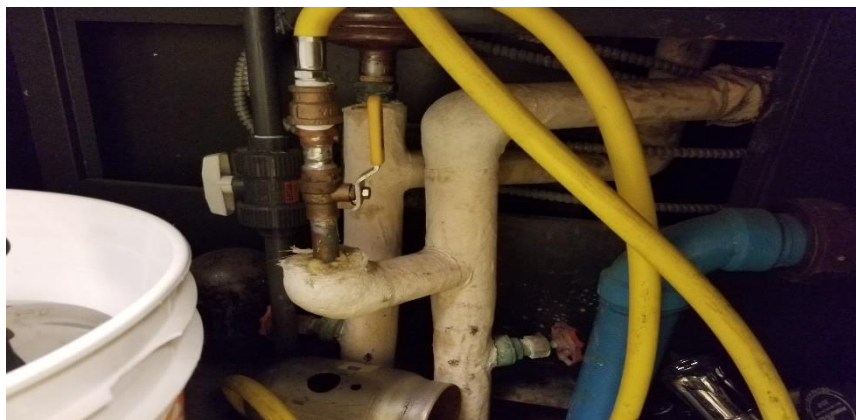
Photo 1: View of asbestos-containing parging cement on fitting observed to be in fair condition underneath the sink in D320.

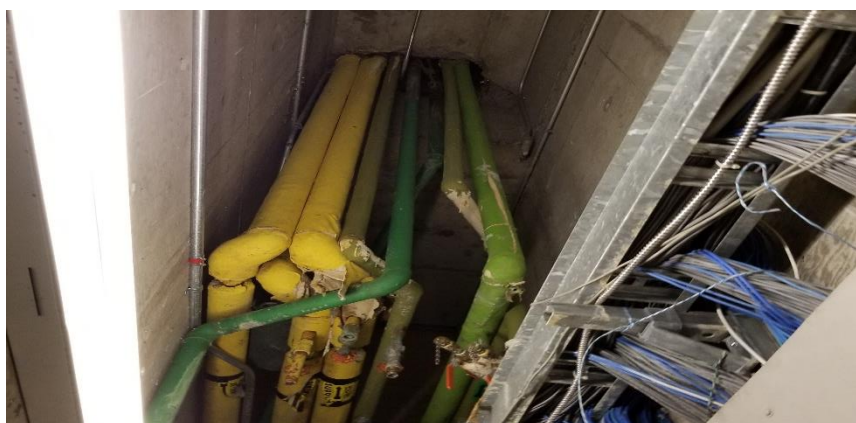
Photo 2: View of asbestos-containing parging cement on fittings observed to be in poor condition in Room C012B.

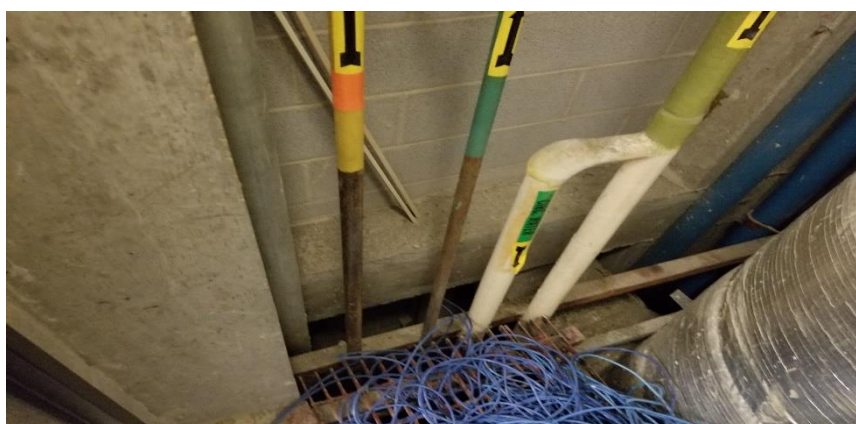
Photo 3: View of asbestos-containing parging cement on pipe fittings observed to be in good condition in Room B408A.

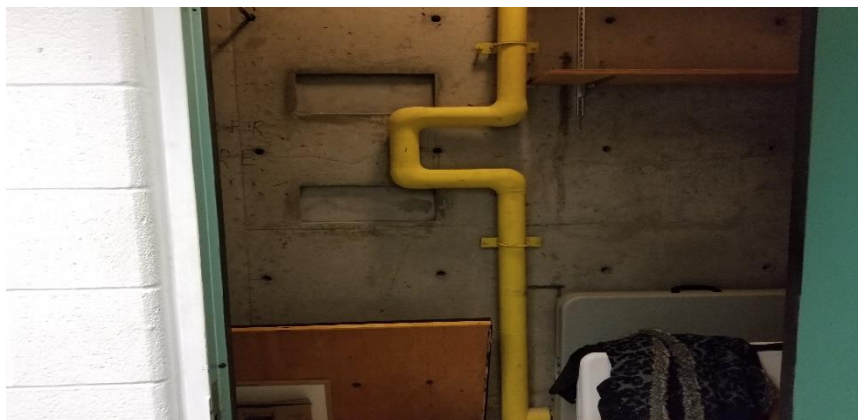
Photo 4: View of asbestos-containing parging cement on pipe fittings observed to be in good condition in Room B305A.

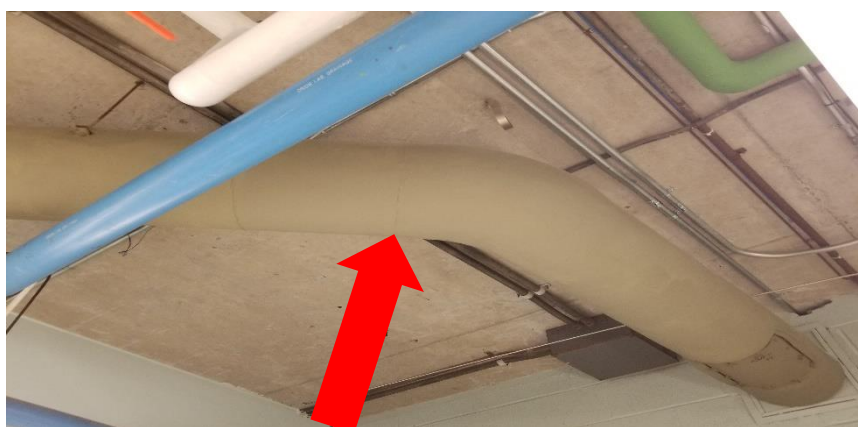
Photo 5: View of asbestos-containing duct insulation observed to be in good condition in Room D320.

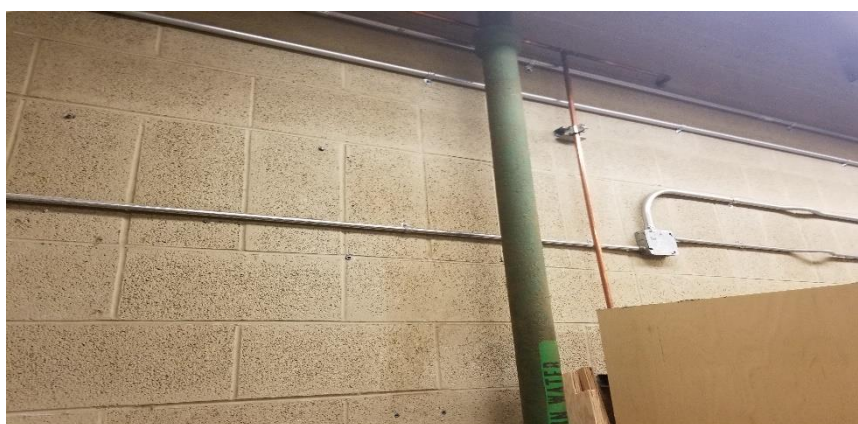
Photo 6: View of asbestos-containing transite pipe observed to be in good condition in E012.

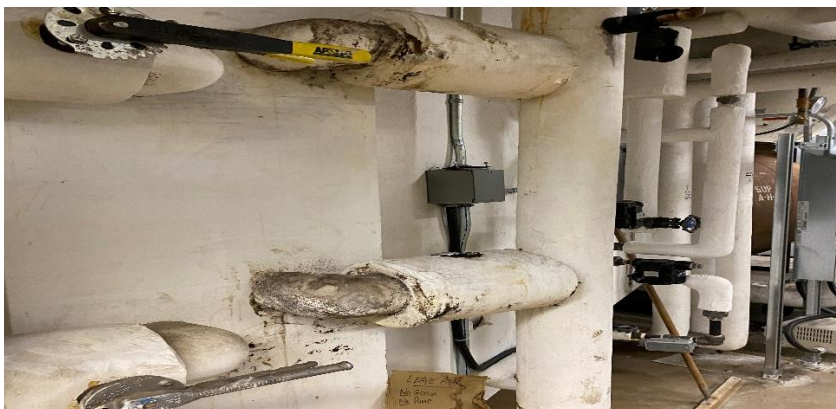
Photo 7: View of mould/water damaged mechanical pipe straights observed in E101.

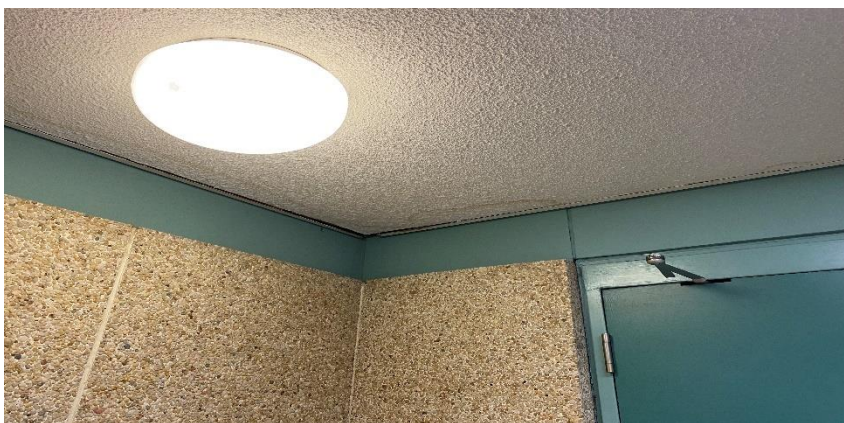
Photo 8: View of poor condition presumed asbestos ceiling texture finish observed in the Hallways outside of A502.

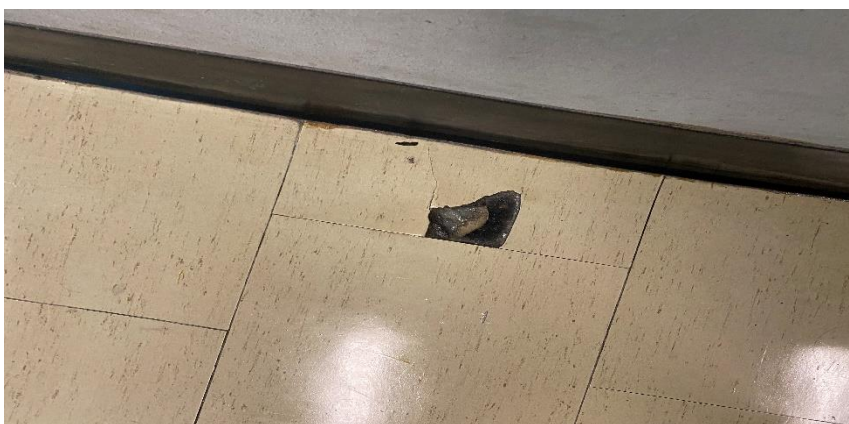
Photo 9: View of fair condition ACM Vinyl Floor Tile (12"x12"-White with Grey Flakes) observed in Location A710.

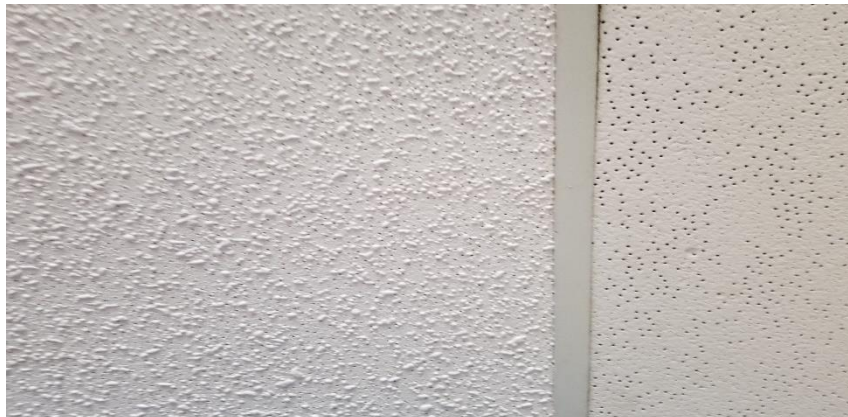
Photo 10: View of non-asbestos ceiling tiles: Pinholes with texture (left) and Pinholes with varying sizes (right) observed in B109C.

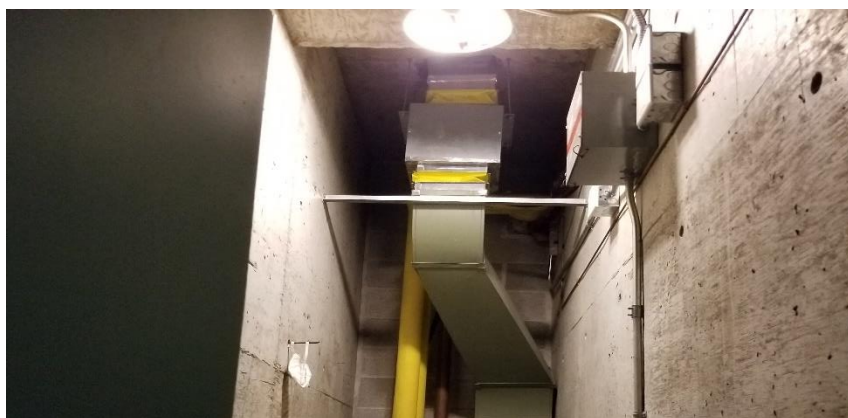
Photo 11: View of non-asbestos containing flexible duct connector observed in Room C503.

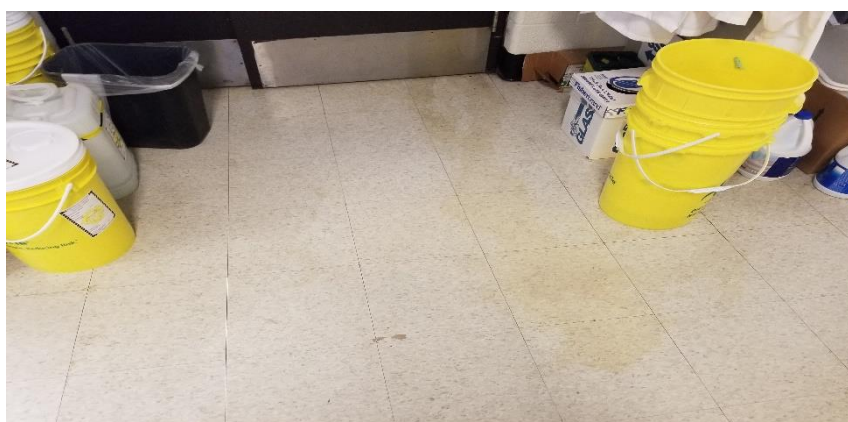
Photo 12: View of non-asbestos containing vinyl floor tiles (12"x12"-White with Grey Flakes) observed in Room D511.

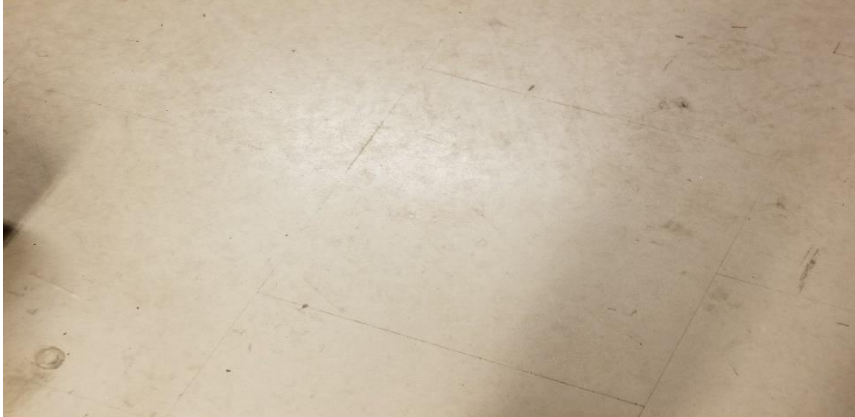
Photo 13: View of non-asbestos containing vinyl floor tiles (12"x12"-Grey) observed in Room E018B.

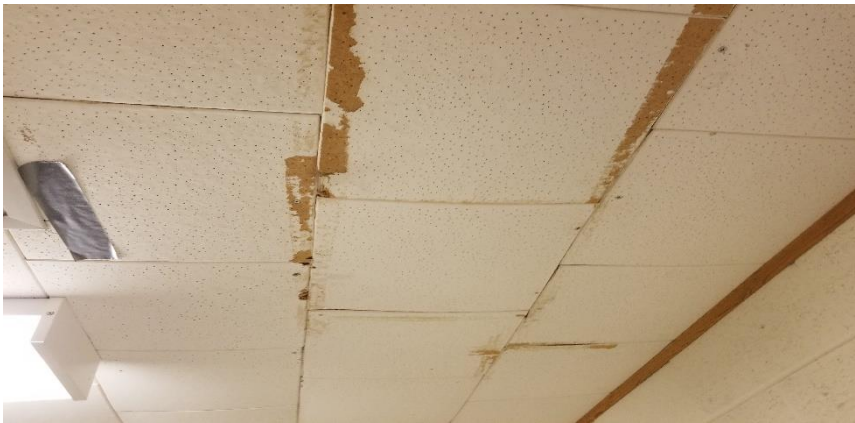
Photo 14: View of non-asbestos screwed on ceiling tiles observed in Room E018B.
