HAZARDOUS MATERIALS SURVEY AND 2022 REASSESSMENT FAUTEUX HALL, 57 LOUIS-PASTEUR PRIVATE, OTTAWA, ON

Project No.: Z1920014HZ / CCC-230252-00

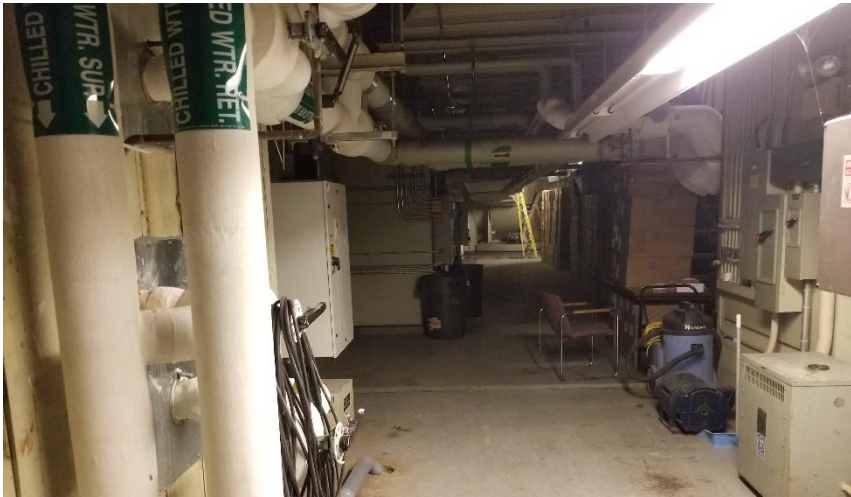
Photo 1: Representative view of the finishes observed throughout Room 600.

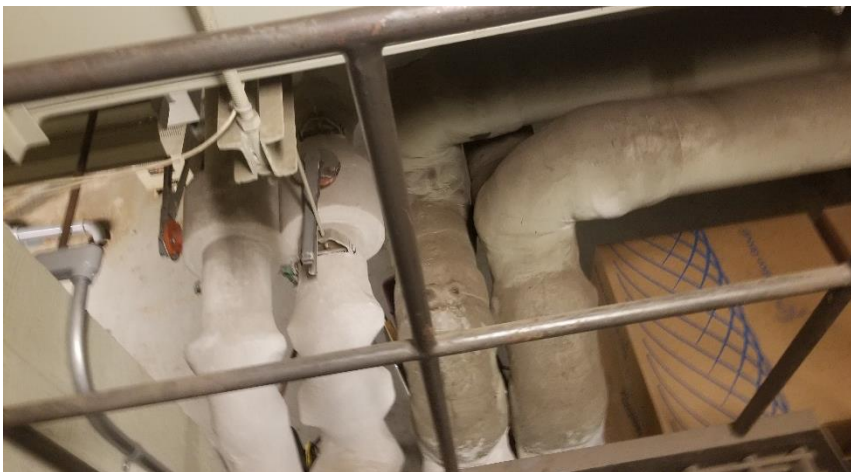
Photo 2: View of the asbestos-containing parging cement elbows observed in good condition throughout Room 600.

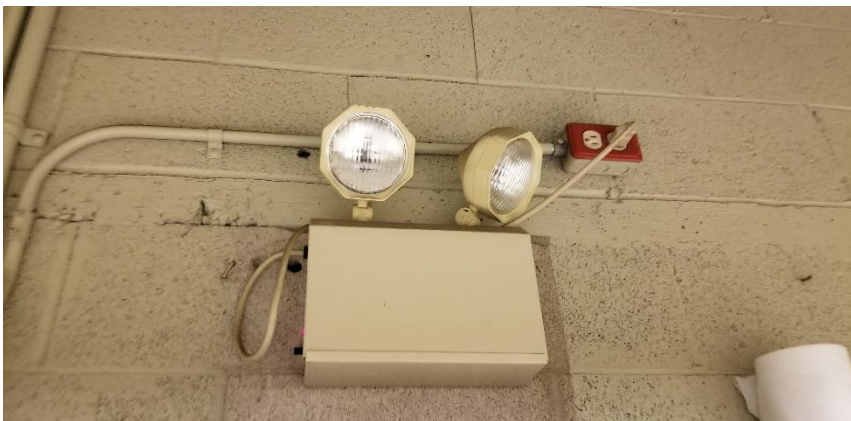
Photo 3: View of the lead battery packs associated with emergency lighting observed in Room 600.

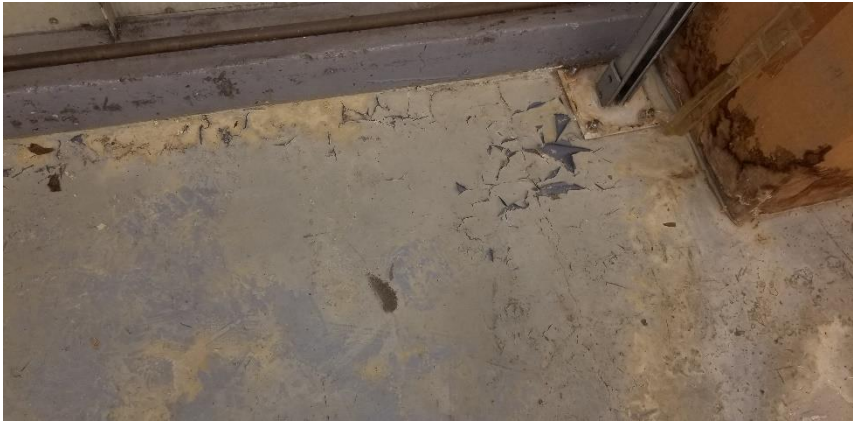
Photo 4: View of the poor condition lead floor paint (Grey) observed throughout Room 600.

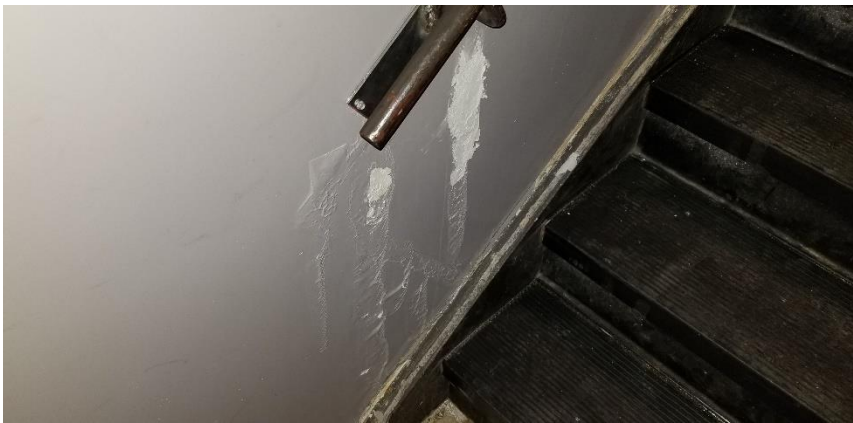
Photo 5: View of the water damaged drywall observed in Room 600.

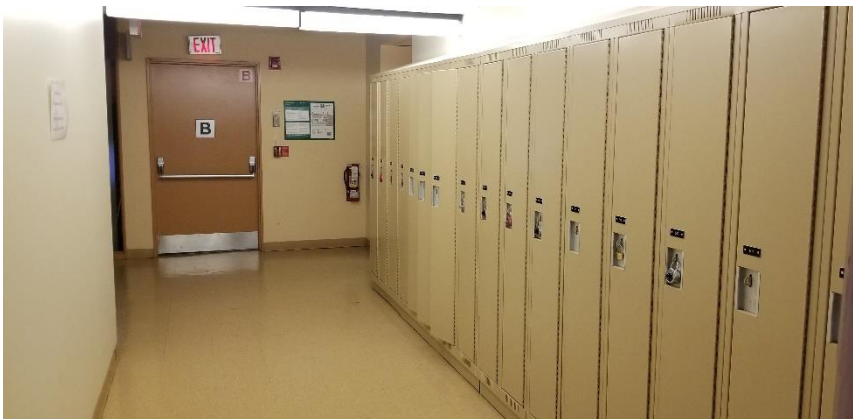
Photo 6: Representative view of the common area finishes observed throughout the 5th floor.

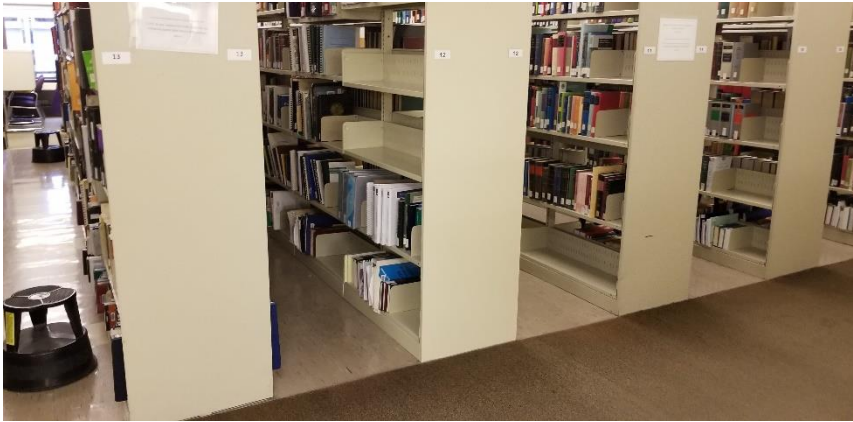
Photo 7: Representative view of Room 523, with asbestos-containing vinyl floor tiles (12"x12" – Brown w/ Brown Stripes).

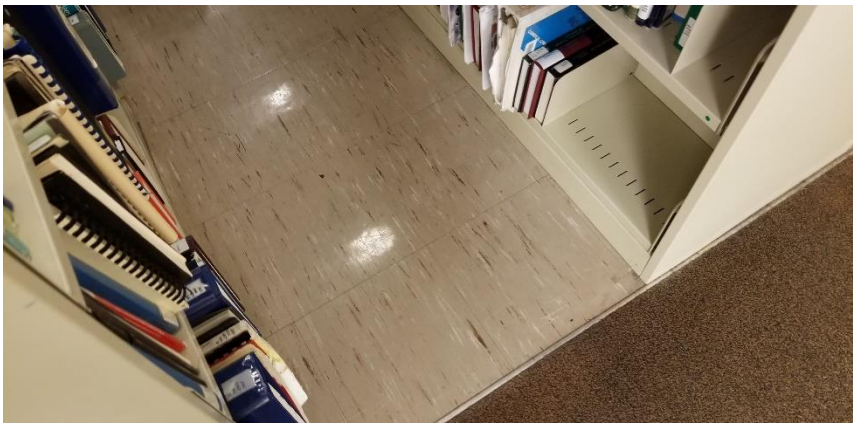
Photo 8: View of the asbestos-containing vinyl floor tiles (12"x12" – Brown w/ Brown Stripes) observed in good condition in Room 523.

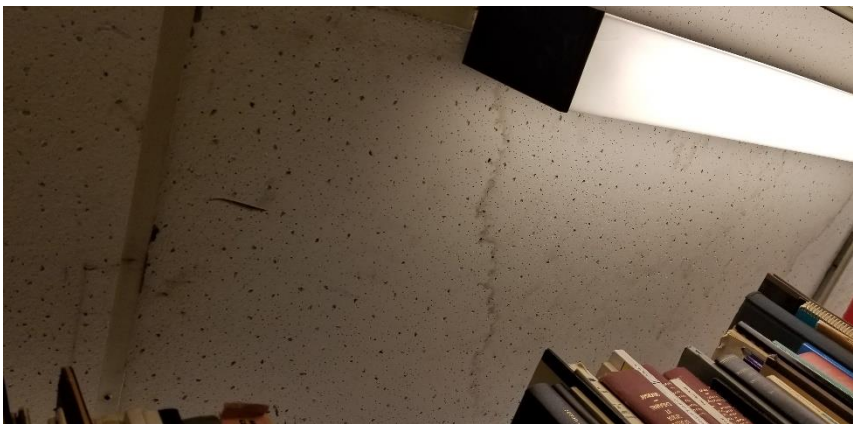
Photo 9: View of the asbestos containing ceiling tiles - 2'x4' Pinholes w/ Triangular Fissures observed in fair condition in Room 523.

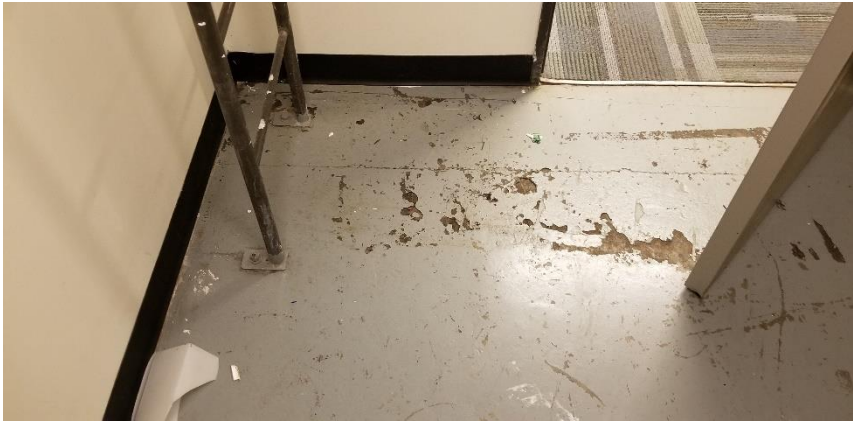
Photo 10: View of the poor condition lead floor paint (Grey) observed throughout Room 525E.

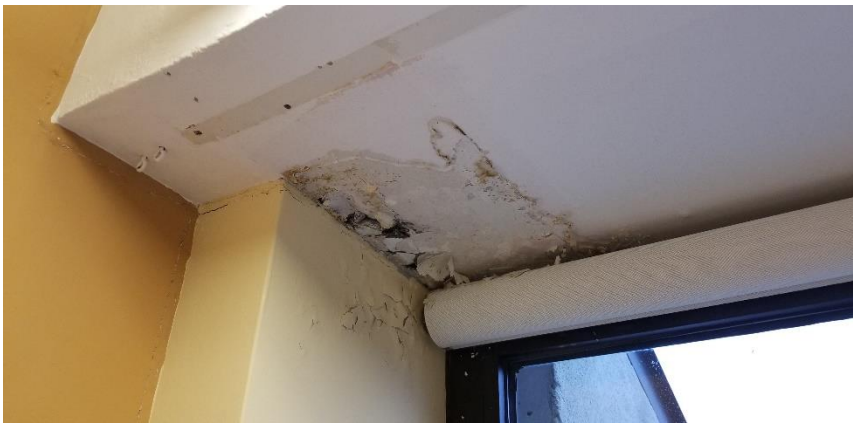
Photo 11: View of the water damaged drywall observed in Room 528.

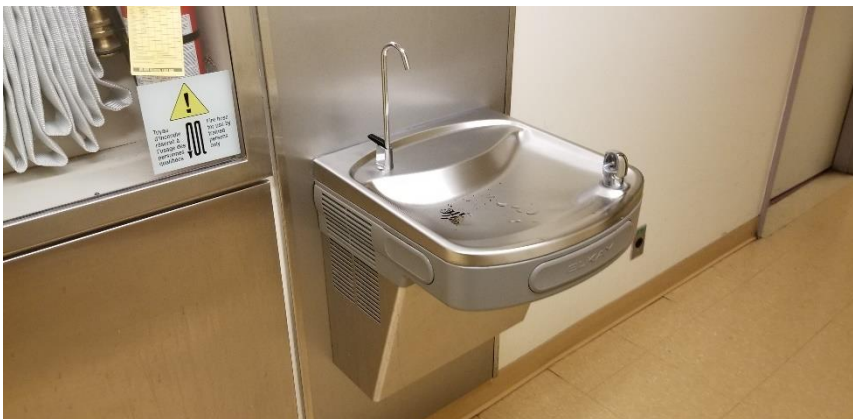
Photo 12: Representative view of the water fountains observed throughout the subject building, containing ODSs.

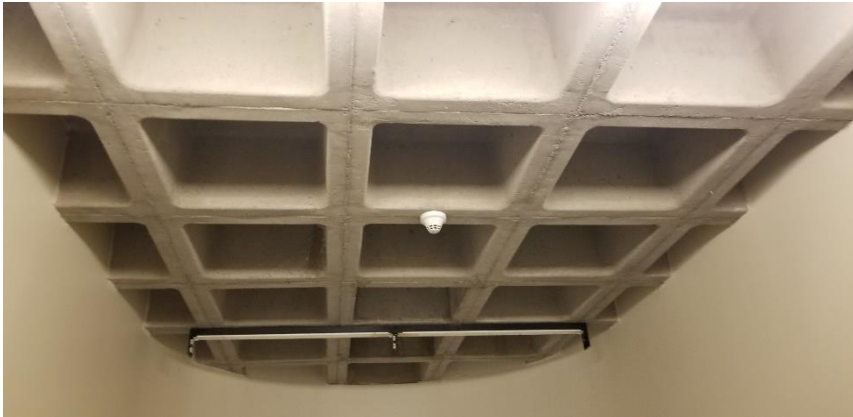
Photo 13: View of the concrete ceilings observed throughout the subject building.

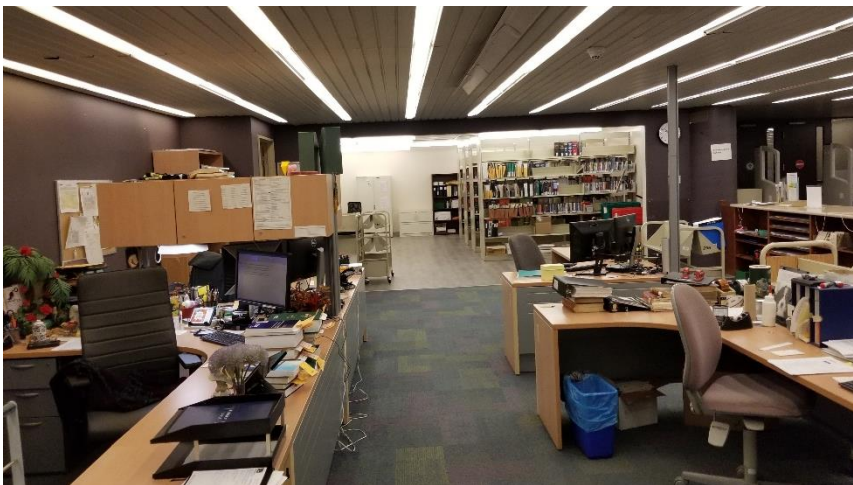
Photo 14: Representative view of the common area finishes observed throughout the 4th floor.

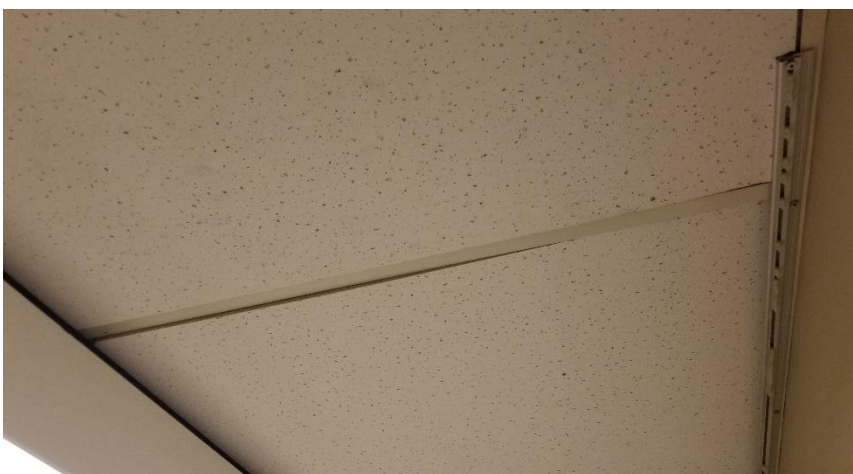
Photo 15: View of the asbestos containing ceiling tiles - 2'x4' Pinholes w/ Triangular Fissures observed in good condition in Room 424.

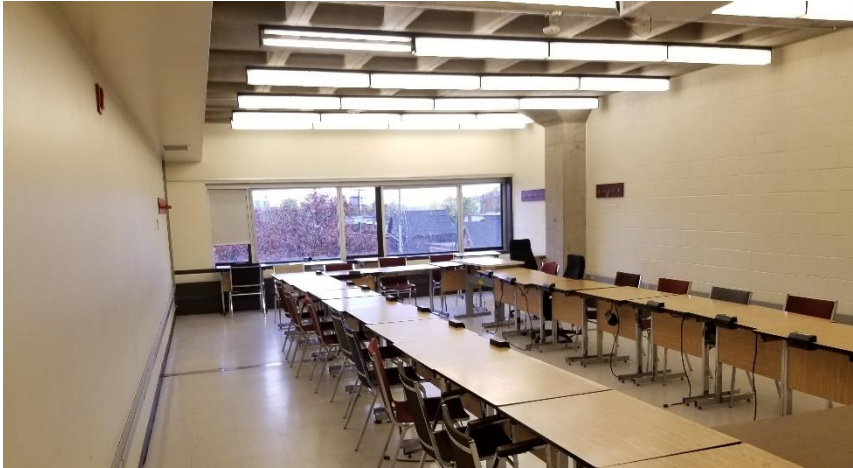
Photo 16: Representative view of the common area finishes observed throughout Room 416.

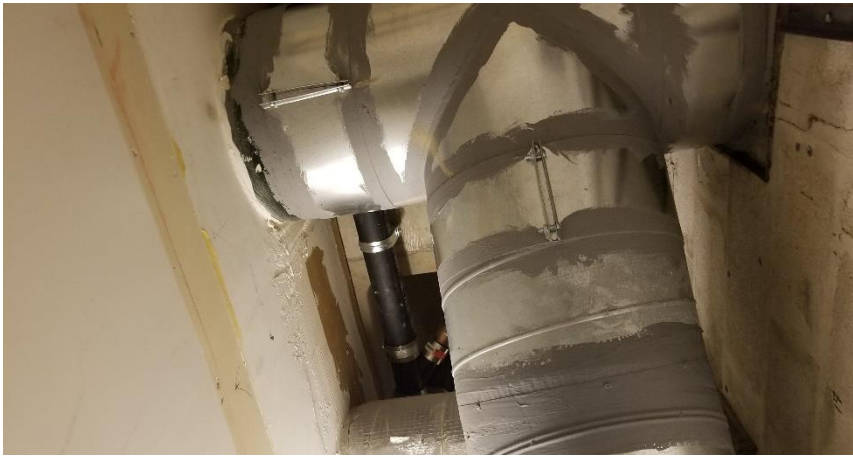
Photo 17: View of the non-asbestos containing caulking (Grey) observed in 371A.

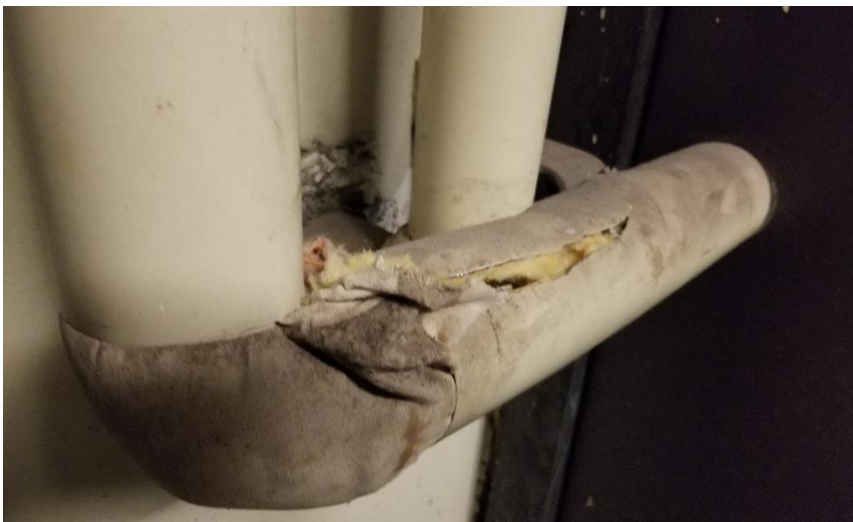
Photo 18: View of the non-asbestos fiberglass pipe straight insulation observed in Room 348.

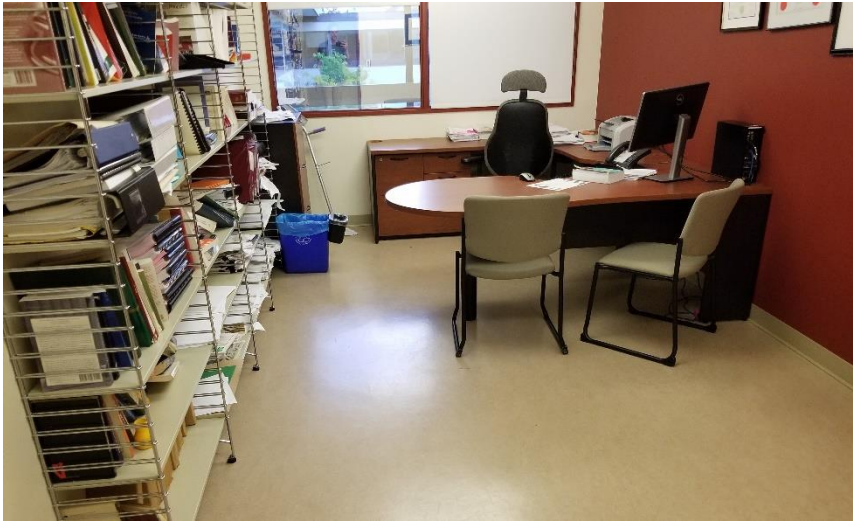
Photo 19: Representative view of the common area finishes observed throughout Room 332.

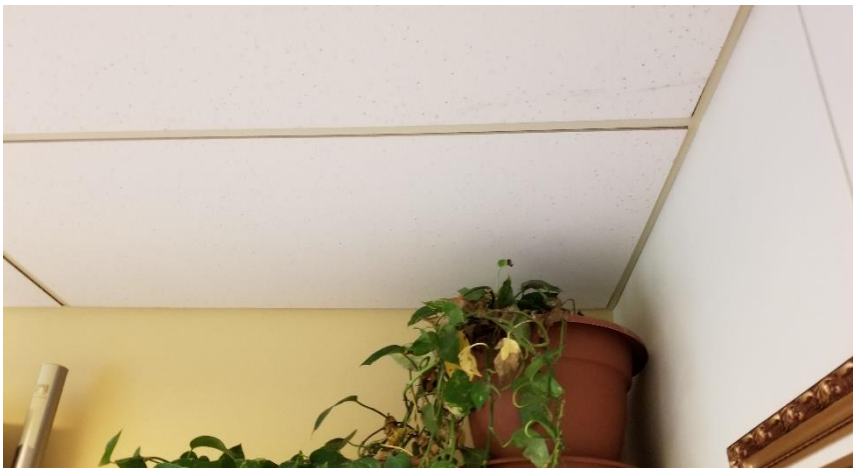
Photo 20: View of the asbestos containing ceiling tiles - 2'x4' Pinholes w/ Triangular Fissures observed in good condition in Room 306.

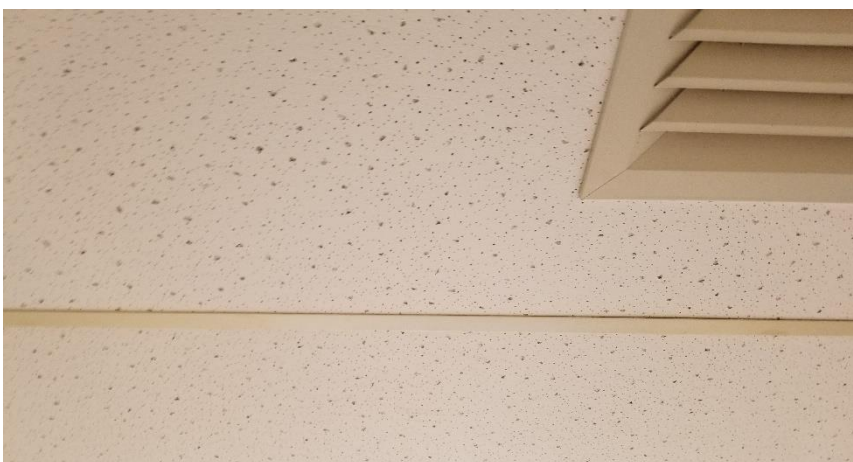
Photo 21: View of the asbestos containing ceiling tiles - 2'x4' Pinholes w/ Triangular Fissures observed in good condition in Room 327.

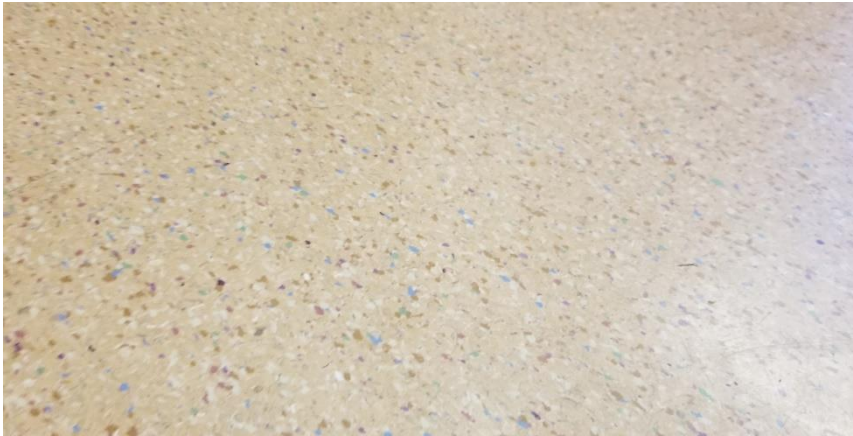
Photo 22: View of the non-asbestos VFT (12"x12" - Pink w/ Multicolour Streaks) observed in Room 223.

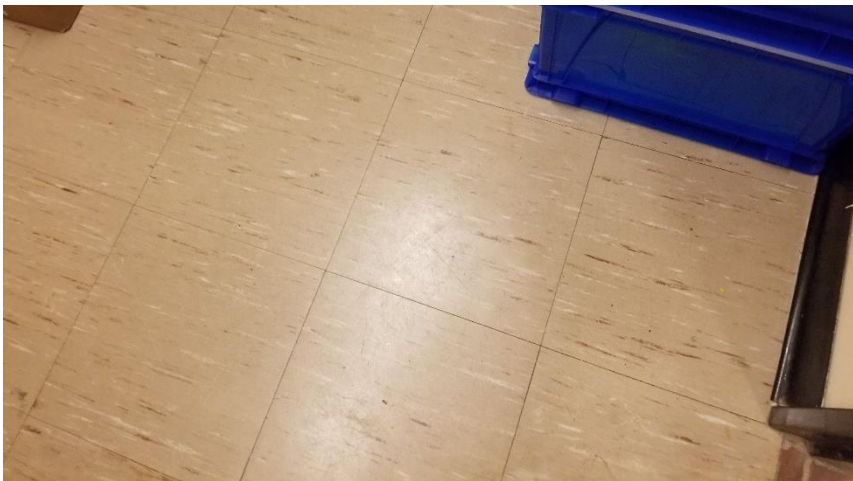
Photo 23: View of the asbestos-containing vinyl floor tiles (12"x12" – Brown w/ Brown Stripes) observed in good condition in Room 224.

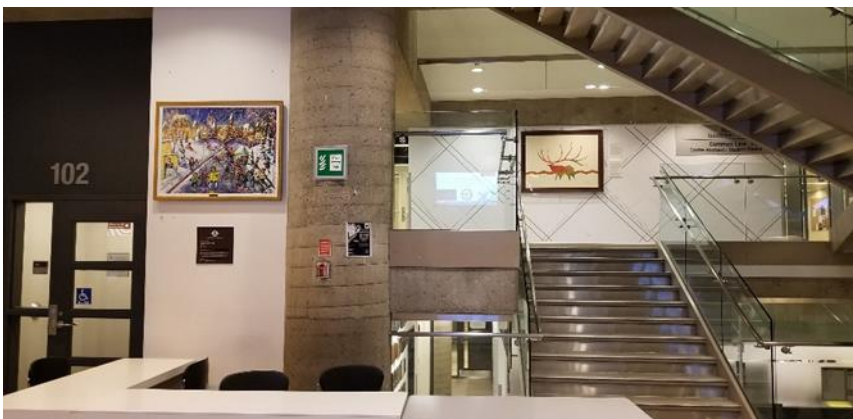
Photo 24: Representative view of the common area finishes observed throughout the Ground Floor entrance.

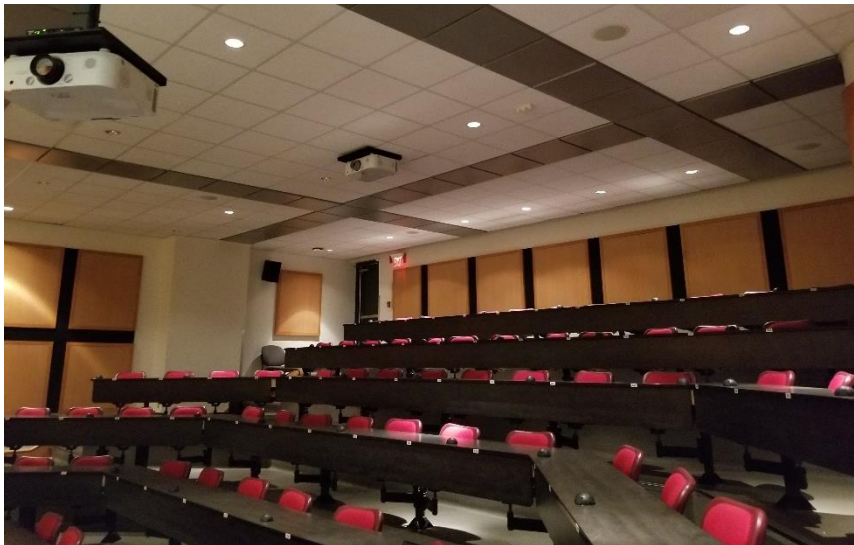
Photo 25: Representative view of the common area finishes observed throughout Room 147B.

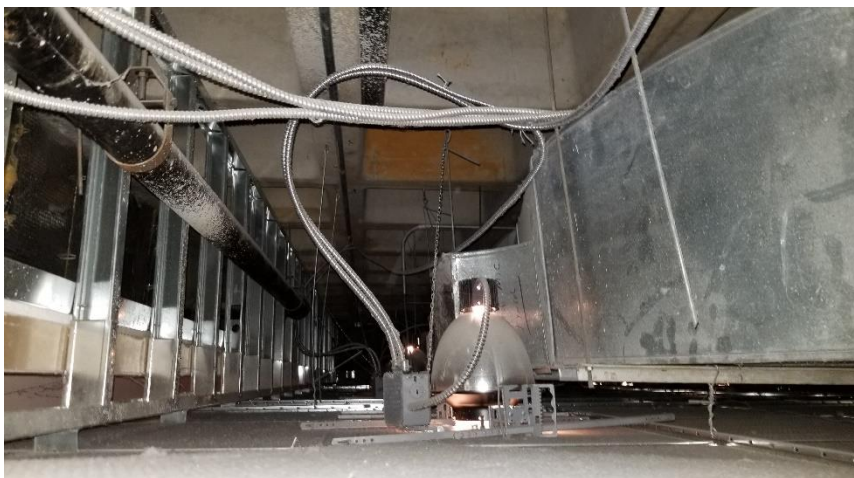
Photo 26: Representative view of the ceiling space in Room 147B.

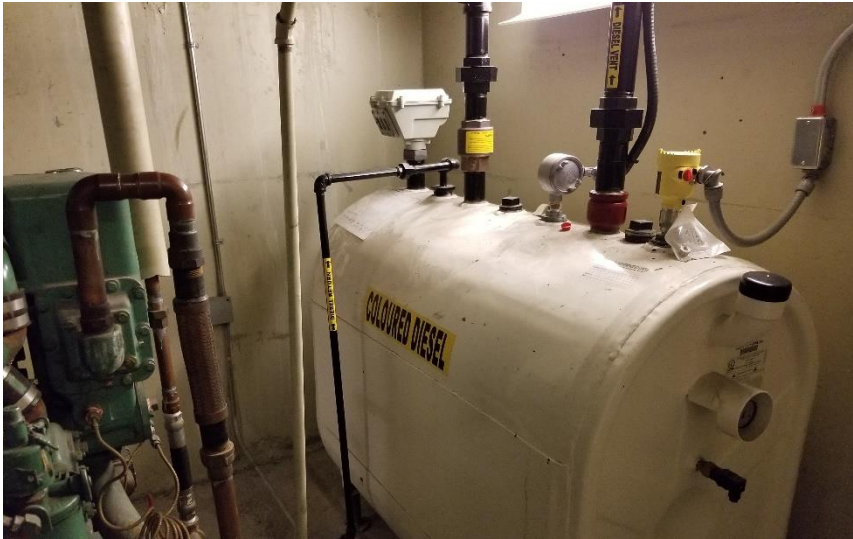
Photo 27: View of the above ground storage tank (AST) containing diesel, observed in good condition in Room 142C.
