HAZARDOUS MATERIALS SURVEY AND 2022 REASSESSMENT 30 MARIE CURIE (GENDRON), OTTAWA, ON

Project No.:0Z2021101HZ / CCC-230252-00

University of Ottawa

November 28, 2022

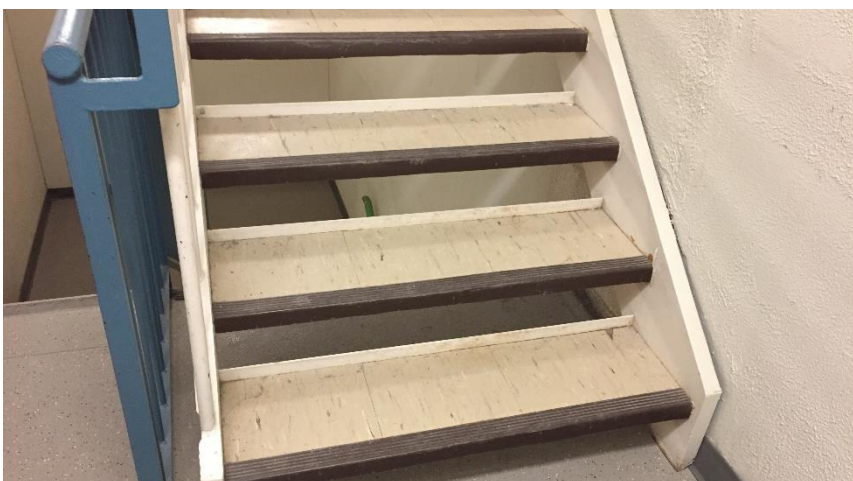
- Previously identified asbestos-containing vinyl floor tiles (12"x12" – Beige with Grey Streaks) were observed in Room 361 and 444. This material **contains 15.2% Chrysotile asbestos**. This material is considered to be non-friable and was observed in good condition.

Photo 3: View of the asbestos-containing vinyl floor tiles (12"x12" Beige w/ Grey Streaks) observed in Room 361.

- All repairs or removal of asbestos-containing materials must be conducted according to Ontario Regulation 278/05, Regulation respecting Asbestos on Construction Projects and in Buildings and Repair Operations - made under the Occupational Health and Safety Act. Asbestos containing waste must also be handled and disposed of according to Ontario Regulation 347/90 as amended – made under the Environmental Protection Act. Any suspect building materials encountered that were not assessed as part of this survey, should be assumed to contain asbestos until proven otherwise by analytical testing;

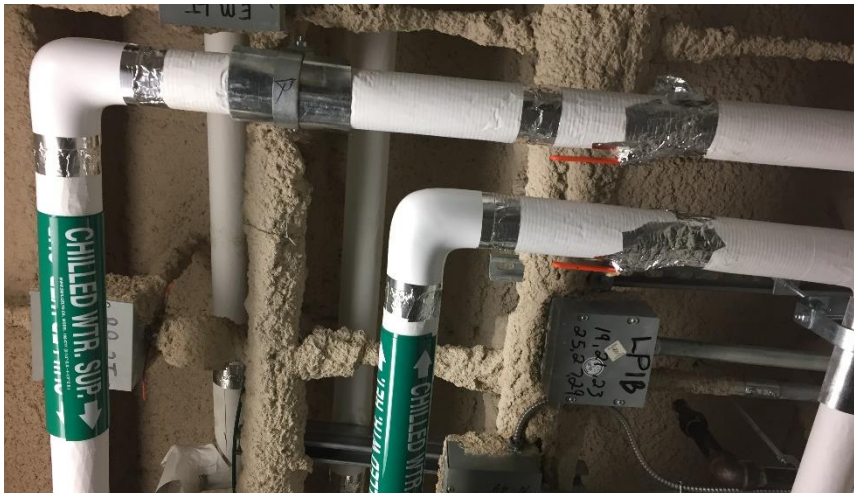
Sprayed fireproofing (Grey) was observed and sampled in Room 540. The laboratory analytical results of the samples collected indicate that this material does not contain asbestos.

Photo 5: View of the non-asbestos sprayed fireproofing observed throughout the subject building.

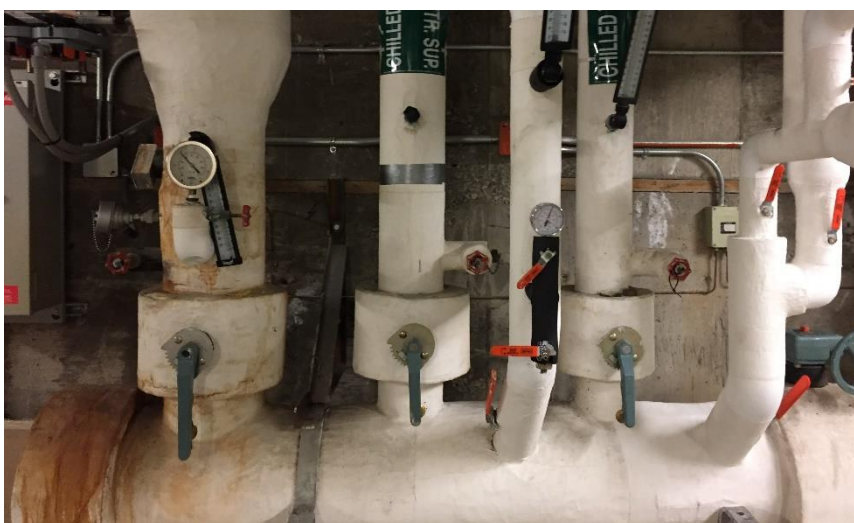
Mechanical pipe elbows/fittings insulation was observed throughout the subject building. MPL made several incisions throughout to investigate its composition, and it was visually identified as fiberglass, and therefore not suspected of containing asbestos.

Photo 6: Representative view of the non-asbestos containing mechanical insulation observed throughout the subject building.

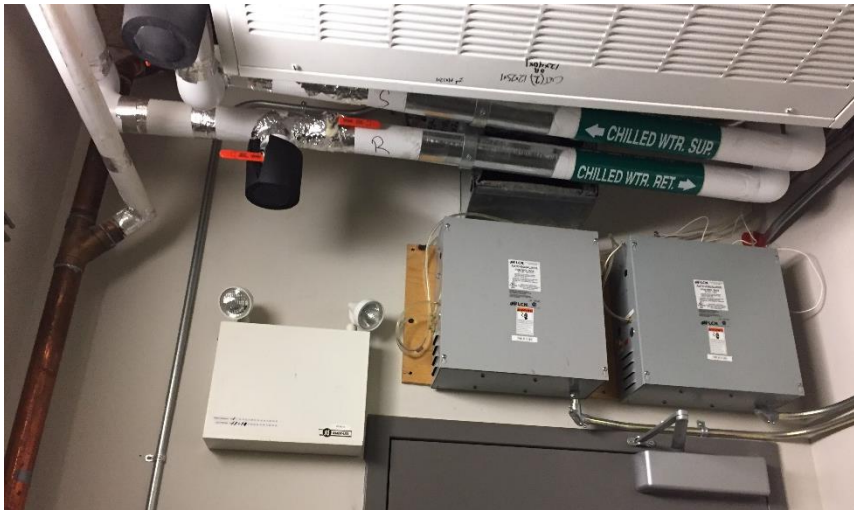
MPL observed lead-containing acid battery packs in Room 061, 154, 244, 443, 461, and 540.

Photo 7: View of the lead-containing battery packs observed in Room 154.

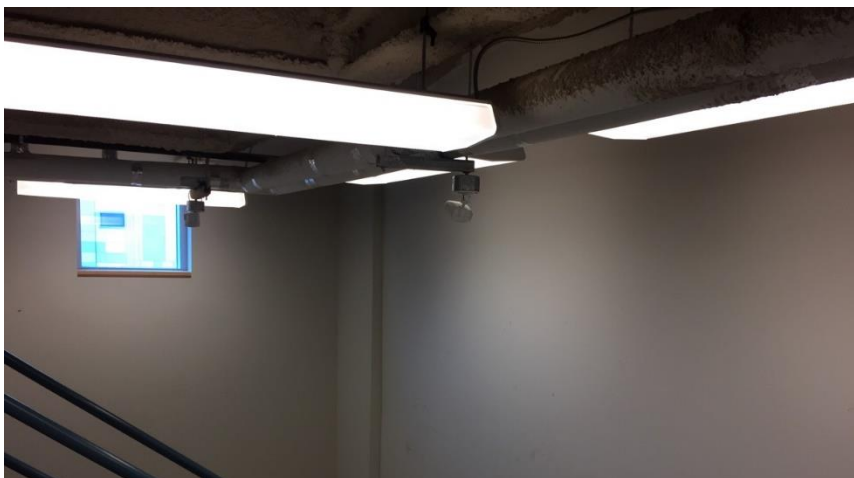
Photo 8: Representative view of the mercury-containing fluorescent light fixtures observed throughout the subject building.

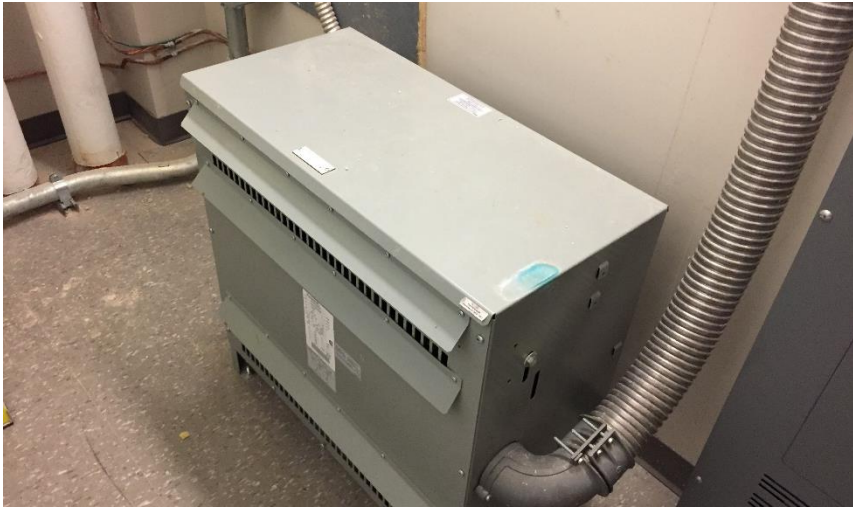
MPL did not observe any PCBs containing electrical transformers within the subject building. Transformers that could be assessed were observed to be dry-type and manufactured by Siemens.

Photo 10: Representative view of the non-PCB dry-type transformers observed throughout the subject building.

Since no PCB-containing equipment was observed or suspected to be present during the site survey, no further action is required.
