# HAZARDOUS MATERIALS SURVEY AND 2022 REASSESSMENT HAGEN HALL, 115 SERAPHIN-MARION PRIVATE, OTTAWA, ON

Project No.: Z1920014HZ / CCC-230252-00

November 8, 2022

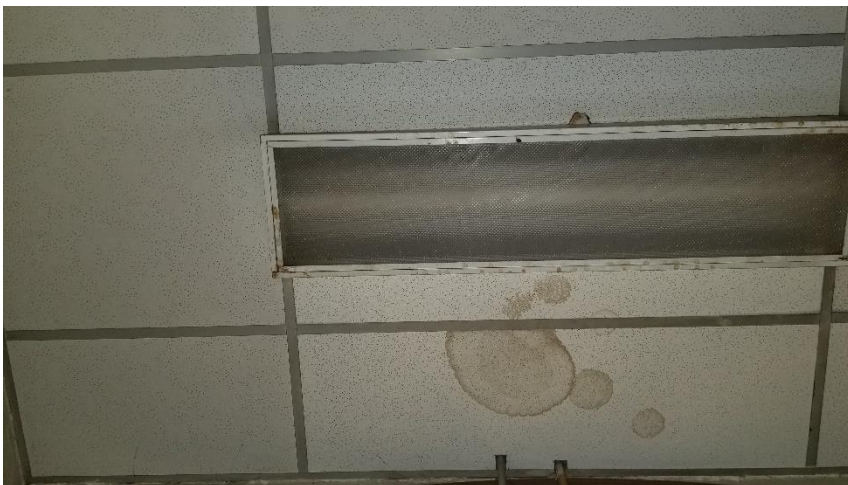
**Photo 6:** View of the water damaged ceiling tiles identified in Room 106A.

- Please refer to Appendix F – Hazardous Materials Checklist for equipment conditions, approximate quantities (where applicable), and recommended actions.
- Water stained/damaged ceiling tiles observed throughout the subject building should be replaced as part of regular maintenance and the underlying cause of the water leakage should be identified and repaired;
- Water stained/damaged ceiling tiles that are also determined to contain asbestos must be replaced following appropriate asbestos abatement procedures as outlined in O.Reg. 278/05.

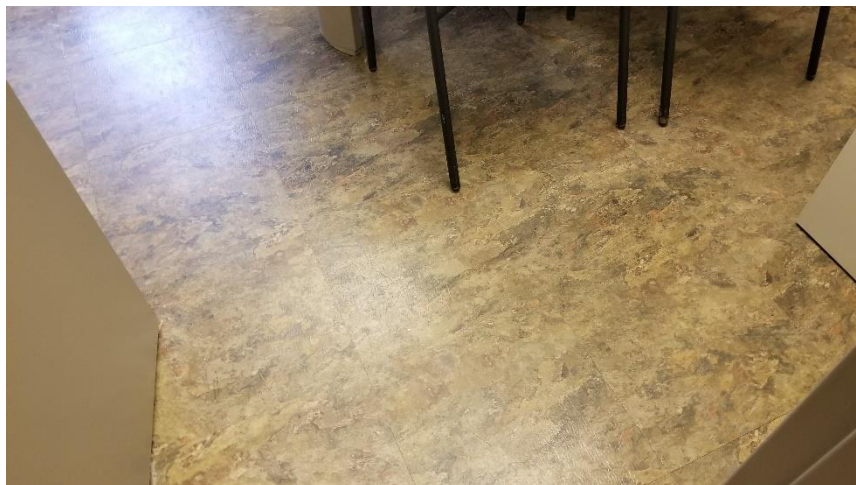
**Photo 8:** View of the non-asbestos vinyl sheet flooring observed throughout the subject building.

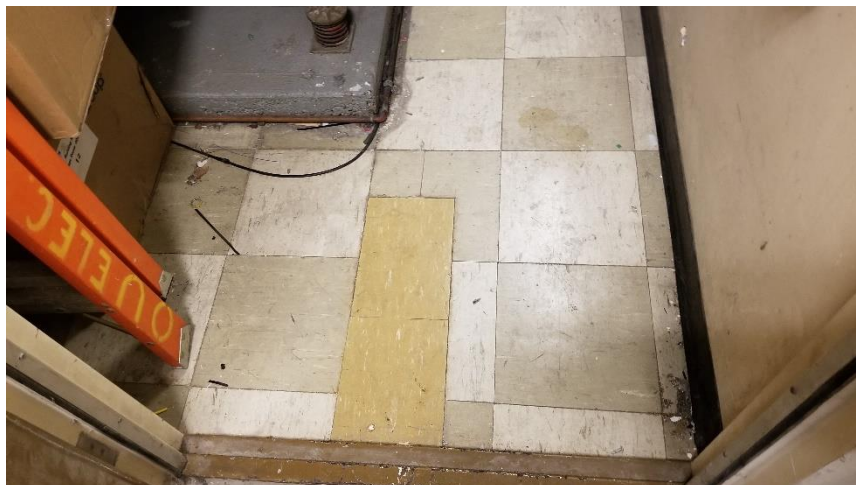
- Previously identified asbestos-containing vinyl floor tiles (12"x12" – Grey w/ Streaks) were observed in Room 107J. This material **contains 2% Chrysotile asbestos** and is considered to be non-friable. **This material was not observed during the 2022 Reassessment Survey.**

- Previously identified asbestos-containing vinyl floor tiles (12"x12" – Beige w/ Streaks) were observed in Room 107J. This material **contains 1% Chrysotile asbestos** and is considered to be non-friable. **This material was not observed during the 2022 Reassessment Survey.**

**Photo 9:** View of the asbestos-containing vinyl floor tiles: (12"x12" – Gold w/ White Streaking), (12"x12" – Grey w/ Streaks), and (12"x12" – Beige w/ Streaks) observed in Room 107J.

**Material not observed in this location during 2022 Reassessment.**

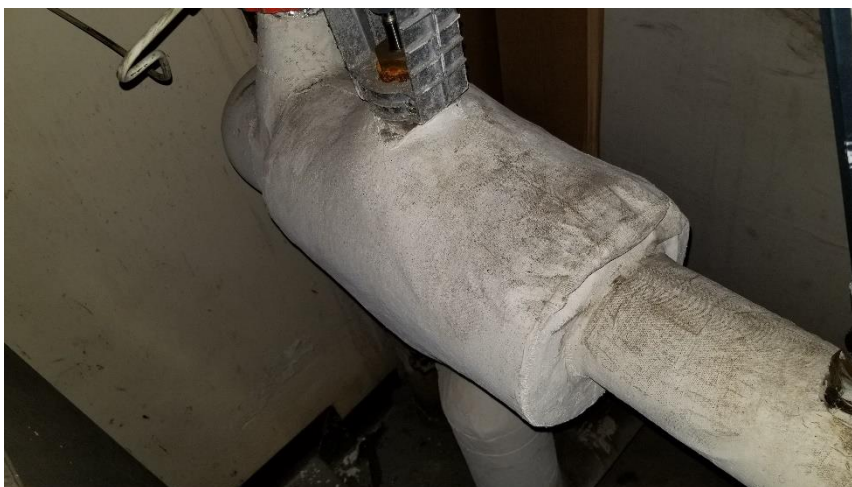
Mechanical pipe straight insulation was observed in Room 107F and 207. MPL made several incisions throughout to investigate its composition, and it was visually identified as fiberglass, and therefore not suspected of containing asbestos.

Mechanical pipe elbow/fitting insulation was observed in Room 107F and 207. MPL made several incisions throughout to investigate its composition, and it was visually identified as fiberglass, and therefore not suspected of containing asbestos.

**Photo 12:** View of the fiberglass mechanical pipe fitting and pipe straight insulation observed throughout the subject building.

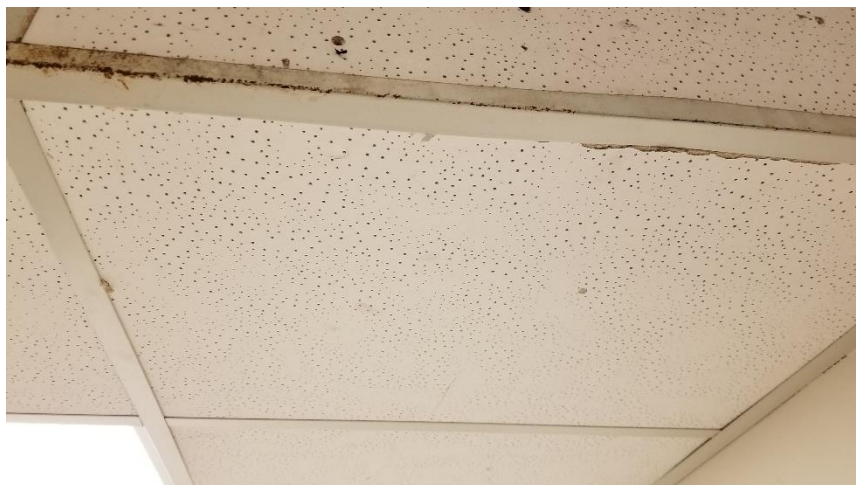
**Photo 16:** View of the asbestos-containing ceiling tiles (2'x4' White w/ Small Pinholes) observed in Room 106.
