HAZARDOUS MATERIALS SURVEY BROOKS RESIDENCE – 620 KING EDWARD AND 75 LOUIS-PASTEUR

Project No.: CCC-230252-00

University of Ottawa

December 6, 2022

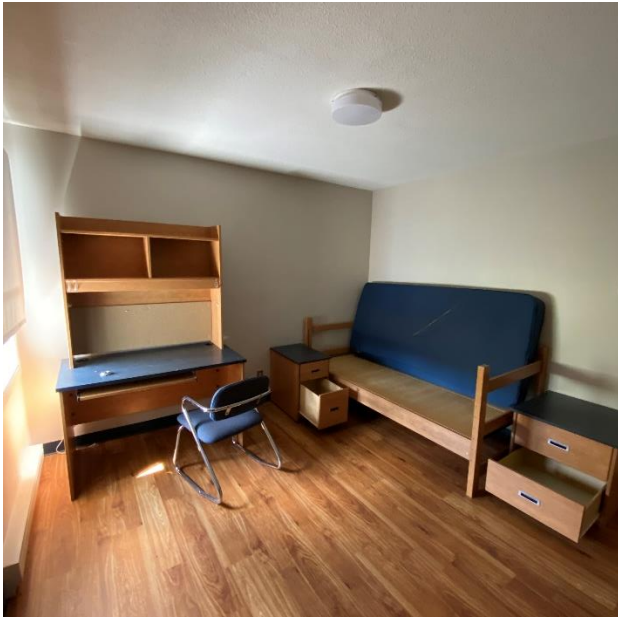
Photo 1: View of typical finished observed throughout the subject building bedrooms

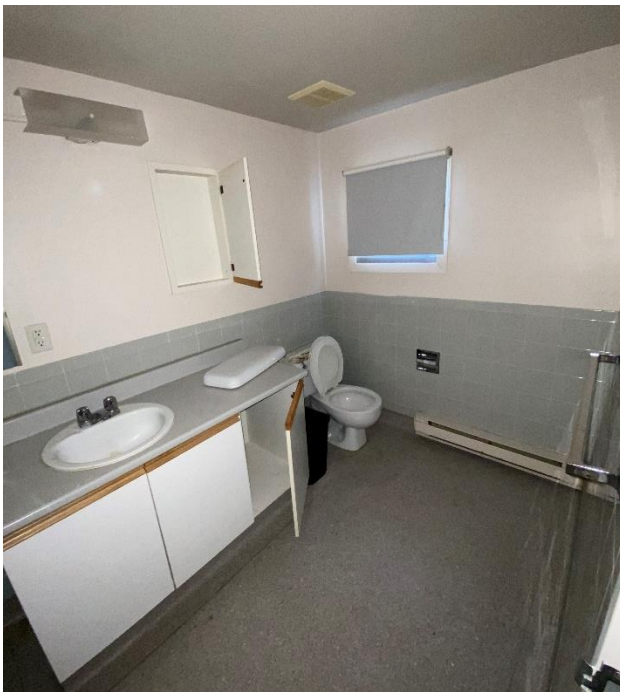
Photo 2: View of typical finished observed throughout the subject building bathrooms

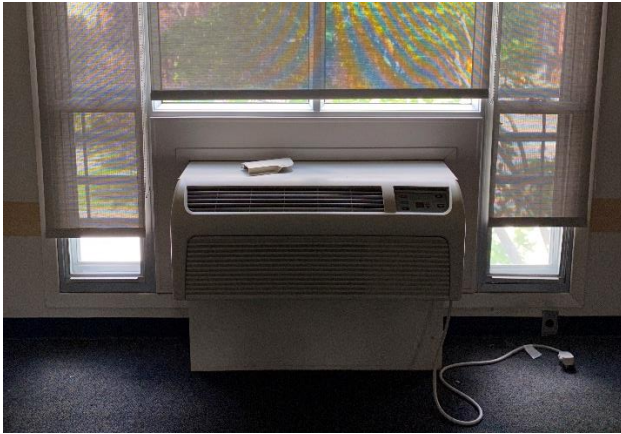
Photo 3: View of air conditioner observed in the apartment living rooms of the subject buildings

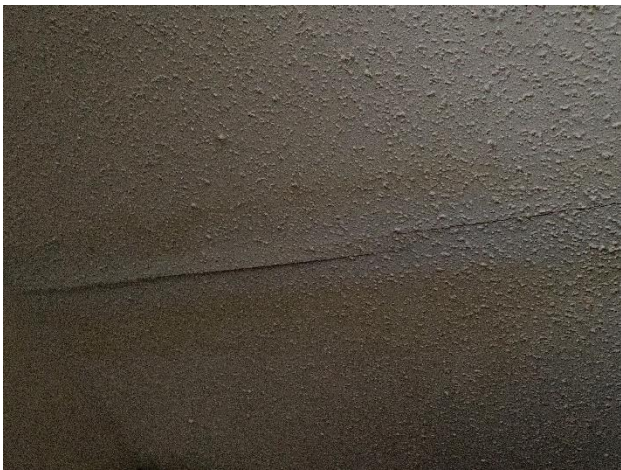
A visual survey of the subject buildings was conducted to determine if any water damaged was present. MPL identified select areas throughout the subject building, where materials were affected by water damage.

Photo 4: View of water damaged ceiling texture coat observed in apartment 198 - bedroom of 620 King Edward

Please refer to Appendix F – Hazardous Materials Checklist for equipment conditions, quantities (where applicable), and recommended actions.

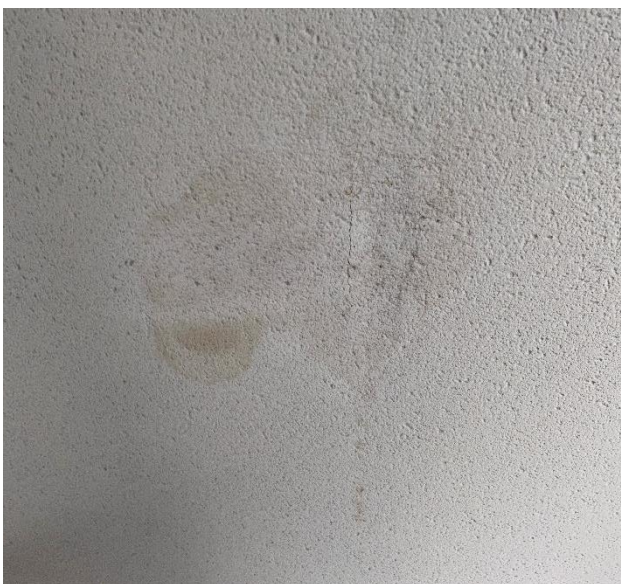
Photo 5: View of water damaged ceiling texture coat observed in apartment 196 – living room of 620 King Edward

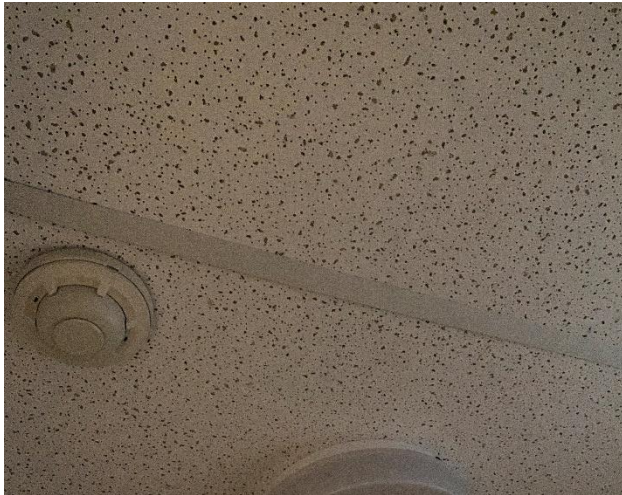
Suspended ceiling tiles (2'x4' White with small round fissures & pinholes) were observed in the 1st floor janitor closet. The date stamp on the back of these tiles indicated that they were manufactured in 2010 and therefore, this material is not considered to contain asbestos.

Photo 6: View of non-asbestos containing ceiling tiles observed in the 1st floor janitor closet

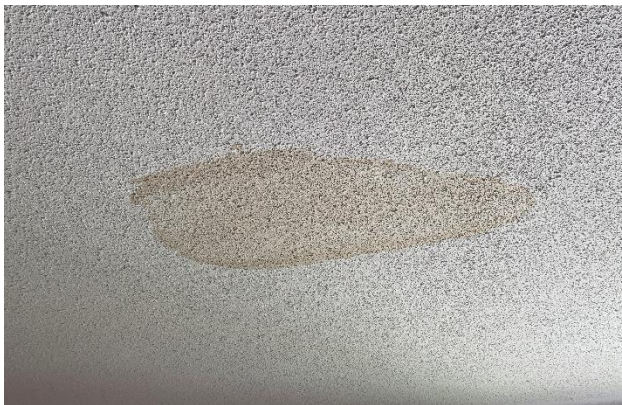
Photo 7: View of water damaged ceiling texture coat observed in apartment 187 – living rooms of 75 Louis-Pasteur

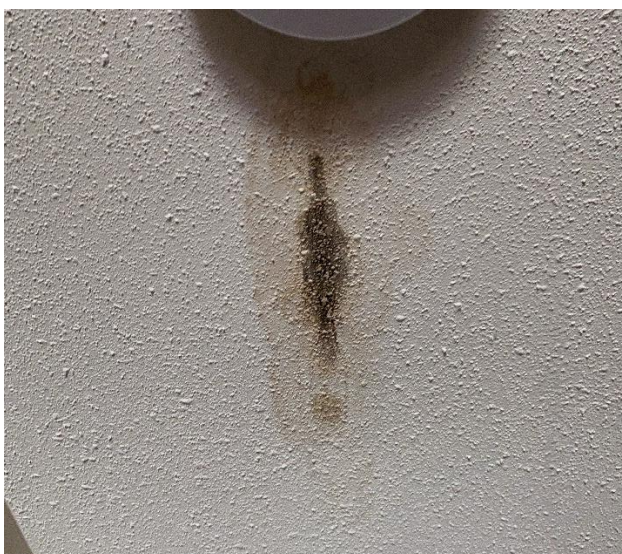
Photo 8: View of water damaged ceiling texture coat observed in apartment 184 - hallway of 75 Louis-Pasteur
