HAZARDOUS MATERIALS SURVEY BROOKS RESIDENCE – 624 KING EDWARD, 622 KING EDWARD, 79 LOUIS-PASTEUR

Project No.: CCC-230252-00

University of Ottawa

McIntosh Perry Limited (MPL)

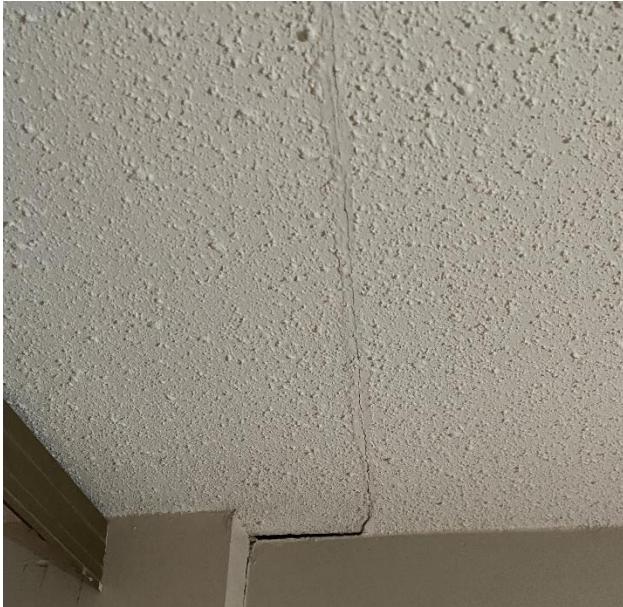
Ceiling texture coating was observed throughout the subject buildings. The laboratory analytical results of ceiling texture coat samples collected from 624 King Edward, 622 King Edward and 79 Louis-Pasteur indicate that this material does not contain asbestos.

Photo 1: View of non-asbestos containing ceiling texture coat observed throughout the subject buildings

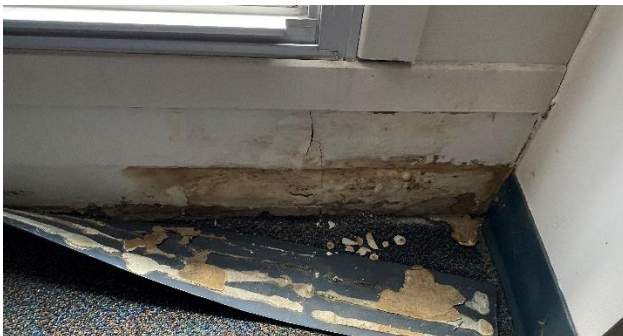
Photo 2: View of water damaged drywall wall observed in apartment 180 - living room of 79 Louis-Pasteur

Please refer to Appendix F – Hazardous Materials Checklist for equipment conditions, quantities (where applicable), and recommended actions.

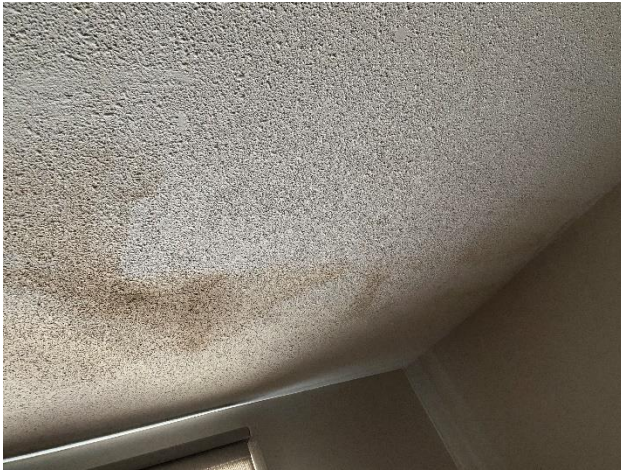
Photo 3: View of water damaged ceiling texture coating observed in apartment 177 – living room of 79 Louis-Pasteur

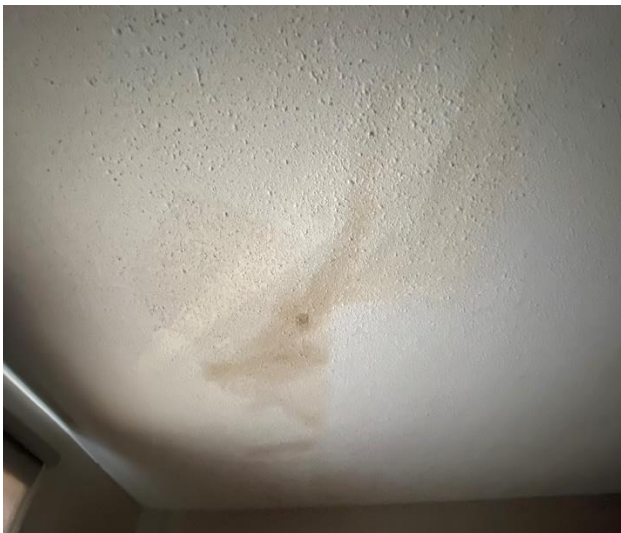
Photo 4: View of water damaged ceiling texture coating observed in apartment 173 – dining room of 79 Louis-Pasteur

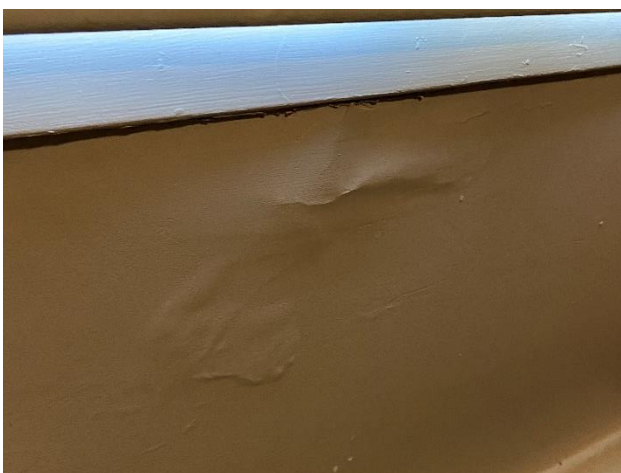
Photo 5: View of water damaged drywall wall observed in apartment 174 - bedroom of 79 Louis-Pasteur

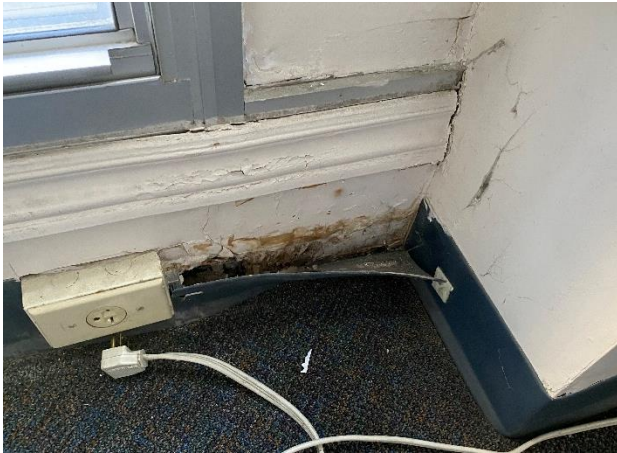
Photo 6: View of water damaged drywall wall observed in apartment 168 – living room of 624 King Edward

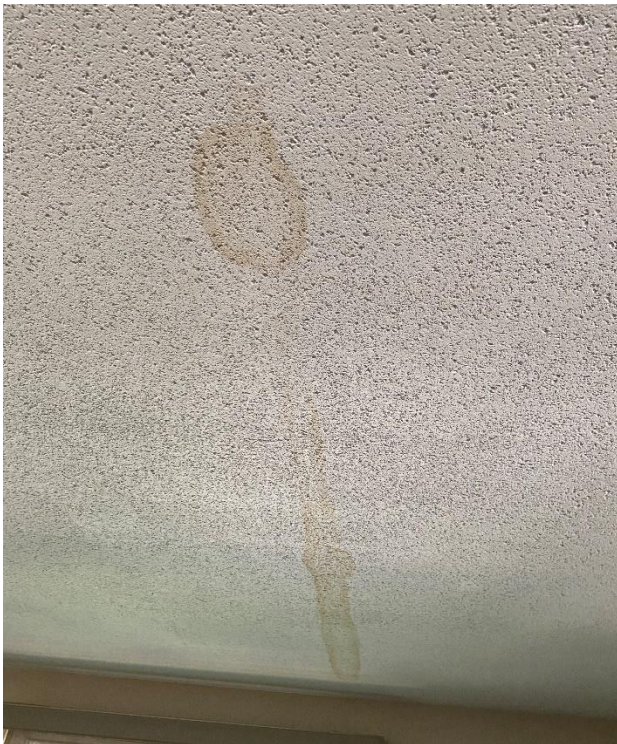
Photo 7: View of water damaged ceiling texture coat observed in apartment 164 – living room of 624 King Edward

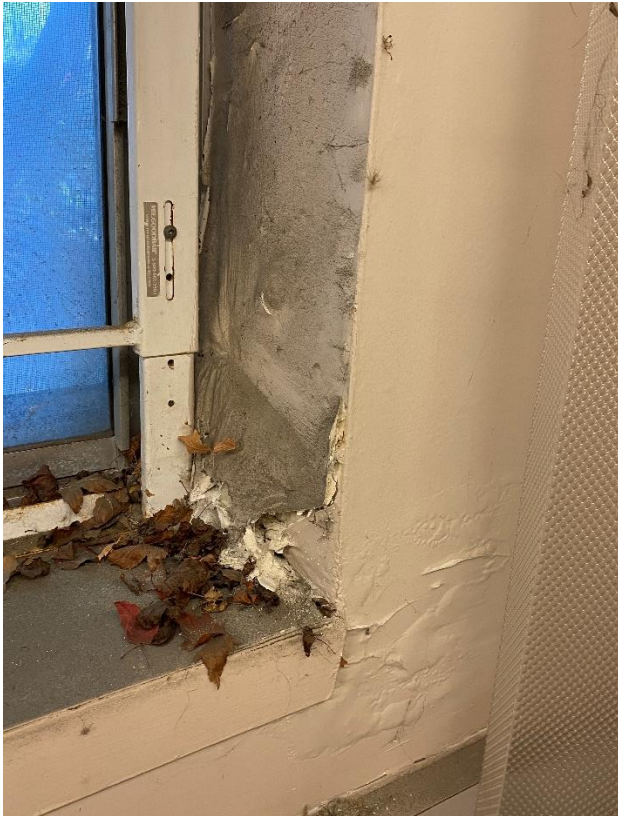
Photo 8: View of water damaged window sill observed in the basement laundry room of 624 King Edward

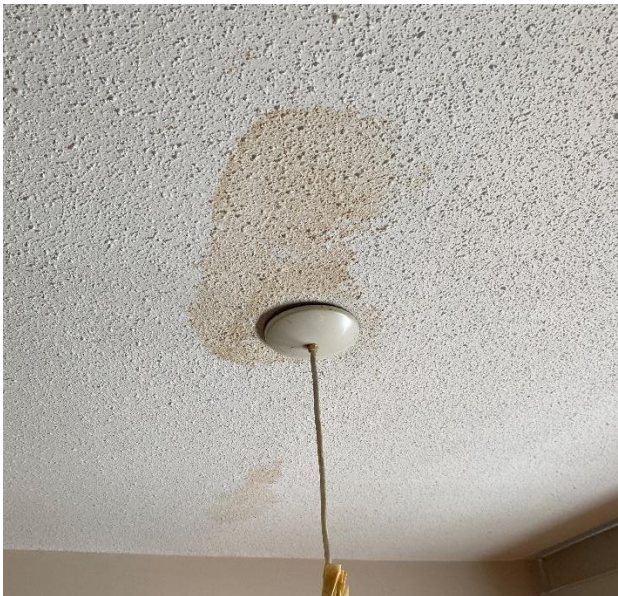
Photo 9: View of water damaged ceiling texture coat observed in apartment 157 – dining room of 624 King Edward

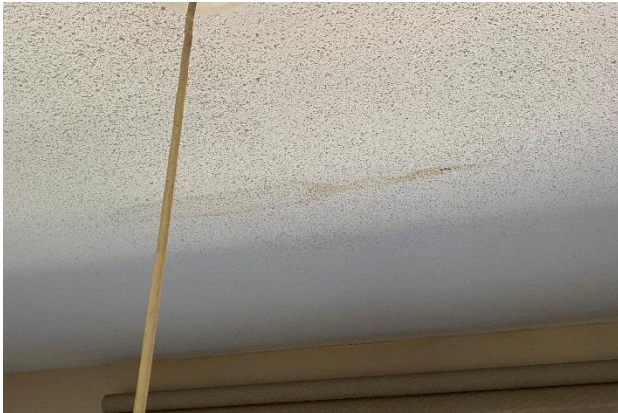
Photo 10: View of water damaged ceiling texture coat observed in apartment 155 – dining room of 622 King Edward

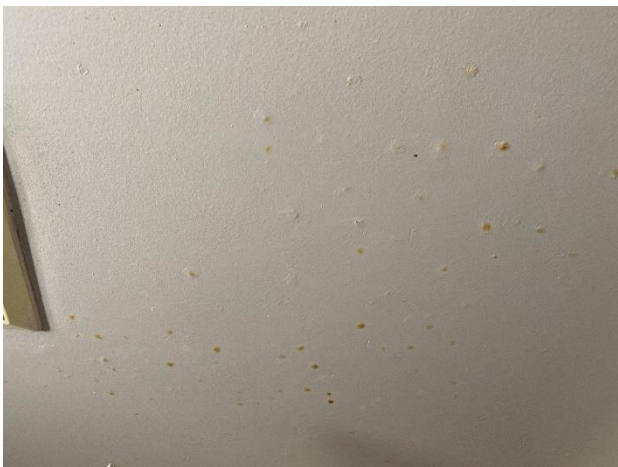
Photo 11: View of mould observed in apartment 155 – full bath ceiling of 622 King Edward

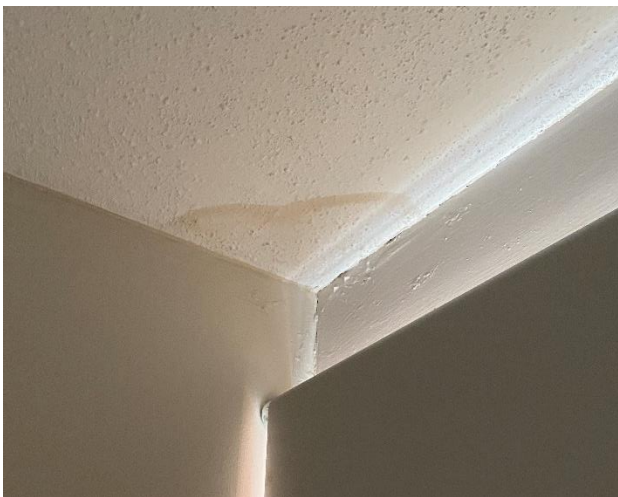
Photo 12: View of water damaged ceiling texture coat observed in apartment 151 - bedroom of 622 King Edward

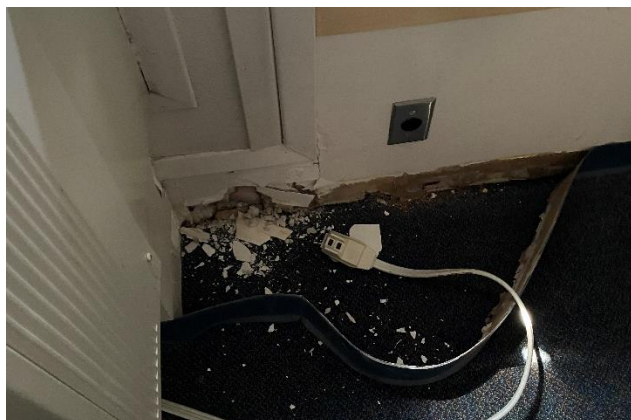
Photo 13: View of water damaged drywall wall observed in apartment 152 – living room of 622 King Edward
