HAZARDOUS MATERIALS SURVEY BROOKS RESIDENCE – 632 KING EDWARD, 630 KING EDWARD, 99 LOUIS-PASTEUR

Project No.: CCC-230252-00

December 5, 2022

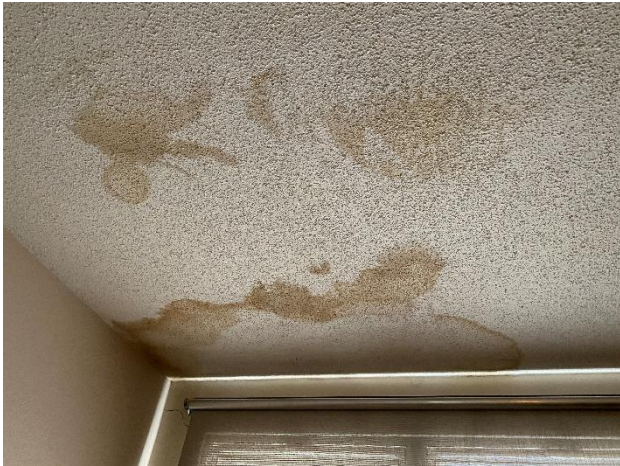
Photo 1: View of water damaged ceiling texture coat observed in apartment 81 – living room of 630 King Edward

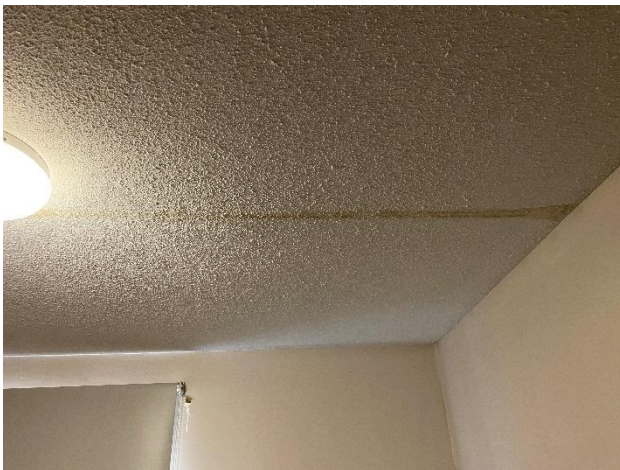
Photo 2: View of water damaged ceiling texture coat observed in apartment 76 – bedroom of 630 King Edward

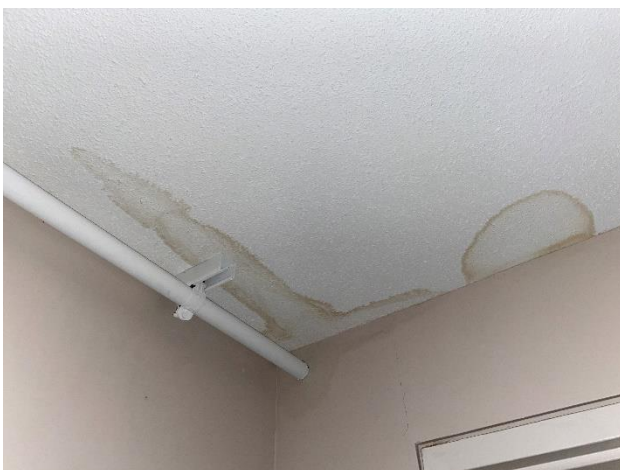
Photo 3: View of water damaged ceiling texture coat observed in apartment 73 doorway of 630 King Edward

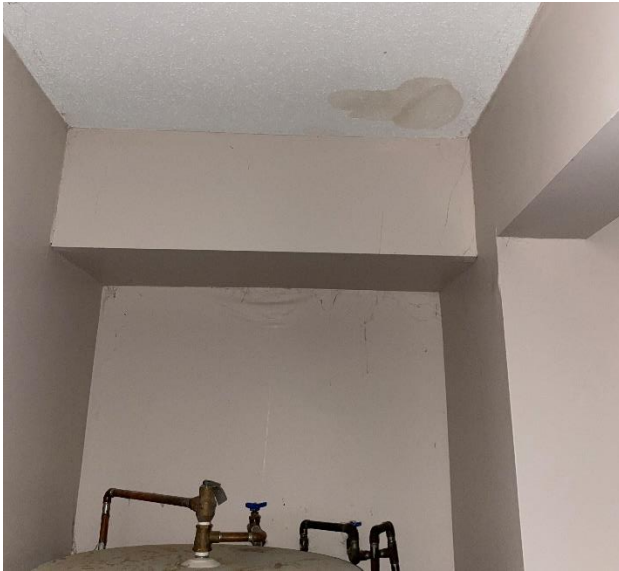
Photo 4: View of water damaged ceiling texture coat observed in apartment 74 – hot water tank storage closet of 630 King Edward

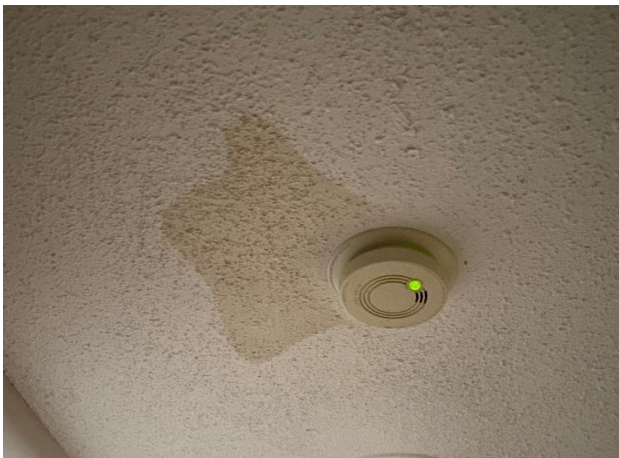
Photo 5: View of water damaged ceiling texture coat observed in apartment 90 – hallway of 632 King Edward

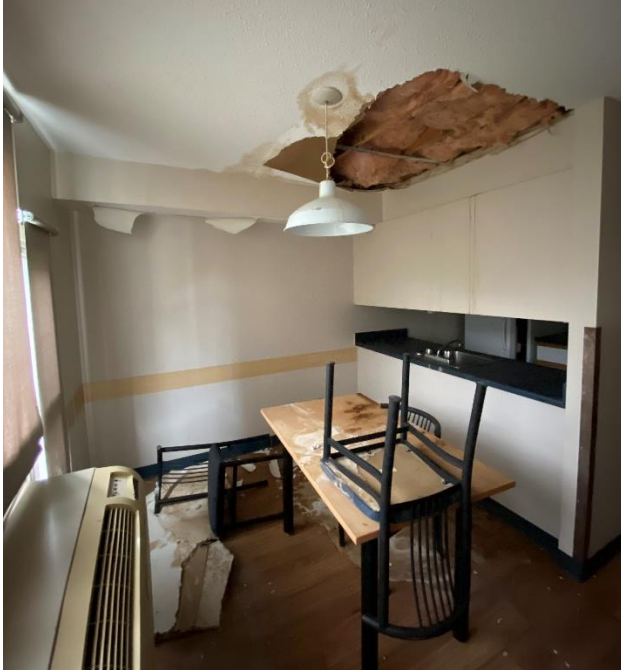
Photo 6: View of collapsed water damaged ceiling texture coat observed in apartment 104 – kitchen of 99 Louis-Pasteur
