HAZARDOUS MATERIALS SURVEY

BROOKS RESIDENCE – 636 KING EDWARD, 634 KING EDWARD, 101 LOUIS-PASTEUR

Project No.: CCC-230252-00

December 5, 2022

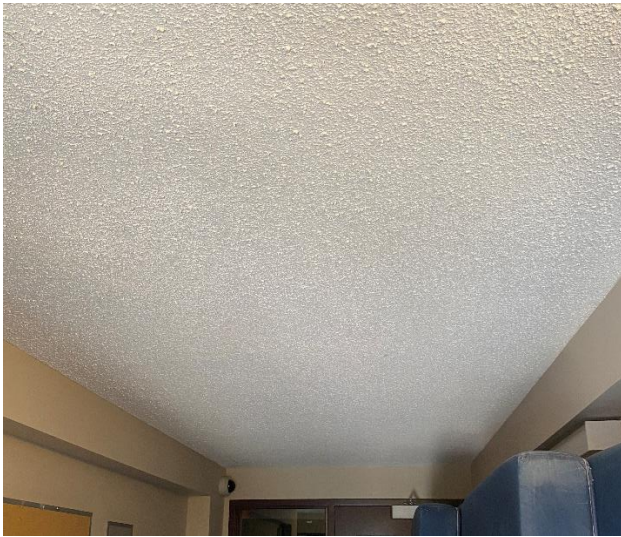
Ceiling texture coating was observed throughout the subject buildings. The laboratory analytical results of ceiling texture coat samples collected from 636 King Edward, 634 King Edward and 101 Louis-Pasteur indicate that this material does not contain asbestos.

Photo 1: View of non-asbestos containing ceiling texture coat observed throughout the buildings

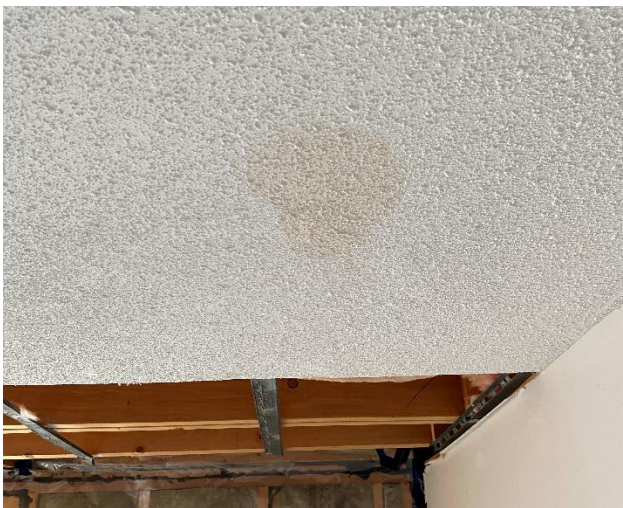
A visual survey of the subject buildings was conducted to determine if any water damaged was present. MPL identified select areas throughout the subject building, where materials were affected by water damage.

Photo 2: View of water damaged ceiling texture coat observed in apartment 69 – living room of 101 Louis-Pasteur

Please refer to Appendix F – Hazardous Materials Checklist for equipment conditions, quantities (where applicable), and recommended actions.

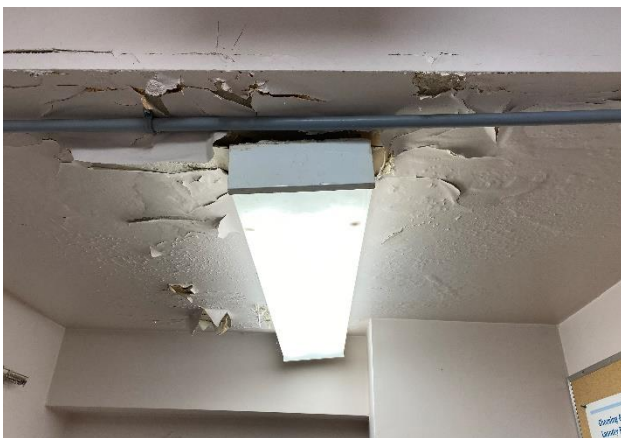
Photo 3: View of water damaged ceiling drywall observed in the basement laundry room of 101 Louis-Pasteur

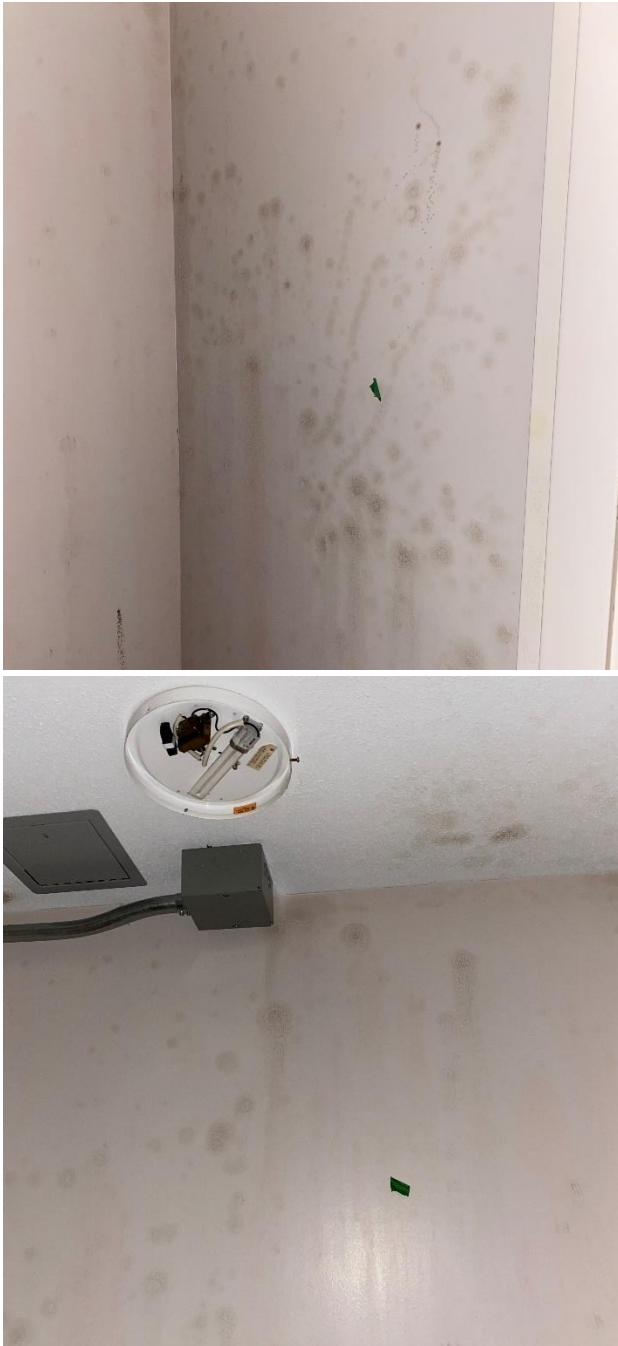
Photo 4: View of mould observed in apartment 51 – hot water tank storage closet of 634 King Edward
