# HAZARDOUS MATERIALS SURVEY BROOKS RESIDENCE – 638 KING EDWARD, 85 MARIE CURIE, 95 MARIE CURIE

Project No.: CCC-230252-00

University of Ottawa

December 5, 2022

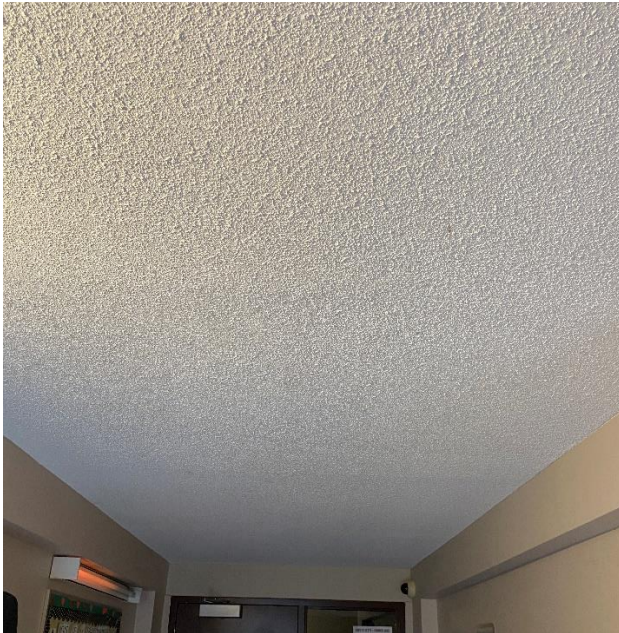
Ceiling texture coating was observed throughout the subject buildings. The laboratory analytical results of ceiling texture coat samples collected from 638 King Edward, 85 Marie Curie and 95 Marie Curie indicate that this material does not contain asbestos.

**Photo 1:** View of non-asbestos containing ceiling texture coat observed throughout the buildings

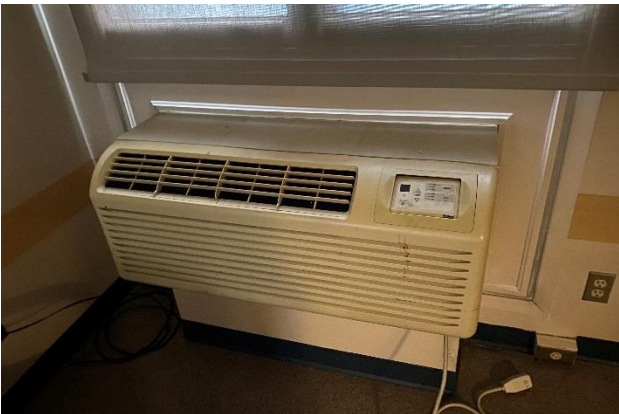
A visual assessment for equipment potentially containing ODSs and other halocarbons was conducted. MPL observed equipment such as refrigerators, freezers, air conditioning units, etc. which contain or are suspected of containing ODSs or other halocarbons.

**Photo 2:** View of air conditioner observed throughout the buildings

Please refer to Appendix F – Hazardous Materials Checklist for equipment conditions, quantities (where applicable), and recommended actions.

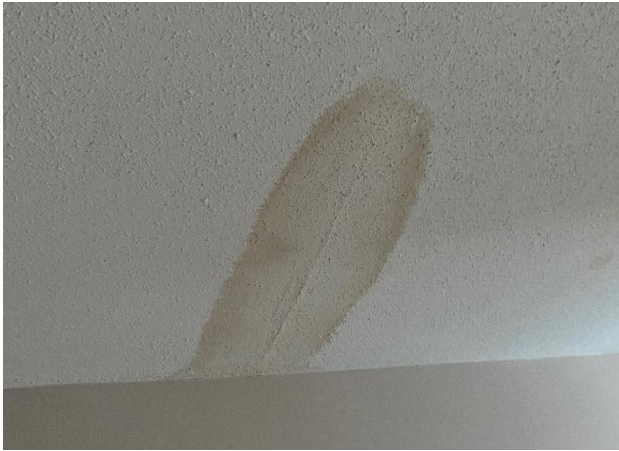
A visual survey of the subject buildings was conducted to determine if any water damaged was present. MPL identified select areas throughout the subject building, where materials were affected by water damage.

**Photo 3:** View of water damaged ceiling texture coat observed in apartment 9 - dining room of 638 King Edward

Please refer to Appendix F – Hazardous Materials Checklist for equipment conditions, quantities (where applicable), and recommended actions.

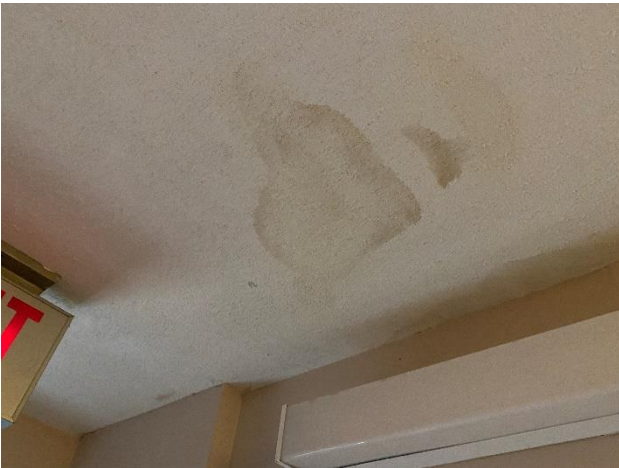
**Photo 4:** View of water damaged ceiling texture coat observed in the basement hallway of 638 King Edward

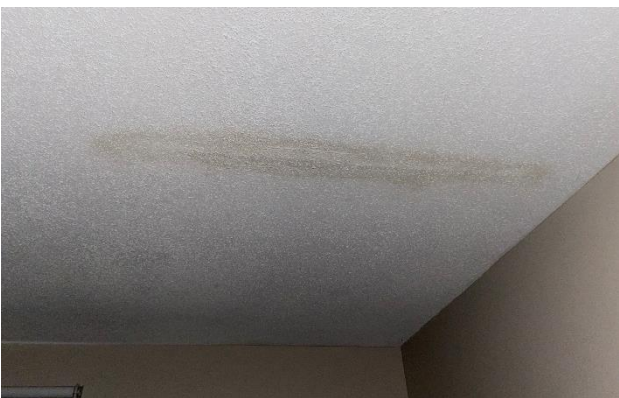
**Photo 5:** View of water damaged ceiling texture coat observed in apartment 4 - bedroom of 638 King Edward

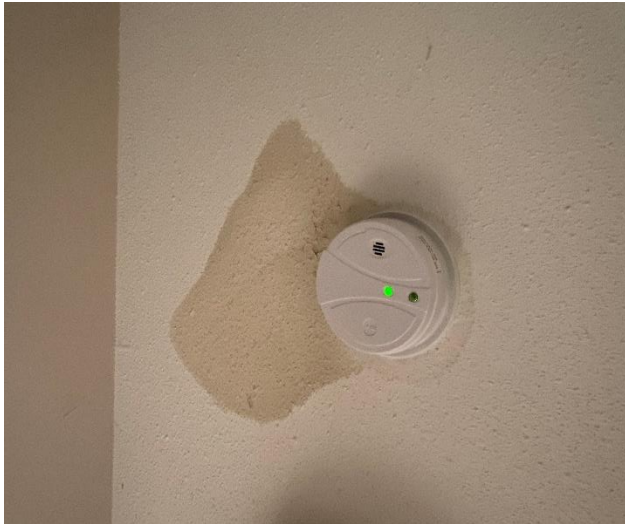
**Photo 6:** View of water damaged ceiling texture coat observed in apartment 1 - bedroom of 638 King Edward

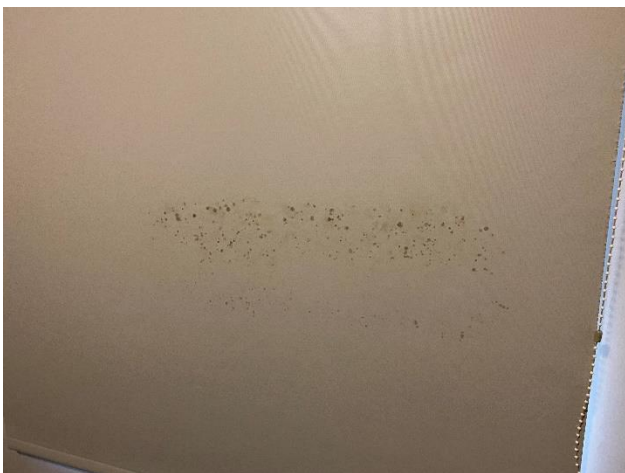
**Photo 7:** View of mould on window coverings observed in apartment 12 of 638 King Edward

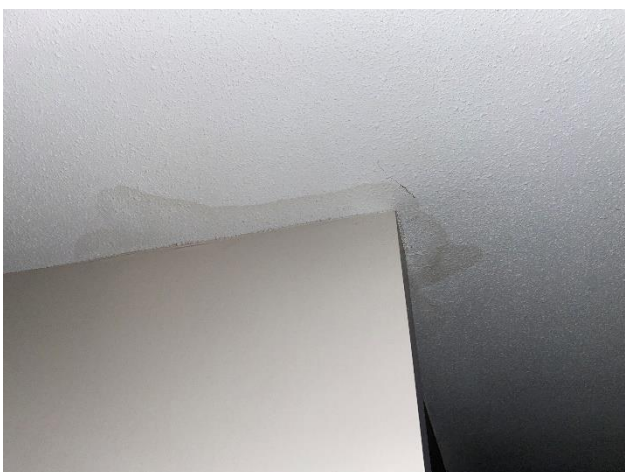
**Photo 8:** View of water damaged ceiling texture coat observed in apartment 17 - kitchen of 95 Marie Curie

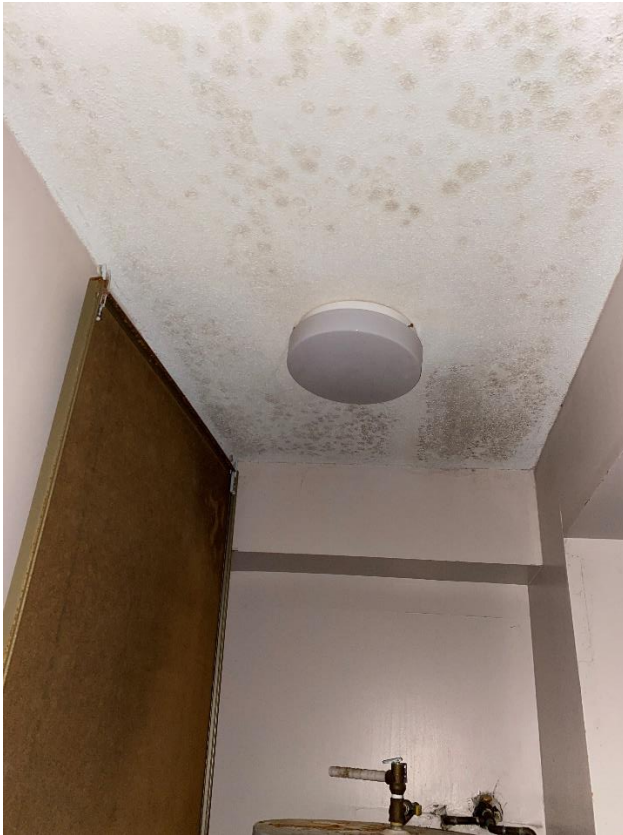
**Photo 9:** View of mould on ceiling of the hot water tank storage closet observed in apartment 18 of 95 Marie Curie

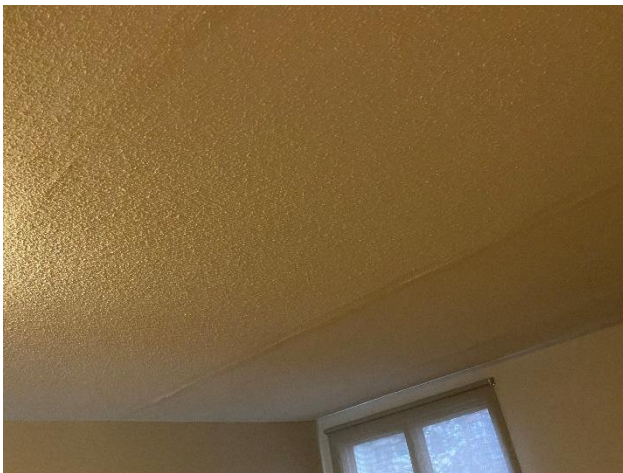
**Photo 10:** View of water damaged ceiling texture coat observed in apartment 19 – living room of 95 Marie Curie

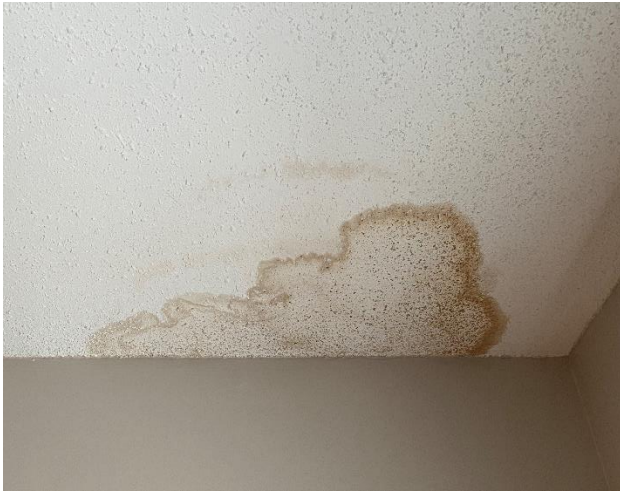
**Photo 11:** View of water damaged ceiling texture coat observed in apartment 35 – bedroom of 85 Marie Curie

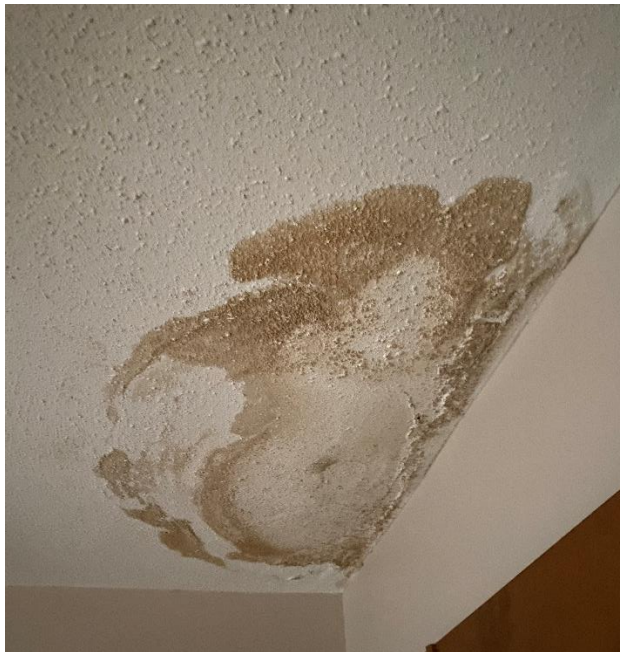
**Photo 12:** View of water damaged ceiling texture coat observed in apartment 29 – Dining Room of 85 Marie Curie
