HAZARDOUS MATERIALS SURVEY AND 2022 REASSESSMENT HYMAN SOLOWAY RESIDENCE, OTTAWA, ON

Project No.: Z2021102HZ / CCC-230252-00

University of Ottawa

September 8, 2022

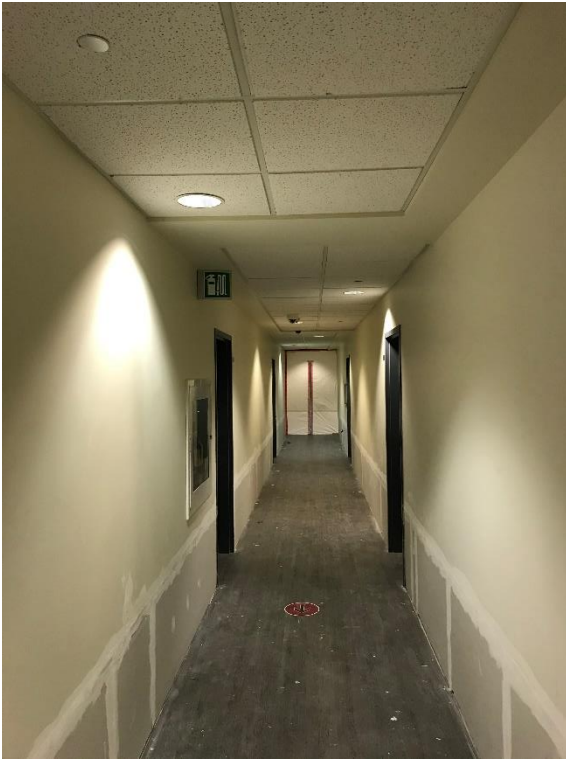
Photo 1: View of typical finishes observed at the building located at 157 Laurier Avenue East.

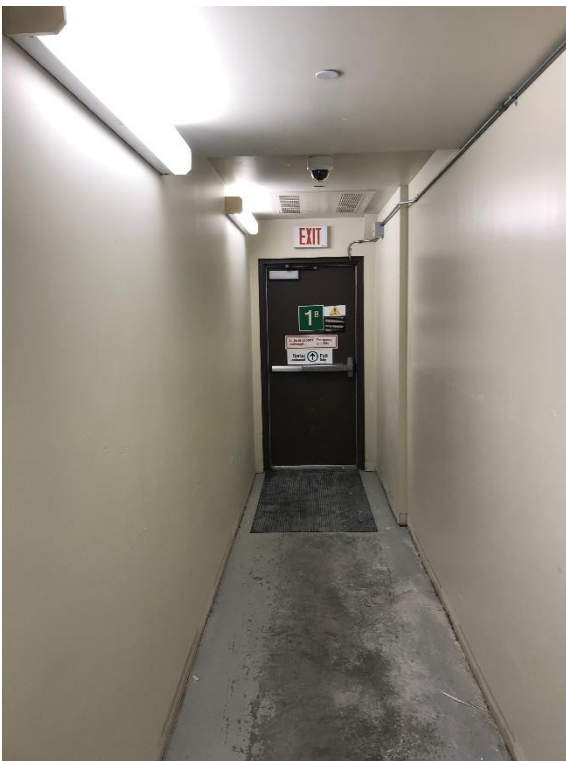
Photo 2: View of typical finishes observed at the building located at 157 Laurier Avenue East.

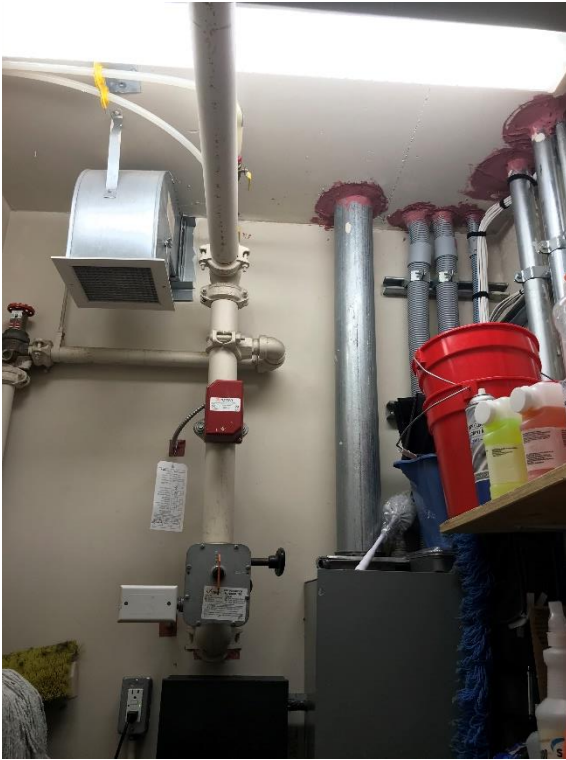
Photo 3: View of typical finishes observed at the building located at 157 Laurier Avenue East.

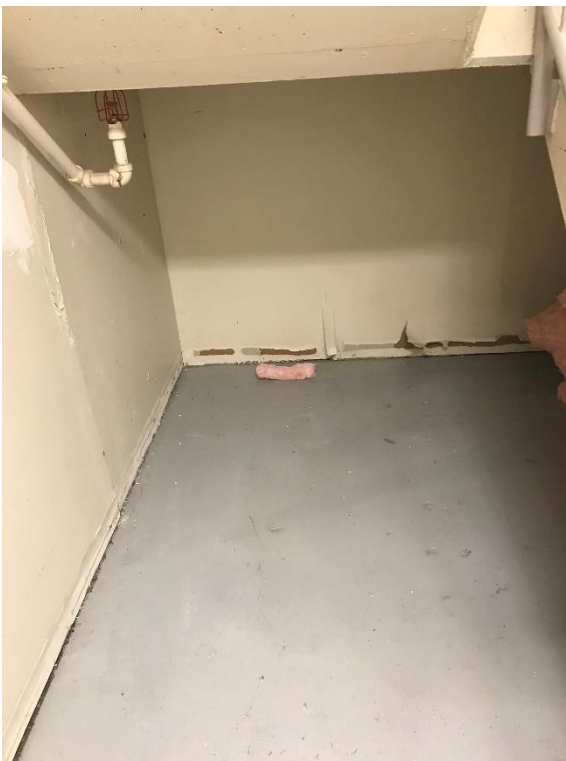
Photo 4: View of beige paint in the north stairwell, observed to be in poor condition.

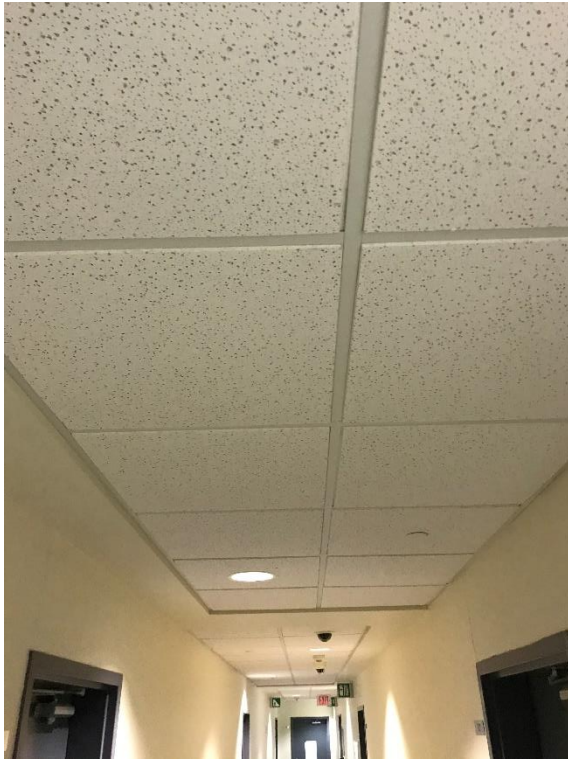
Photo 5: View of suspended ceiling tiles observed in the main corridors.

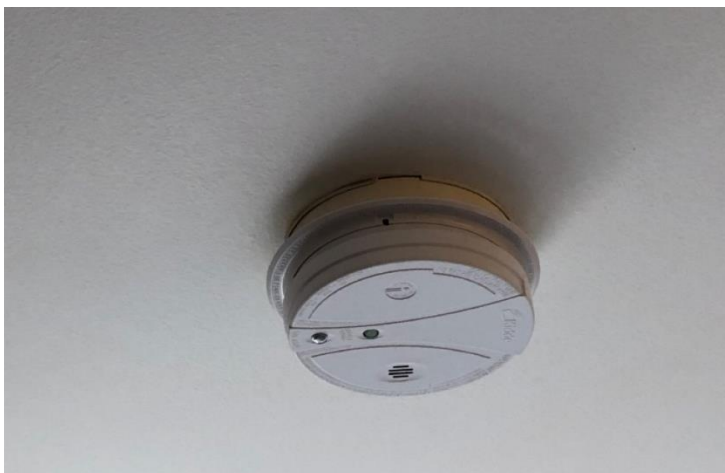
A visual assessment of the subject building was conducted to determine if any electrical components containing radioactive materials were present. MPL observed smoke detectors throughout the subject building which contain small quantities of radioactive material.

Photo 6: Typical view of smoke detectors containing radioactive materials.

Please refer to Appendix F – Hazardous Materials Checklist for equipment conditions, quantities (where applicable), and recommended actions.

The radioactive sources in smoke alarms are sealed and contained within a metal case inside the smoke detector and must not be damaged or tampered with. These materials do not pose a hazard as long as they remain contained and properly disposed at the time of removal or replacement.

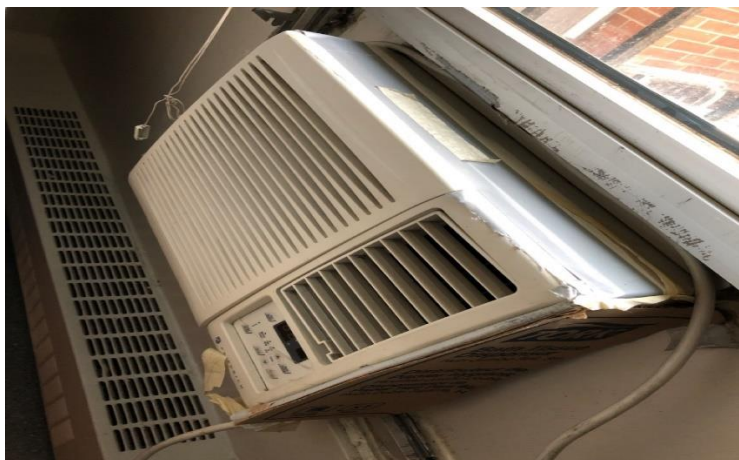
A visual assessment for equipment potentially containing ODSs and other halocarbons was conducted. MPL observed equipment such as refrigerators and air conditioners which contain or are suspected of containing ODSs or other halocarbons.

Photo 7: Typical view of ODS containing air-conditioning unit.

Please refer to Appendix F – Hazardous Materials Checklist for equipment conditions, approximate quantities (where applicable), and recommended actions.
