HAZARDOUS MATERIALS SURVEY AND 2022 REASSESSMENT LAMOUREUX HALL & LEARNING CROSSROADS, OTTAWA, ON

Project No.: Z2021101HZ / CCC-230252-00

University of Ottawa

January 9, 2023

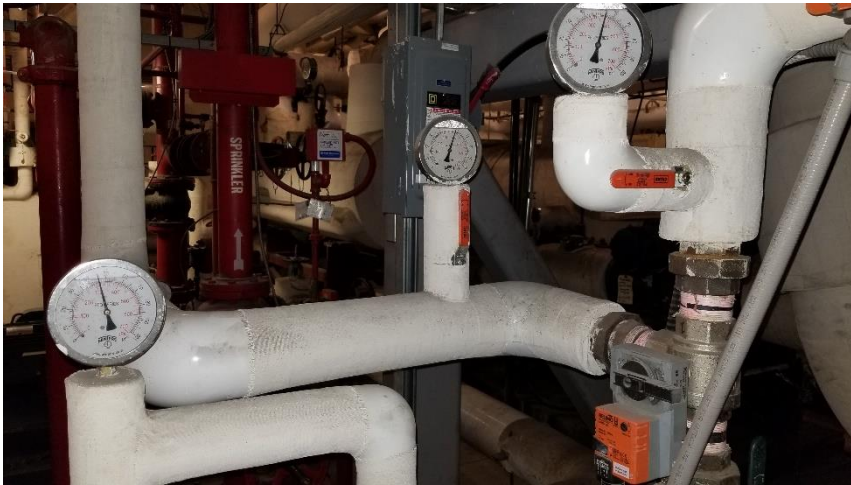
Photo 1: Representative view of the pressure gauges suspected of containing mercury, observed in Room 01.

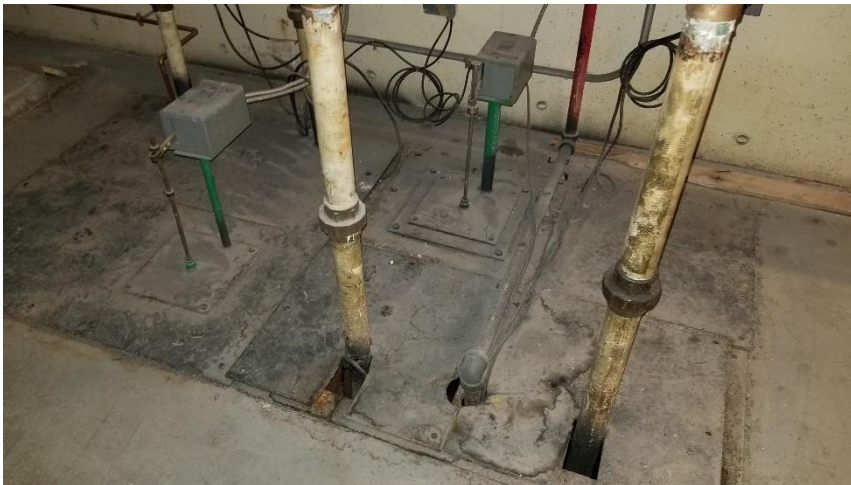
Photo 2: Representative view of the float switches suspected of containing mercury, observed in Room 01.

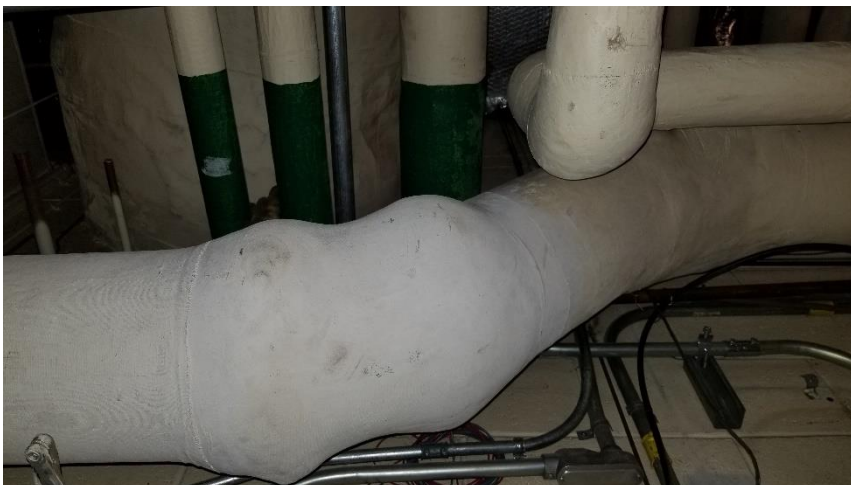
- Previously identified asbestos-containing pipe elbow/fitting insulation (parging cement) was observed in Rooms 500A, Room 500B, 01, and 01B. This material contains between 40-50% Chrysotile asbestos. This material is considered to be friable and was observed in good condition.
- Mechanical pipe elbow/fitting insulation was observed throughout the subject building. MPL made several incisions throughout to investigate its composition, and it was visually identified as fiberglass, and therefore not suspected of containing asbestos.

Photo 3: Representative view of the asbestos containing pipe elbow/fitting insulation (parging cement) observed in good condition throughout Room 01 and Room 01B.

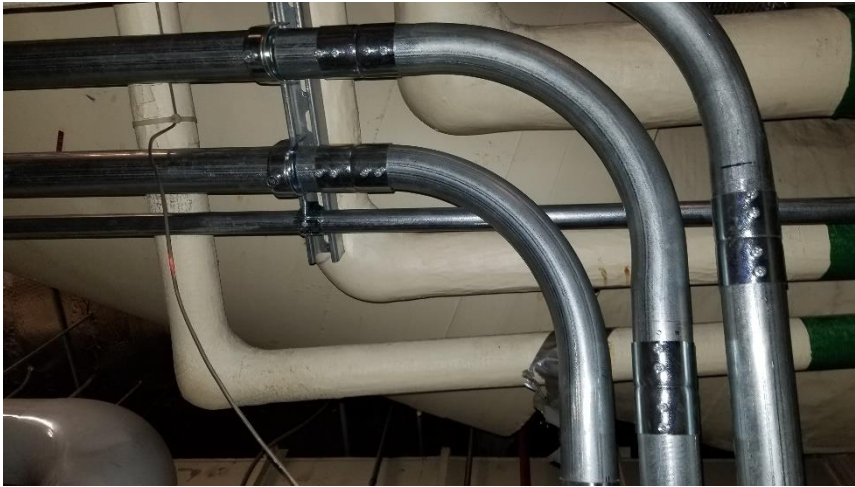
Photo 4: Representative view of the asbestos containing pipe elbow/fitting insulation (parging cement) observed in good condition throughout Room 01 and Room 01B.

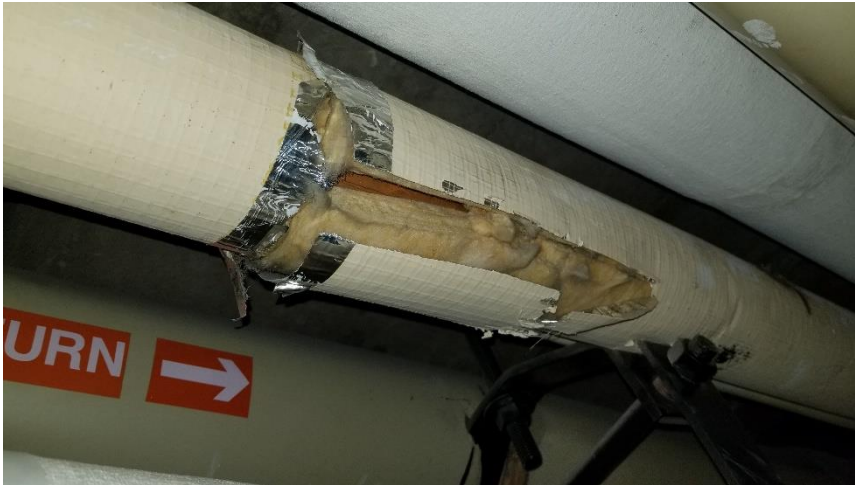
Mechanical pipe straight insulation was observed throughout the subject building. MPL made several incisions throughout to investigate its composition, and it was visually identified as fiberglass, and therefore not suspected of containing asbestos.

Photo 5: View of the non-asbestos containing pipe straight insulation observed throughout Room 01.

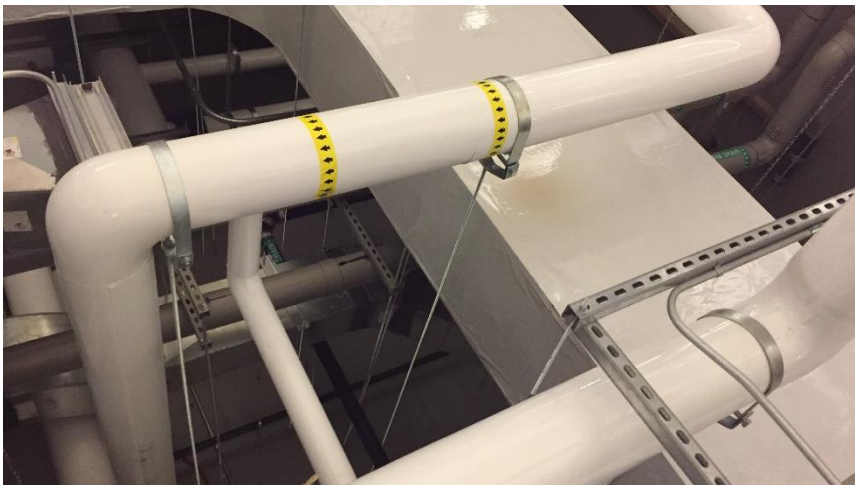
Photo 6: View of the non-asbestos containing pipe straight insulation observed throughout C043.

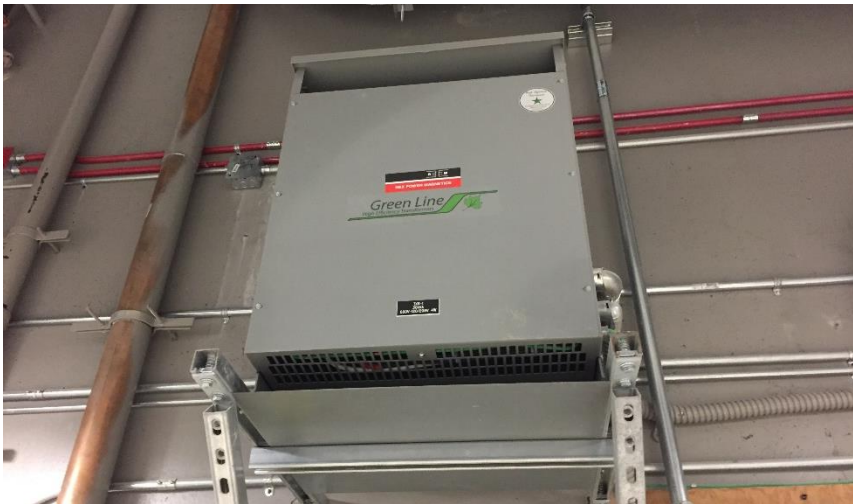
Photo 8: Representative view of the dry-type transformers observed in C043.

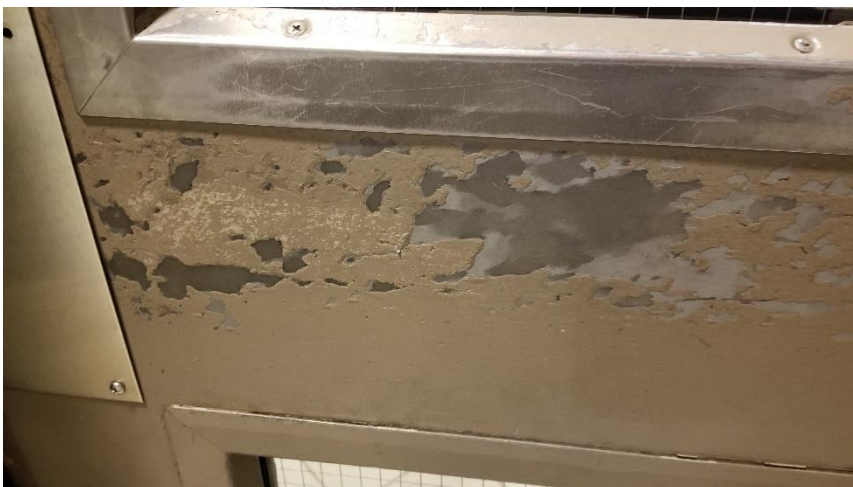
Photo 9: View of the lead-containing door point (Beige) observed in fair condition throughout the first floor.

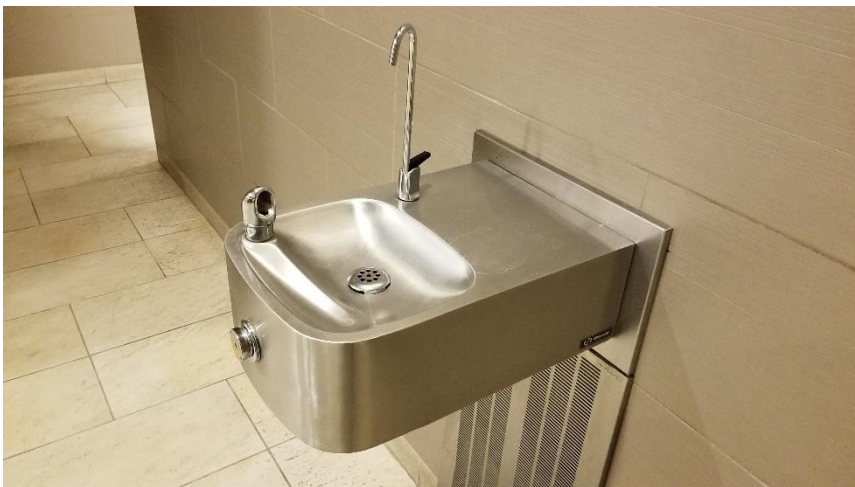
Photo 12: View of the equipment containing ODSs observed in Room C100A.

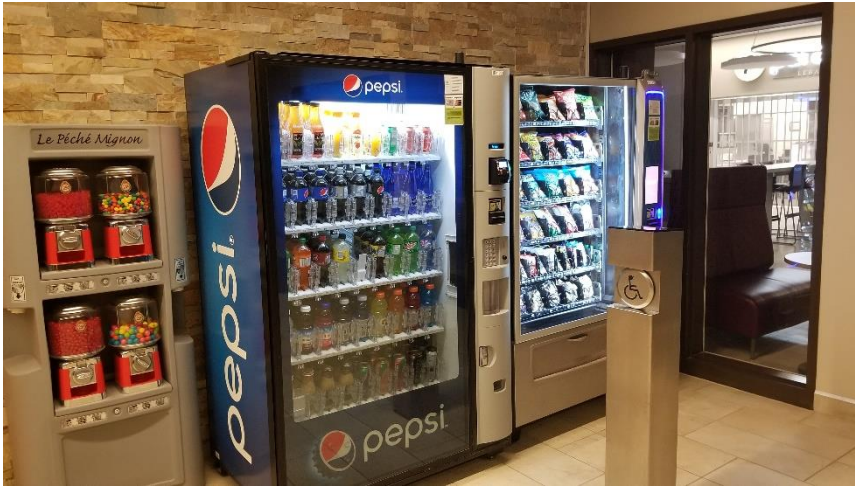
Photo 13: View of the equipment containing ODSs observed in Room 101.

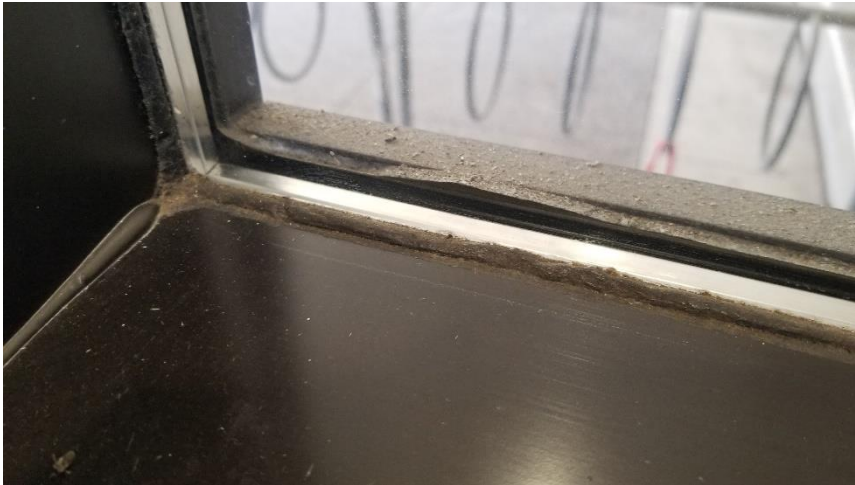
Window glazing (Black) was observed and sampled in Room 105. The laboratory analytical results indicate that this material contains 5% Chrysotile asbestos. This material is considered to be non-friable and was observed in good condition.

Photo 14: View of the asbestos-containing window glazing (Black) identified in Room 105.

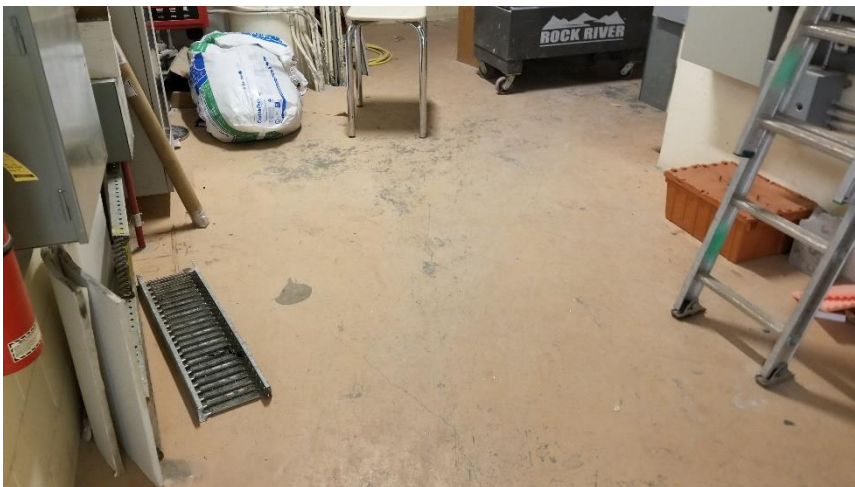
Photo 15: View of the floor paint (Pink) in Room 104A, which was determined not to contain lead.

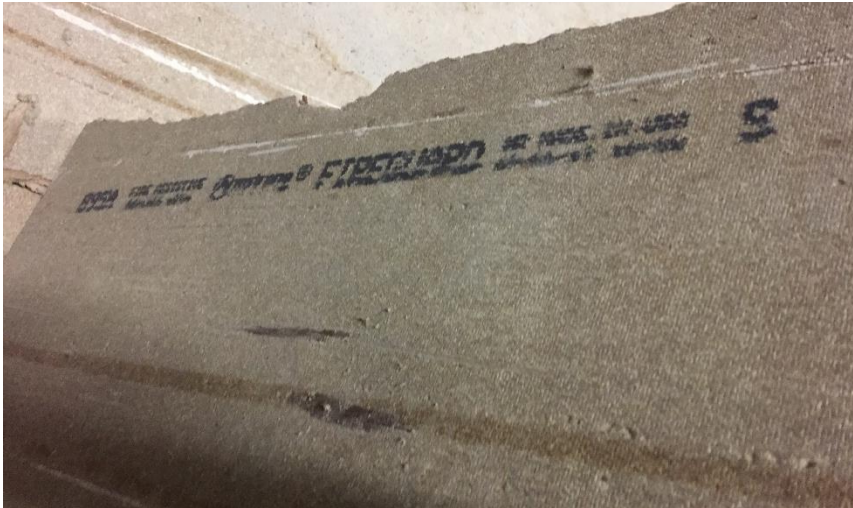
- Suspended ceiling tiles (2'x4' – Pinholes with Medium Fissures) were observed in Room C143B. The date stamp on the back of these tiles indicated that they were manufactured in 2017 and therefore, this material is not considered to contain asbestos.

Photo 16: View of the non-asbestos ceiling tiles observed in Room C144 with the date stamp of 2017.

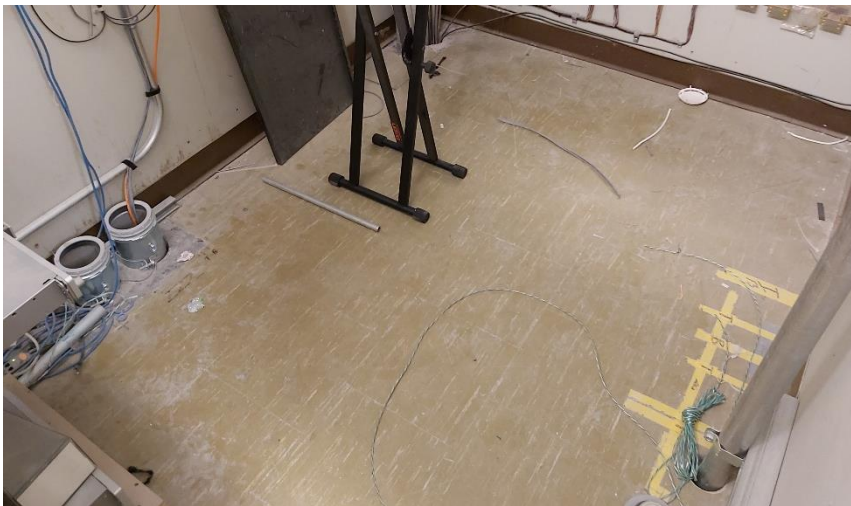
- Previously identified asbestos containing vinyl floor tiles (12"x12" – Green with White Stripes) were observed throughout the subject building. This material contains 11% Chrysotile asbestos. This material is considered to be non-friable and was observed in good condition, with the exception of select areas which were observed in poor condition.

Photo 20: View of the asbestos-containing vinyl floor tiles (12"x12" Green w/ White Striped) observed in good condition in Room 262A.

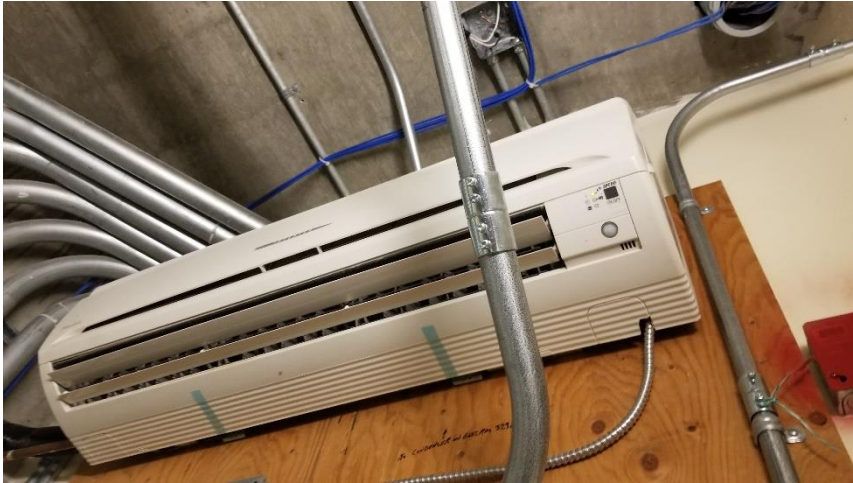
Photo 22: View of the equipment containing ODSs observed in Room 331A.

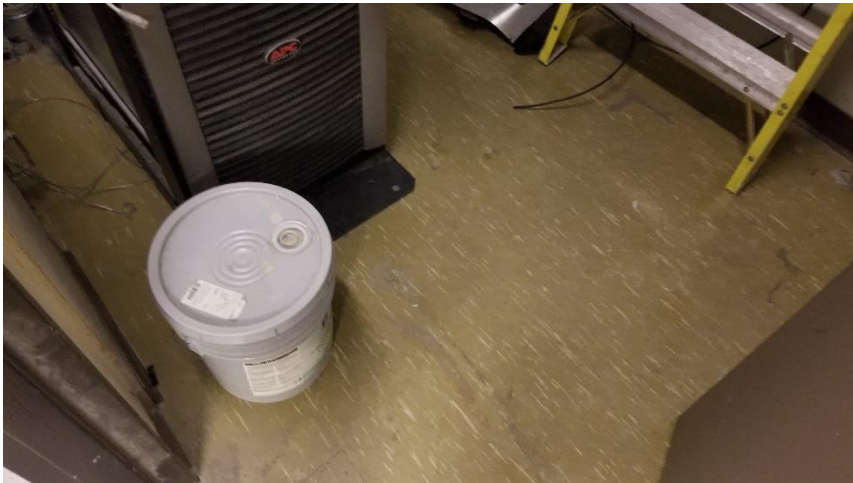
Photo 23: View of the asbestos-containing vinyl floor tiles (12"x12" Green w/ White Striped) observed in good condition in Room 331A.

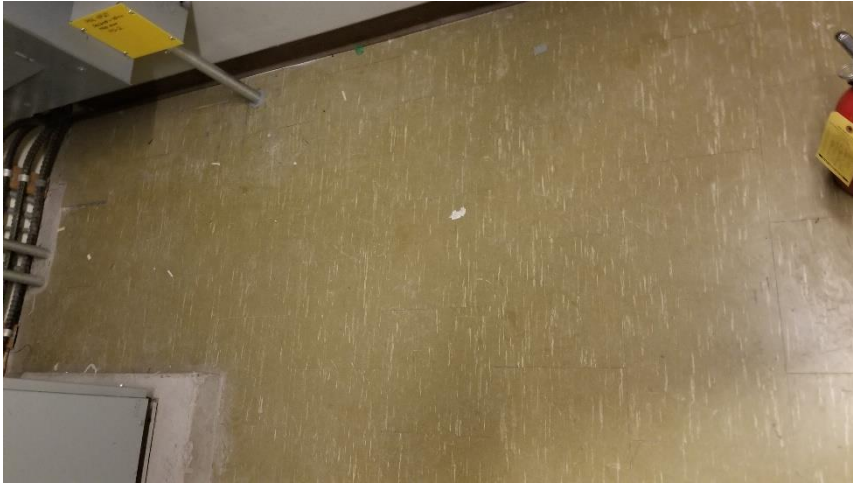
Photo 25: View of the asbestos-containing vinyl floor tiles (12"x12" Green w/ White Striped) observed in good condition in Room 329A.

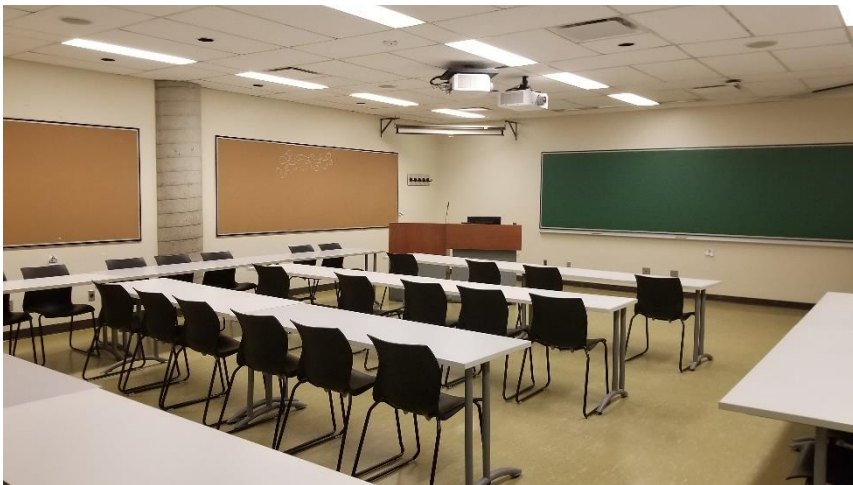
Photo 27: Representative view of the finishes observed throughout Room 407, including asbestos-containing vinyl floor tiles (12"x12" Green w/ White Striped) observed in good condition.

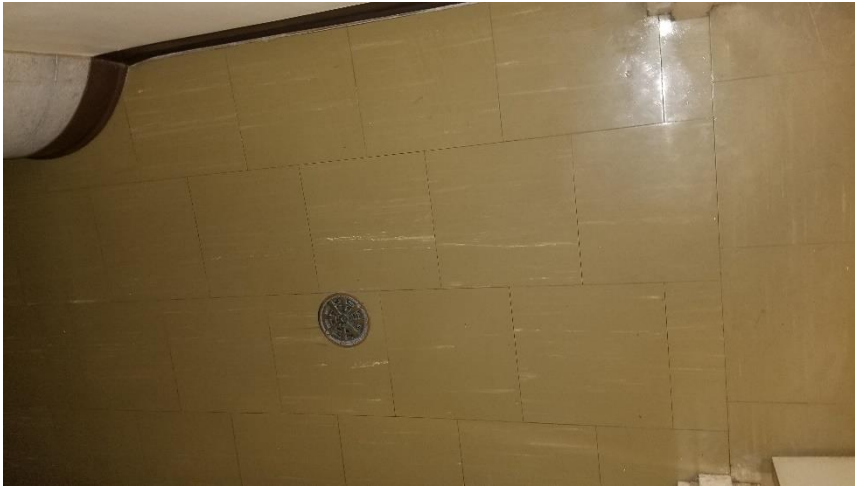
Photo 28: View of the asbestos-containing vinyl floor tiles (12"x12" Green w/ White Striped) observed in good condition in Room 471.

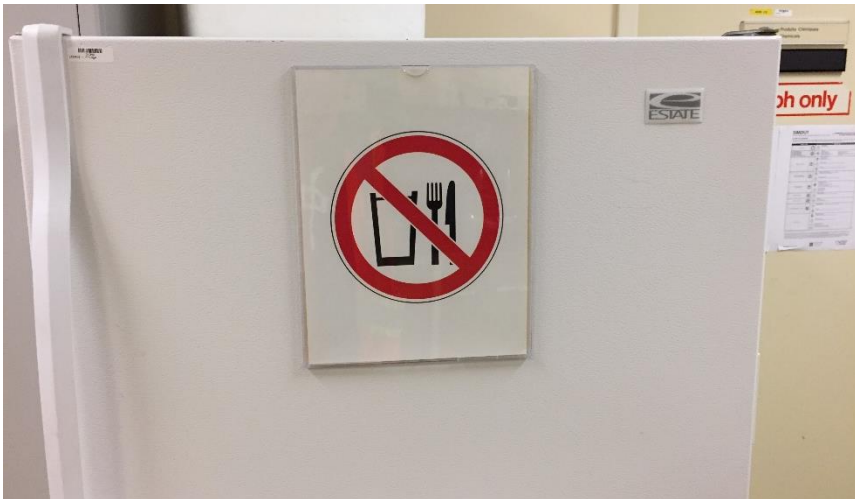
Photo 29: View of the equipment containing ODSs observed in Room 402.

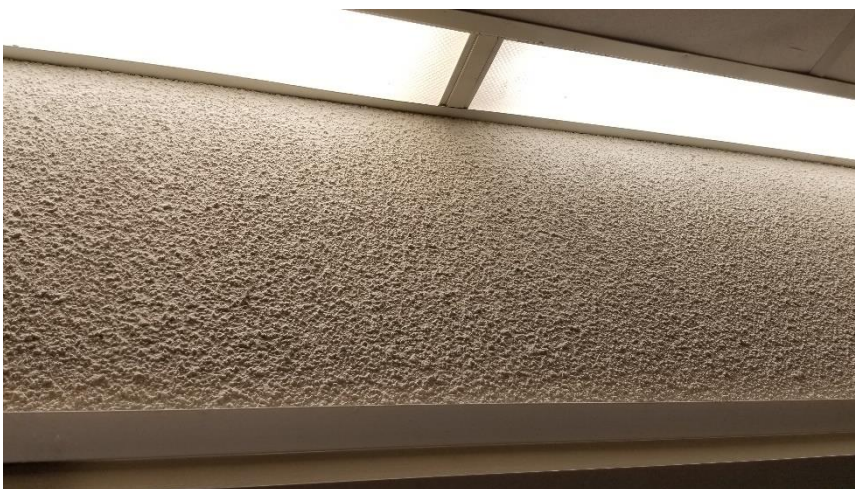
Wall texture coat was observed and sampled throughout the subject building. The laboratory analytical results indicate that this material does not contain asbestos.

Photo 30: View of the non-asbestos containing wall texture coat observed throughout the 4th floor.

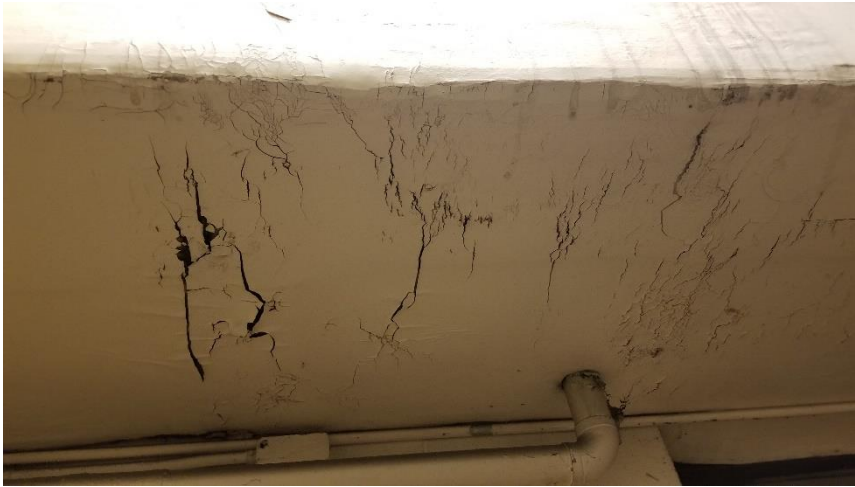
Photo 31: View of the lead-containing paint (Cream) observed in poor condition in Room 500A.

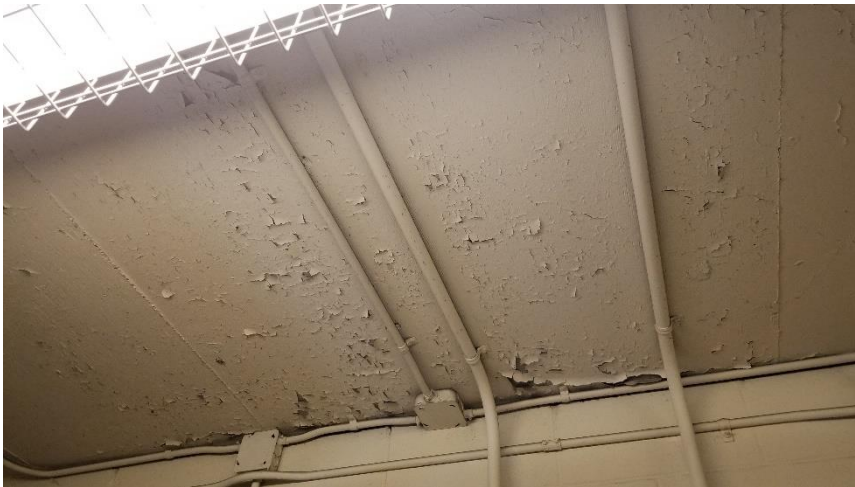
Photo 32: View of the lead-containing paint (Cream) observed in poor condition throughout Room 500B.

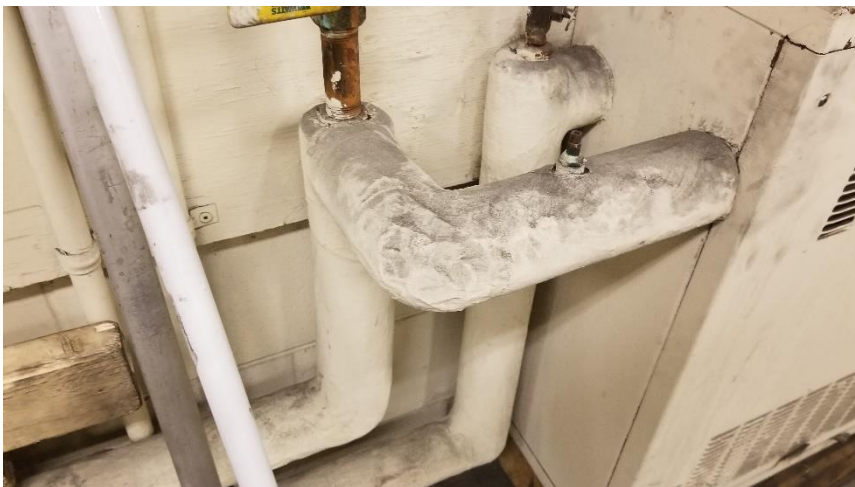
Photo 33: View of the asbestos-containing pipe elbow/fitting insulation (parging cement) observed in good condition in Room 500B.

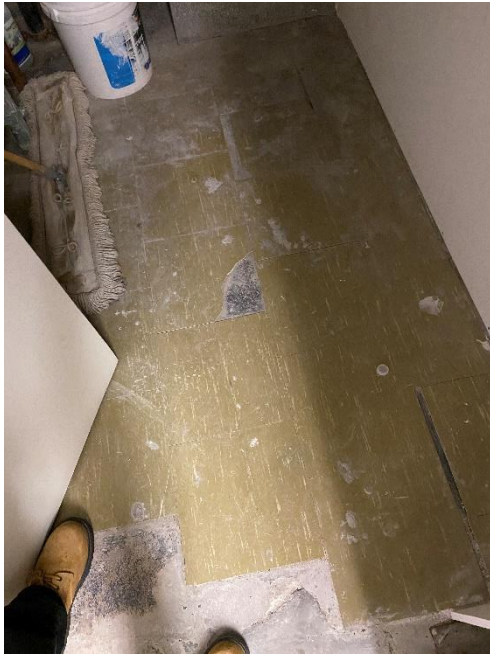
Photo 34: View of the asbestos-containing vinyl floor tiles (12"x12" Green w/ White Striped) observed in good condition in Room 127A during the 2022 Reassessment.

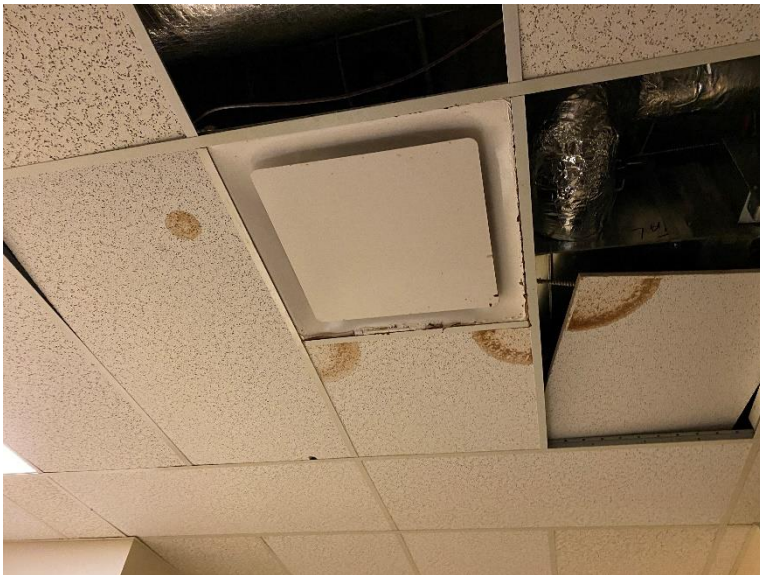
Photo 35: View of the ceiling tiles affected by water damage observed in Room 402 during the 2022 Reassessment.
