HAZARDOUS MATERIALS SURVEY AND 2022 REASSESSMENT MARCHAND RESIDENCE, OTTAWA, ON

Project No.: Z2021102HZ / CCC-230252-00

October 12, 2022

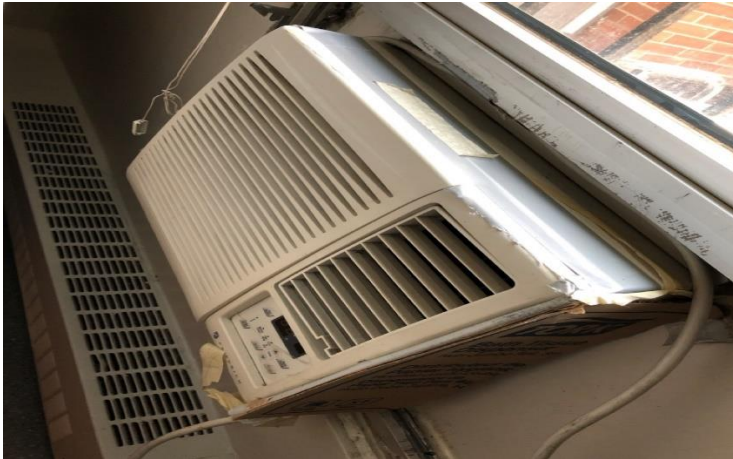
A visual assessment for equipment potentially containing ODSs and other halocarbons was conducted. MPL observed equipment such as refrigerators, water fountains, water coolers, freezers, etc. which contain or are suspected of containing ODSs or other halocarbons.

Photo 12: Typical view of ODS containing air-conditioning unit.
