HAZARDOUS MATERIAL SURVEY AND 2022 REASSESSMENT MONTPETIT HALL - 125 UNIVERSITY PRIVATE, OTTAWA, ON

Project No.: Z2021101HZ / CCC-230252-00

December 20, 2022

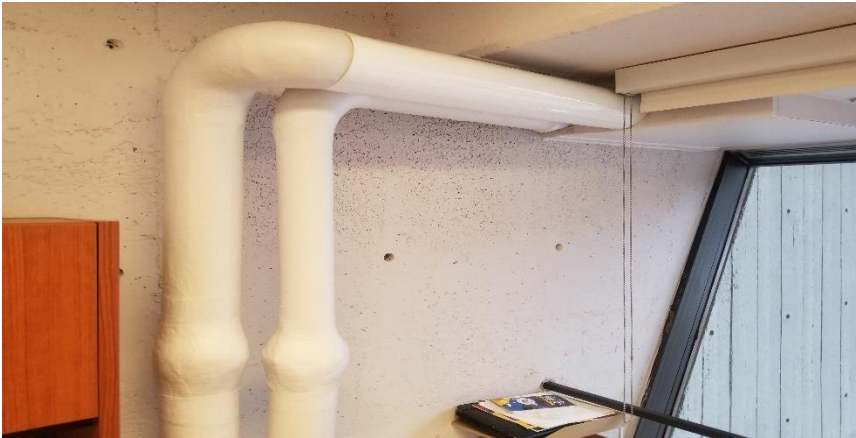
Previously identified asbestos-containing parging cement mechanical insulation on pipe elbows/fittings were observed in Rooms 0012, 002, 003B, 002A, 007B, 007A, 009, 0012, 011, 02C, 022, 023, 024, 050, 051, 213, 200, 205A, 216, 306B, 311D, 316A. This material was previously sampled was determined to contain between 5-60% Chrysotile asbestos and is considered to be friable. This material was observed to be in good condition with the exception of select areas observed to be in poor condition.

Photo 1: View of asbestos-containing pipe fitting insulation observed in Room 306B.

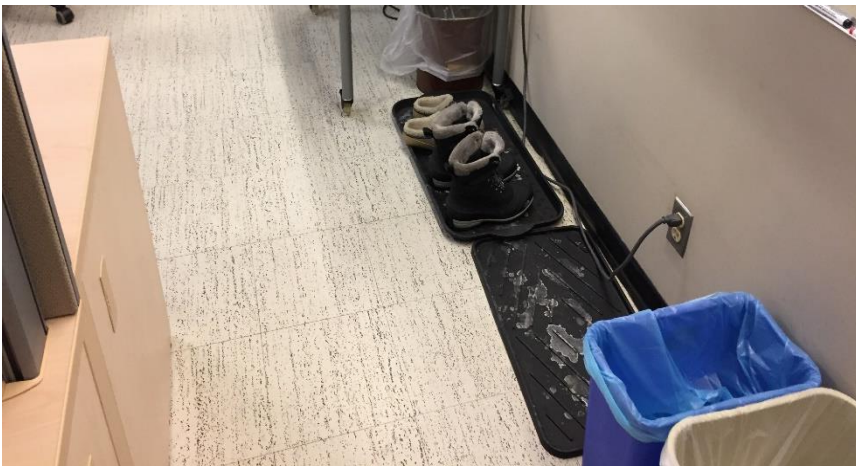
- Previously identified asbestos-containing vinyl floor tiles (12" x 12" – White with Black Dots) were observed in Room 300, 301C, 302, 304A 428 and 400. This material contains 39% Chrysotile asbestos and is considered to be non- friable. This material was observed to be in good condition.

Photo 2: View of asbestos-containing vinyl floor tiles observed in Room 428.

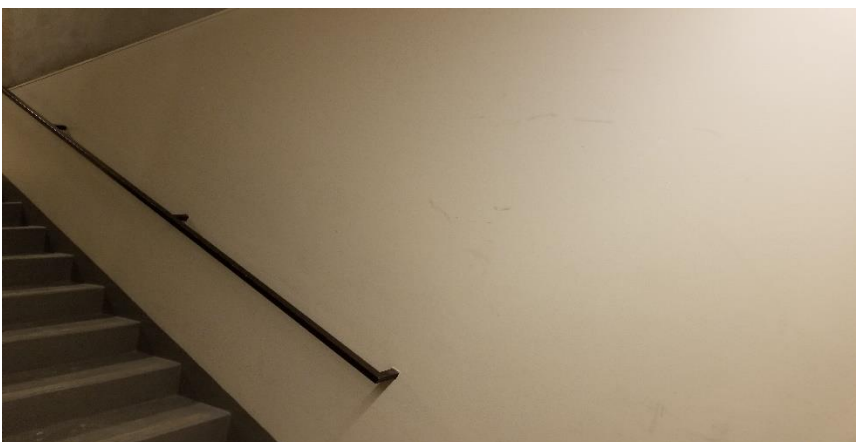
Previously identified asbestos-containing drywall joint compound was observed in Room 404. This material contains 2% Chrysotile asbestos. Since drywall joint compound is a homogeneous material, all areas must be treated as asbestos-containing unless additional testing confirms otherwise. This material was observed in good condition.

Photo 3: Typical view of asbestos-containing drywall observed throughout the subject building.

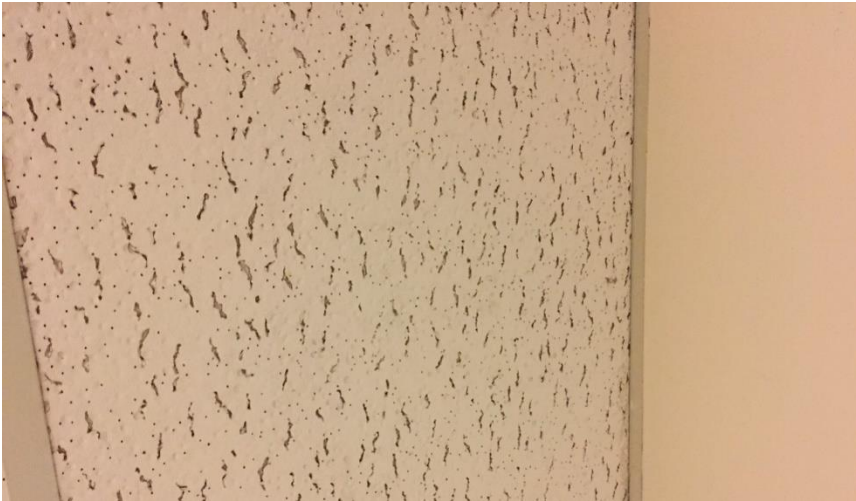
- Suspended ceiling tiles (2'x4' – Pinholes with Wavy Fissures) were observed and sampled in Room 415, 405 and 405A. The laboratory analytical results indicate that this material contains 0.5% Amosite asbestos. This material was observed to be in good condition.

Photo 4: View of asbestos-containing suspended ceiling tiles observed in Room 415.

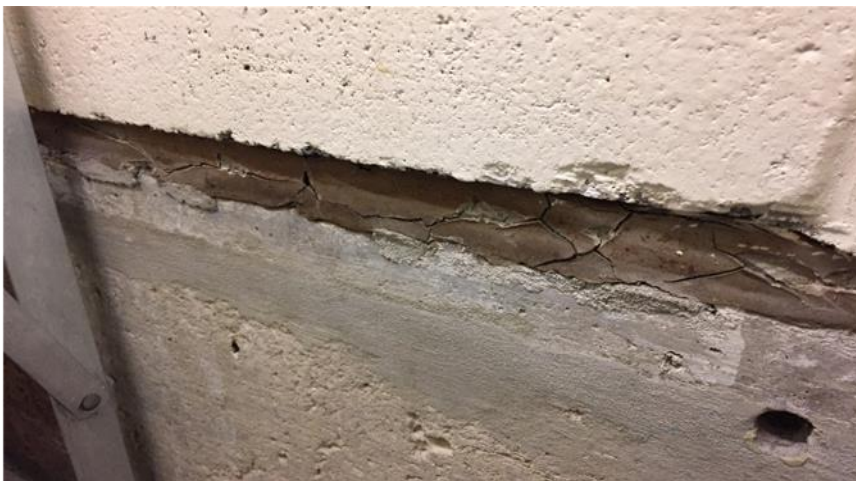
Photo 5: View of asbestos-containing wall caulking (tan) observed in Room 0024.

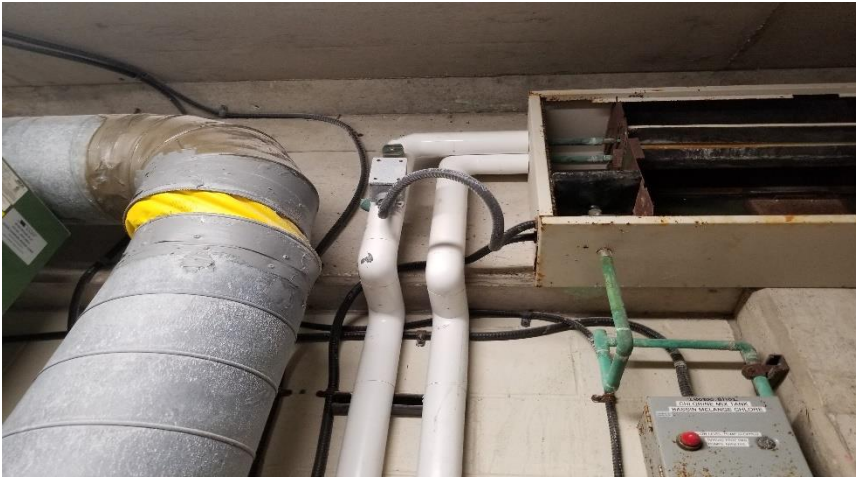
To avoid damage and compromising the integrity of the structure, no bulk samples of the flexible duct connector in Room 020C were collected. Prior to renovation/demolition, flexible duct connector should be examined and tested for asbestos content. Flexible duct connector should therefore be considered to contain asbestos until bulk samples and analysis proves otherwise.

Photo 6: View of flexible duct connector observed in Room 020C suspected to contain asbestos.

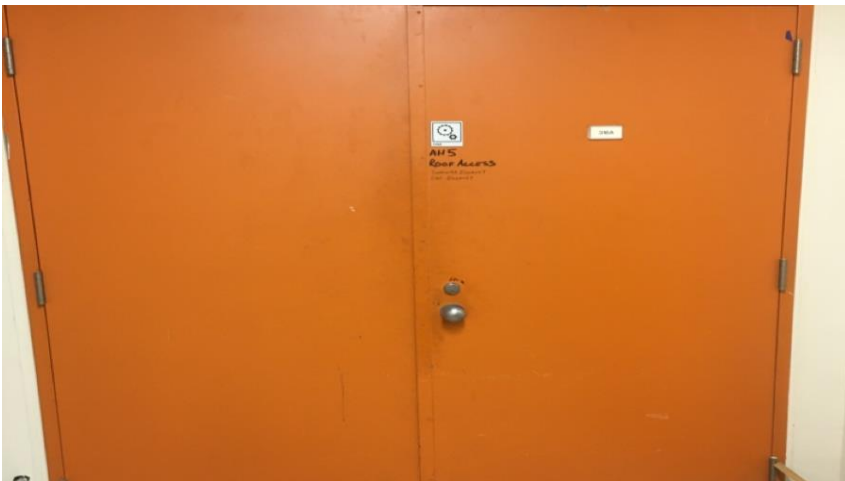
Photo 7: View of orange lead-containing paint observed on the door of Room 316.

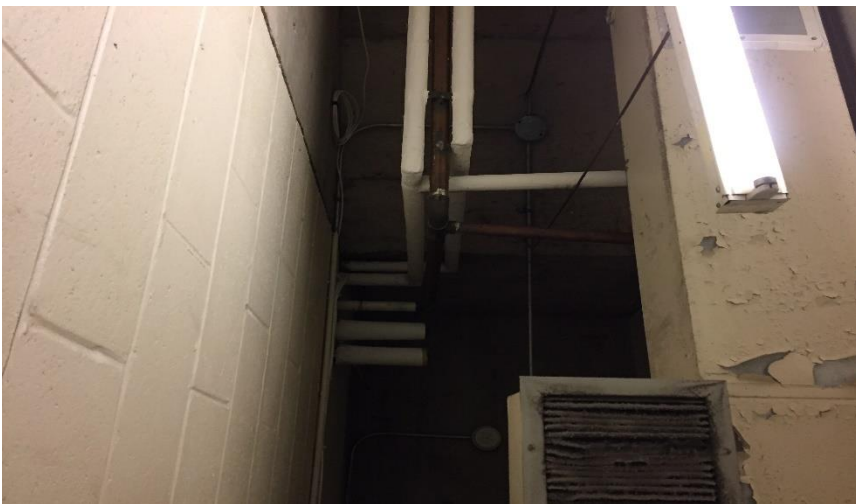
Photo 8: View of lead containing beige paint observed to be in poor condition in Room 023A.

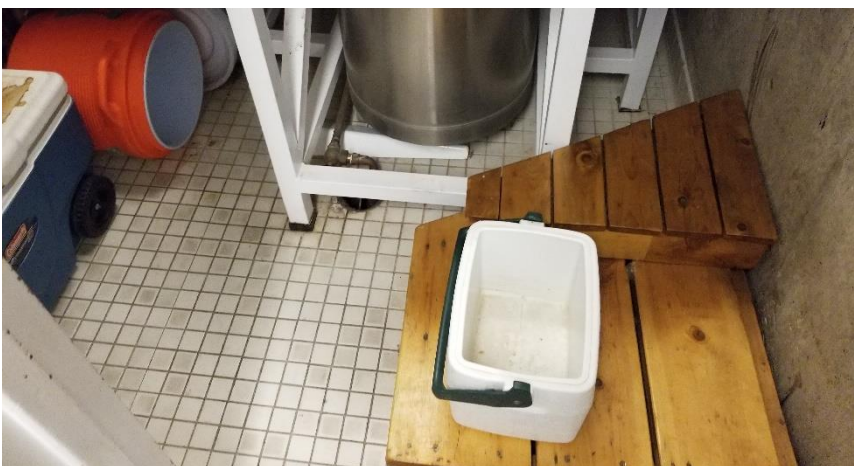
Photo 11: View of ceramic floor tiles grout observed throughout the subject building suspect to contain asbestos.

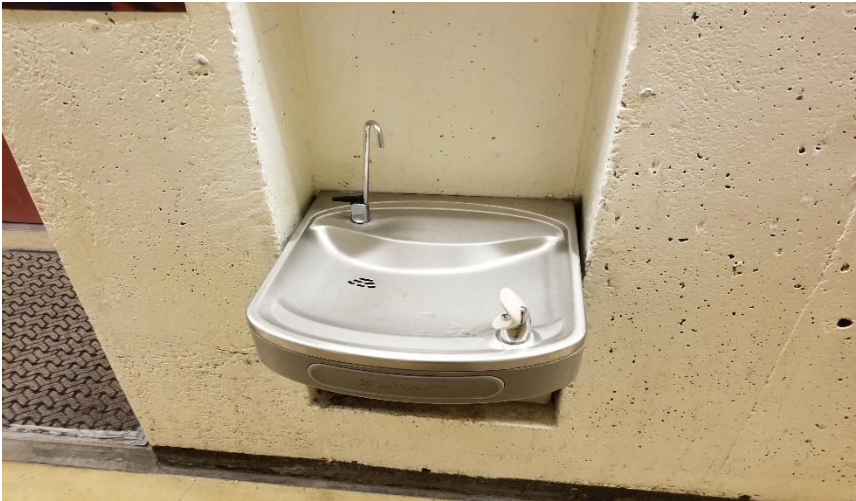
Photo 12: Typical view ODS containing water fountains observed throughout the subject building.

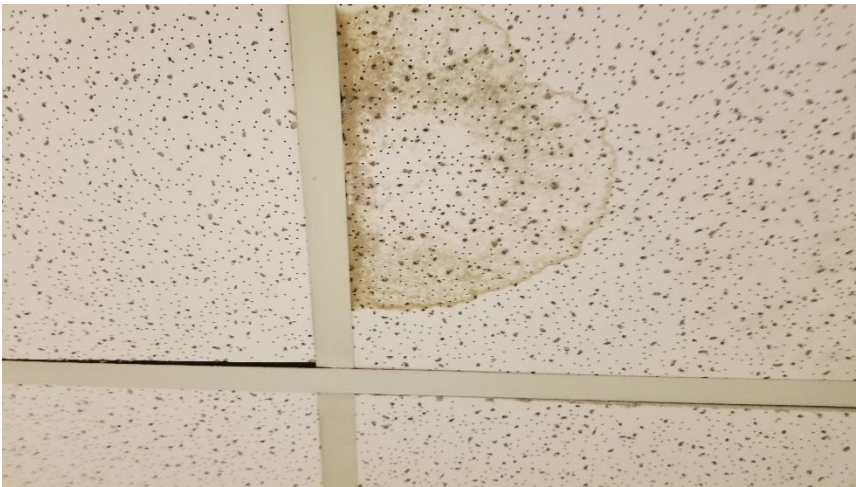
Photo 13: View of water damaged suspended ceiling tile observed in Room 039B.
