HAZARDOUS MATERIALS SURVEY AND 2022 REASSESSMENT MORISSET HALL, 65 UNIVERSITY PRIVATE, OTTAWA, ON

Project No.: Z1920014HZ / CCC-230252-00

Re: Morisset Hall, University of Ottawa - 65 University Private
Hazardous Materials Survey and 2022 Reassessment
McIntosh Perry Limited Reference No. Z1920014HZ / CCC-230252-00

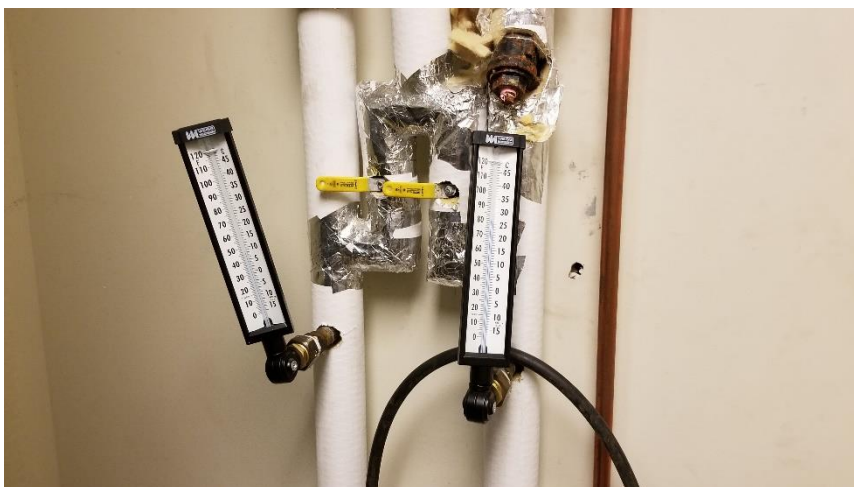
Photo 3: Representative view of the pressure gauges containing liquid mercury observed in Room 038E.

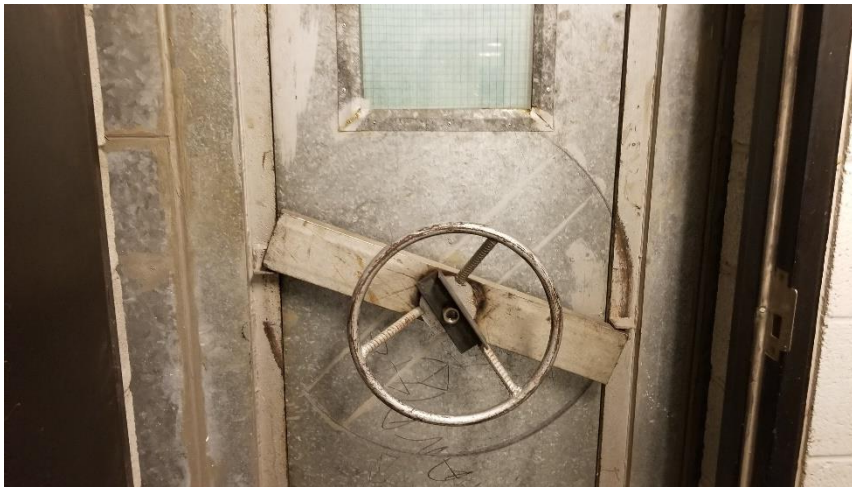
Photo 4: Representative view of the AHU unit doors, with non-asbestos containing thermal insulation in Room 0042.

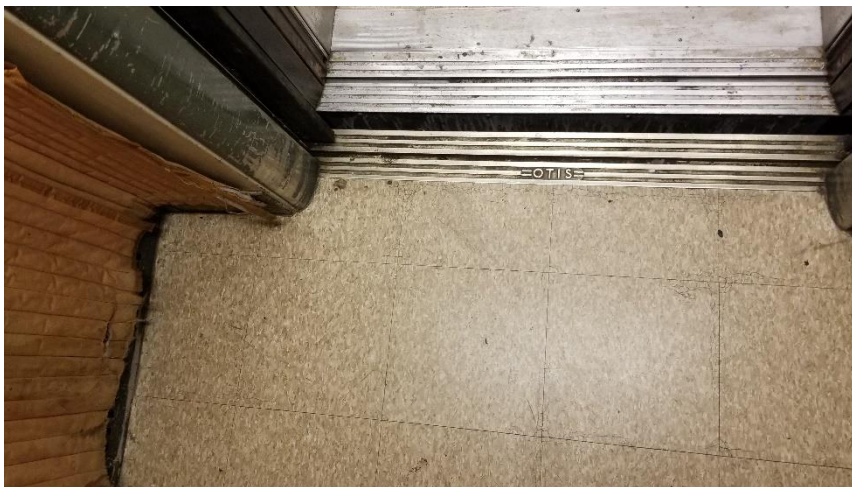
Photo 5: View of the non-asbestos vinyl floor tiles (12"x12" - Brown w/ White Spots) were observed and sampled in Room 007D.

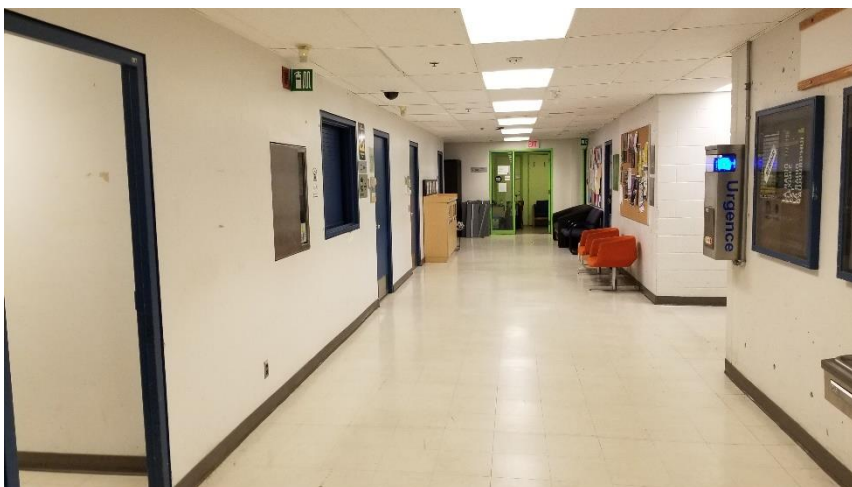
Photo 6: Representative view of Room 001, containing asbestos vinyl floor tiles (12"x12" - White w/ Brown Flakes).

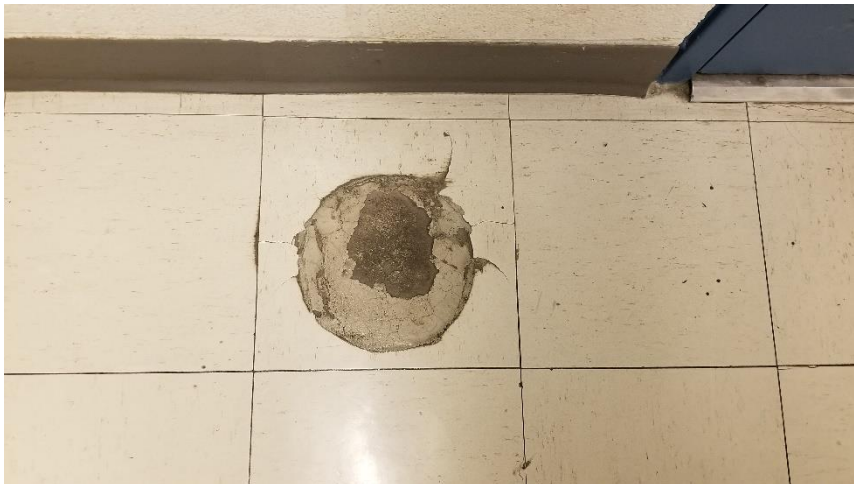
Photo 7: Previously identified vinyl floor tiles (12"x12" – White w/ Brown Flakes) observed in poor condition in Room 001.

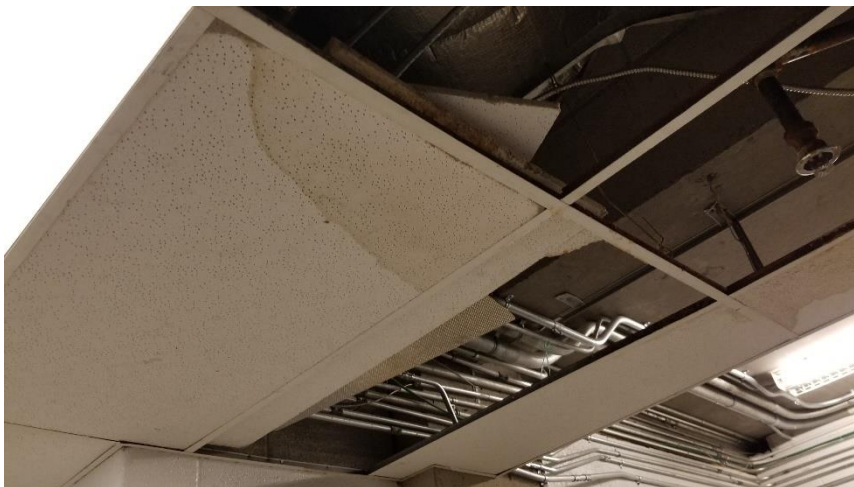
- Suspended ceiling tiles (2'x4' – Pinholes w/ Large Fissures) were observed in Room 001A. The date stamp on the back of these tiles indicated that they were manufactured in 1995 and therefore, this material is not considered to contain asbestos.

Photo 8: View of the suspended ceiling tiles (2'x4' – Pinholes w/ Large Fissures) observed to be manufactured in 1996 in Room 001A. Water staining was observed on select tiles.

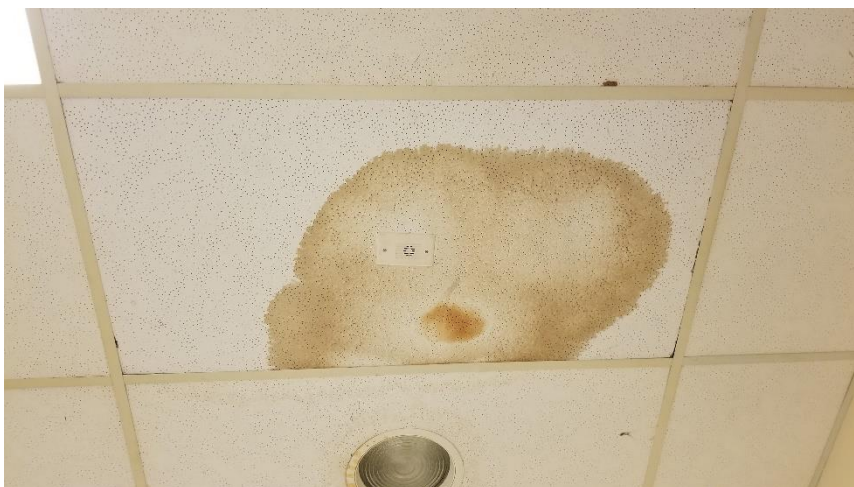
Photo 9: View of the water damaged asbestos-containing ceiling tile observed in Room 0021.

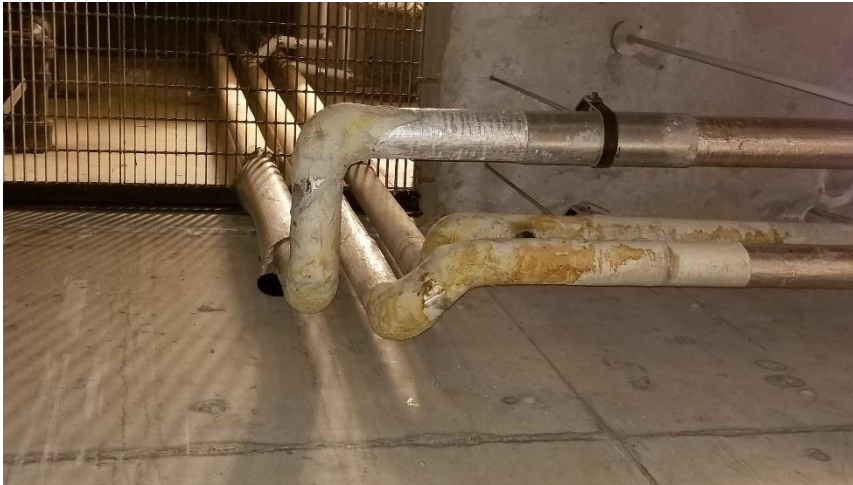
Previously identified paring cement mechanical insulation on pipe elbows/fittings was observed in Rooms 007, 0011, 0012, 0018, 0020, 0021, 0027, 0032, 0042A, 0042B, 0042C, 0050, 0051, 010A, 027A, 037, 037A, 044, 047A, 103A, 127, 128A, 128B, 128C, 132, 132A, 152A, 164E, 204A, 225B, 227, 253A, 304A, 306A, 311A, 319A, 400G, 402A, 413A, 431A, 440A, 503, 505A, 506A, 509A, 510A, 622A, 701, 703, 703A, and 704. This material was previously sampled in Room 0027 and was determined to **contain 65% Chrysotile asbestos**. It was also sampled

in Room 0042C and determined to **contain 10% Amosite and 15% Chrysotile asbestos** and is considered to be friable. This material was observed to be in good condition with the exception of select areas observed to be in poor condition.

Photo 10: View of the asbestos-containing parging cement elbows/fitting observed in good condition in Room 0032.

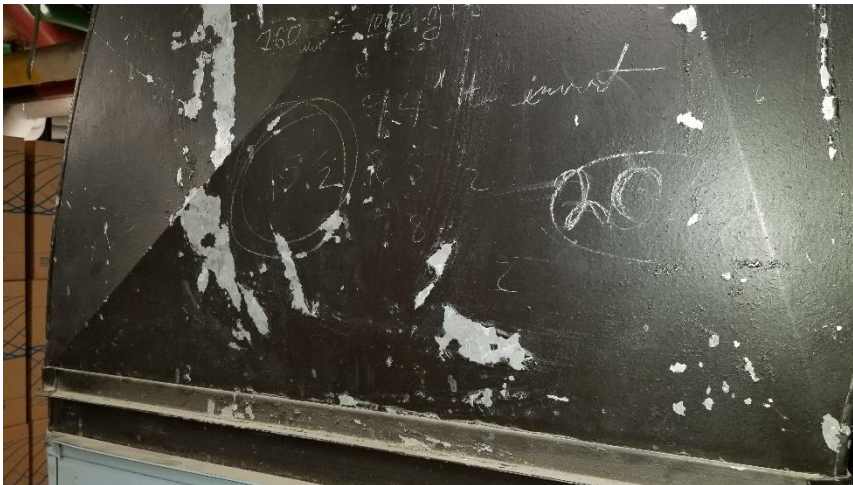
Photo 11: Representative view of the lead containing Black mechanical equipment paint observed throughout Room 0042 in poor condition.

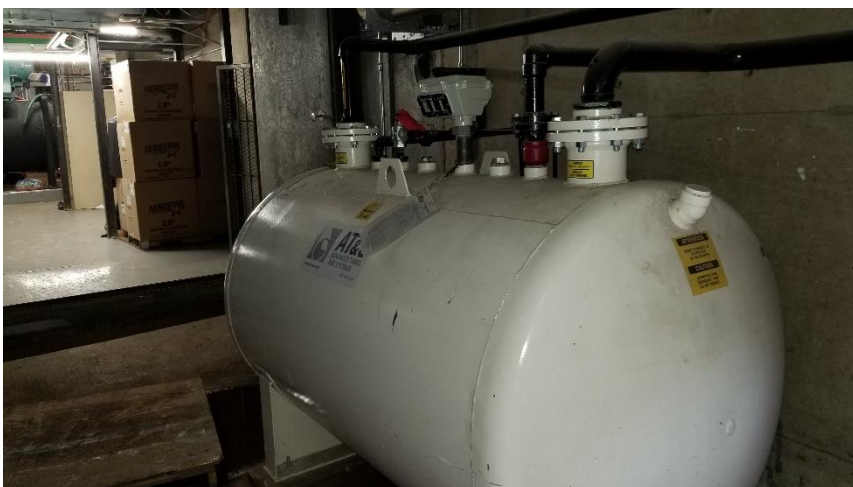
Photo 12: View of the above ground diesel tank observed in Room 0042D.

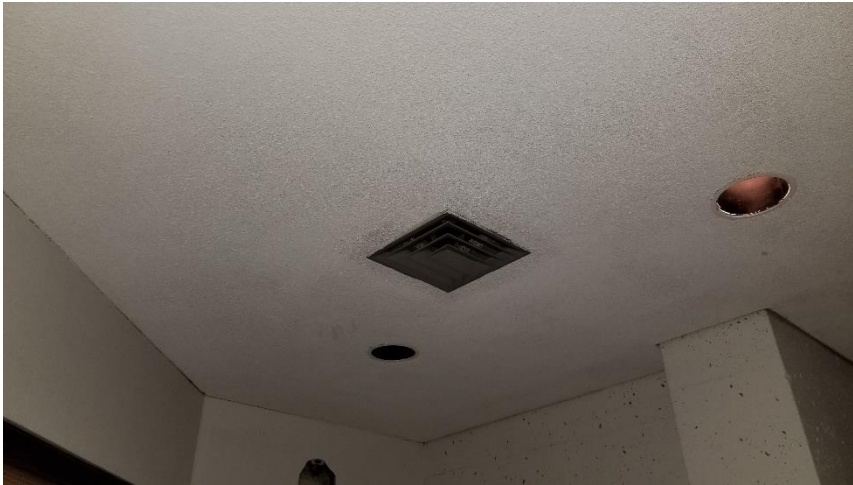
Ceiling texture coating was observed in Room 217 and 218A and previously sampled in Room 218C. This material **contains 10% Chrysotile asbestos** and is considered to be friable. This material was observed to be in good condition.

Photo 13: View of the asbestos-containing textured ceiling observed in good condition in Room 218A.

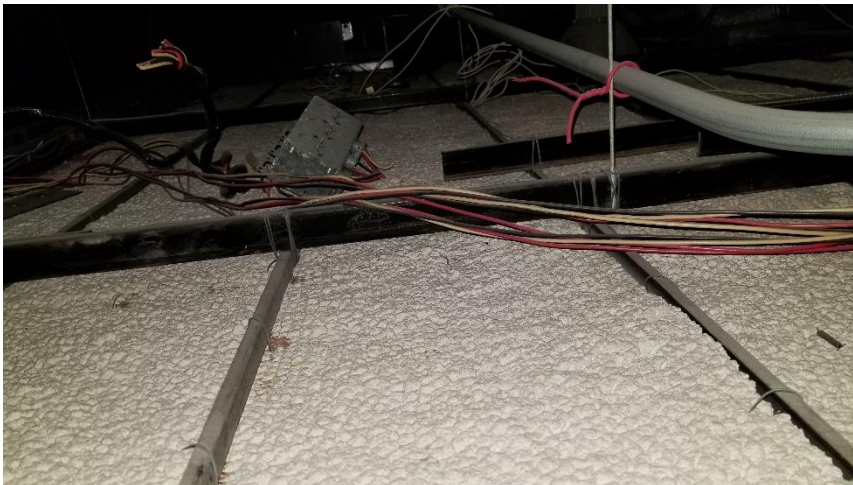
Photo 14: View of the ceiling space above the asbestos-containing ceiling plaster observed in Room 218.

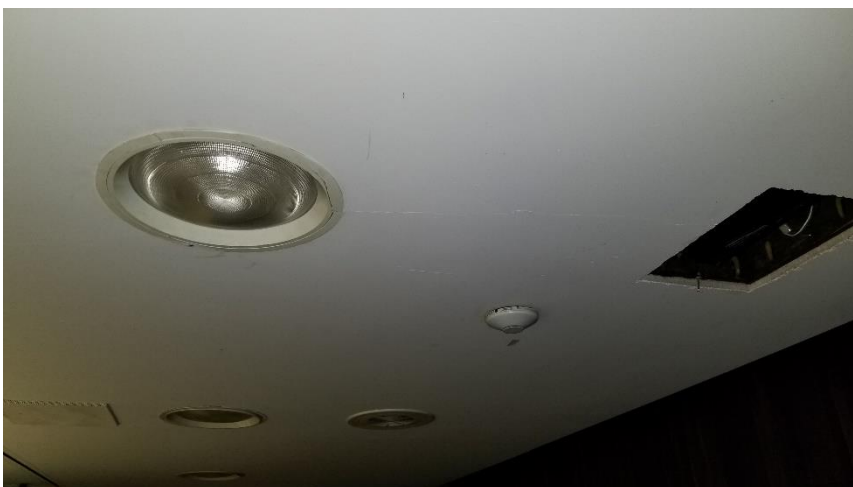
Ceiling plaster was observed throughout the second floor of the subject building and sampled in Room 218. The laboratory analytical results of the ceiling plaster samples collected indicated that this material **contains 1% Tremolite asbestos**.

Since plaster is a homogeneous material, all areas must be treated as asbestos-containing unless additional testing confirms otherwise. This material is considered to be friable and was observed in good condition with the exception of select areas which were observed in poor condition.

Photo 15: View of the asbestos-containing ceiling plaster observed in Room 218D, with poor condition areas.

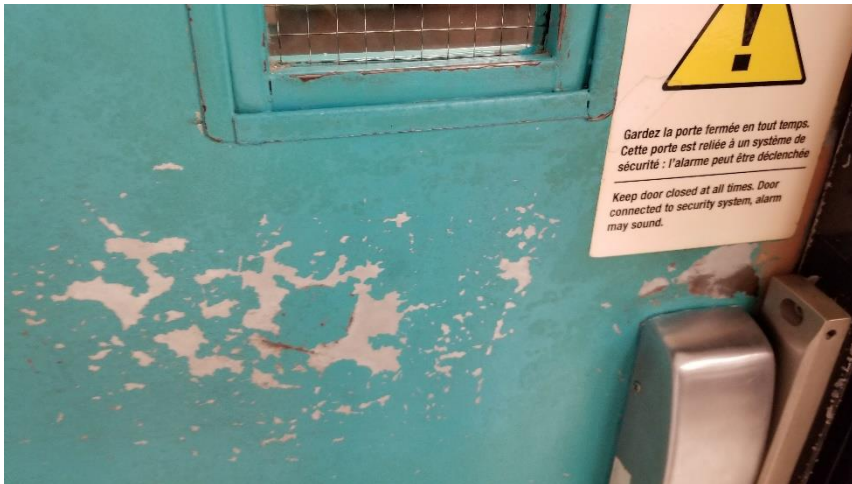
Photo 16: View of the lead containing blue door paint observed in poor condition in Room 217.

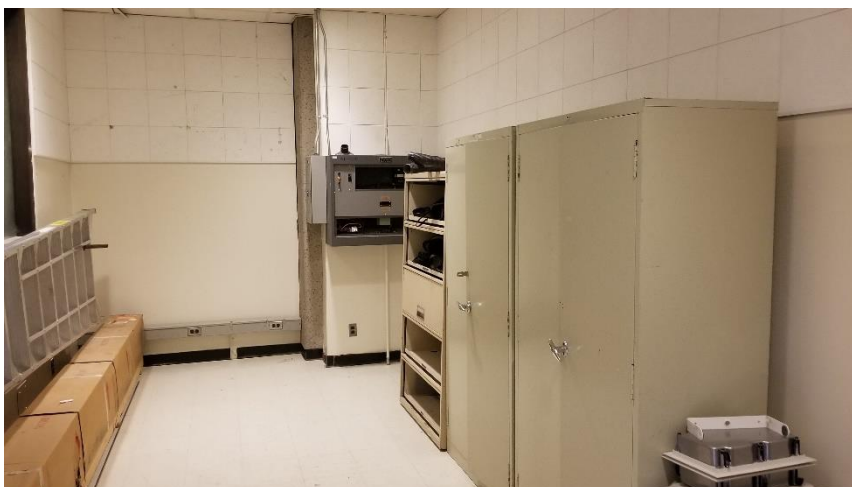
- Acoustic glue-on wall tiles (1'x1' w/ Uniform Holes) were observed and sampled in Room 220. The laboratory analytical results indicate that this material **contains 1% Amosite asbestos**. The associated mastic (Brown) was determined not to contain asbestos. Visually similar acoustic glue-on wall tiles (1'x1' w/ Uniform Holes) were observed and previously sampled in Room 255. This material **contains 5% Amosite and 2% Chrysotile asbestos**. This material was observed in good condition, with the exception of select areas that were observed in poor condition.

Photo 18: View of the asbestos-containing glue-on acoustic walls tiles observed in good condition in Room 255.

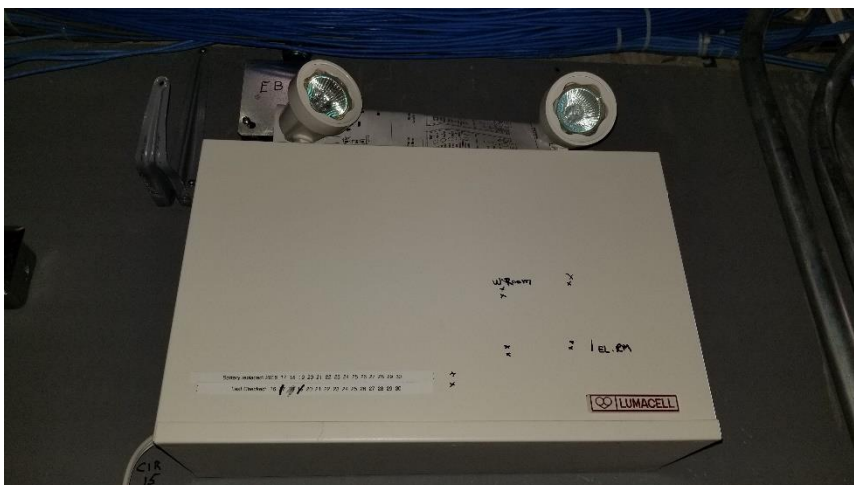
Photo 21: Representative view of the emergency lights containing lead batteries observed in Room 306.

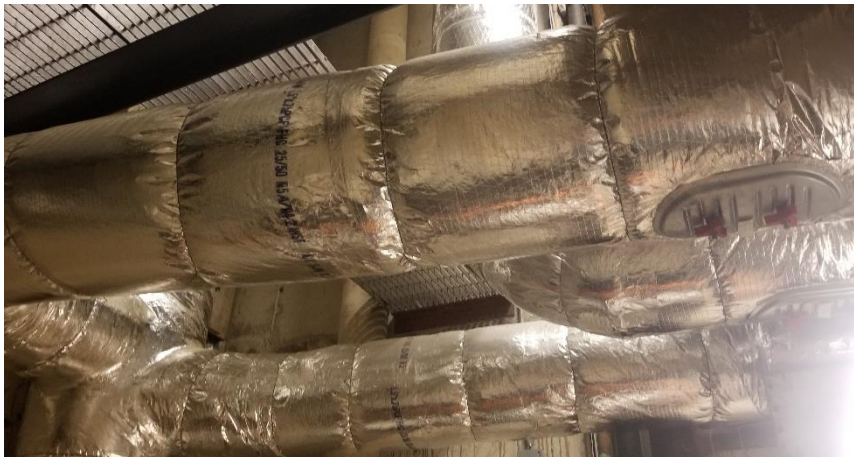
Photo 22: Representative view of the fiberglass insulation observed in Room 431 and 431A.

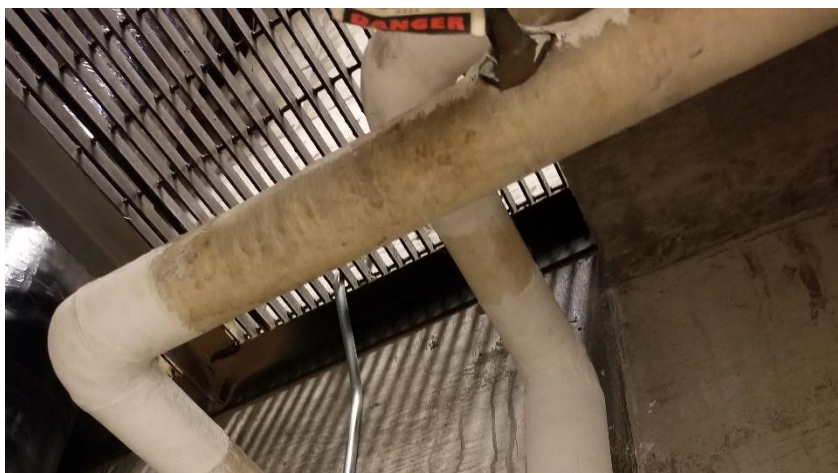
Photo 23: View of the asbestos-containing piping cement elbows observed in good condition in Room 506A.

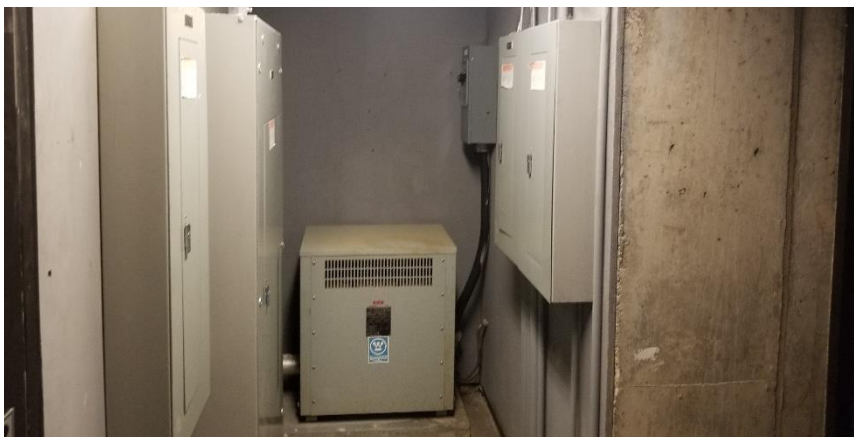
Photo 24: View of the dry-type Westinghouse transformers observed in Room 510.

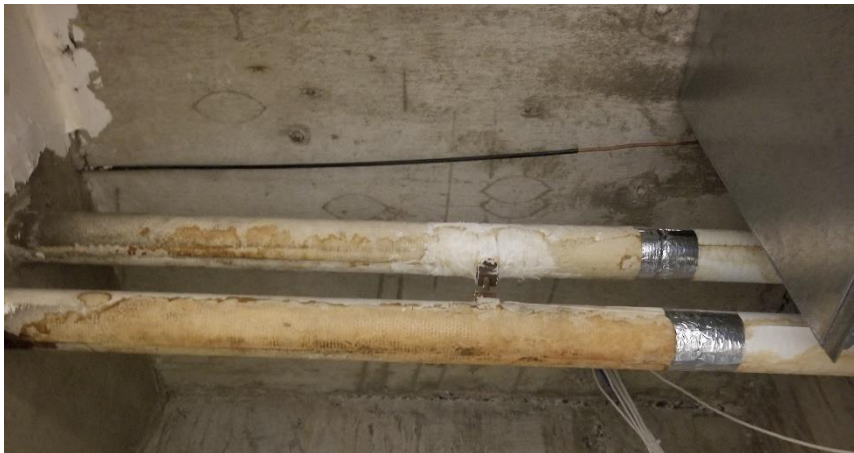
Photo 25: View of the water damaged fiberglass pipe straight insulation observed in Room 510A.

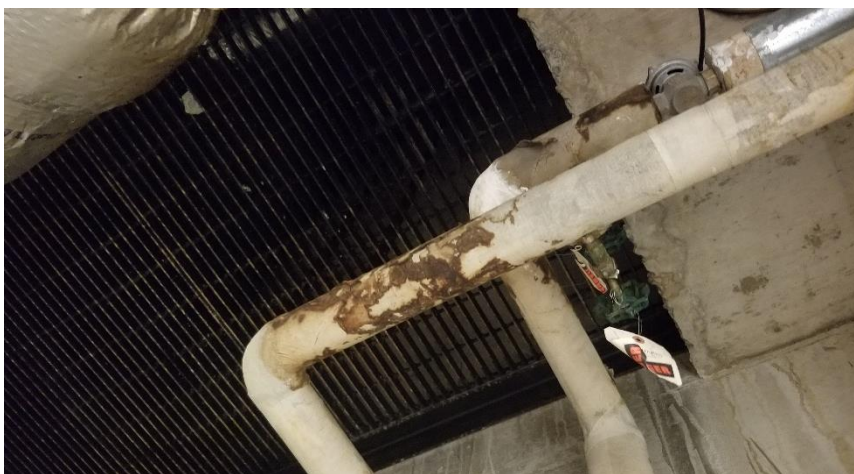
Photo 26: View of the water damaged asbestos-containing paring cement insulation observed in Room 510A.

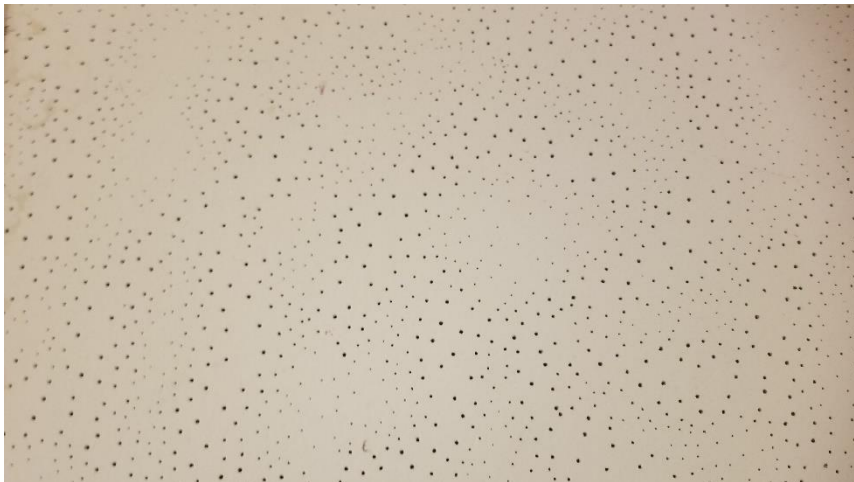
- Suspended ceiling tiles (2'x4' – Beige w/ Varying Pinholes) were observed and sampled in Room 600G. The laboratory analytical results of the samples collected in Room 600G indicate that this material contains **1% Chrysotile asbestos**. Visually similar ceiling tiles were observed in Rooms 621, 502A, 418, 400F, 312, 302, 256, 250, 255, 221, 220, 130, 050, 043, 005, 0014, 0015, 0017, 0021, 0021A, 0025A, 0034, 0034A, 0035, 0040. This material was observed in good condition with the exception of select areas which were observed in poor condition.

Photo 28: View of the asbestos-containing ceiling tiles (Beige w/ Varying Pinholes) observed and sampled in Room 600G.

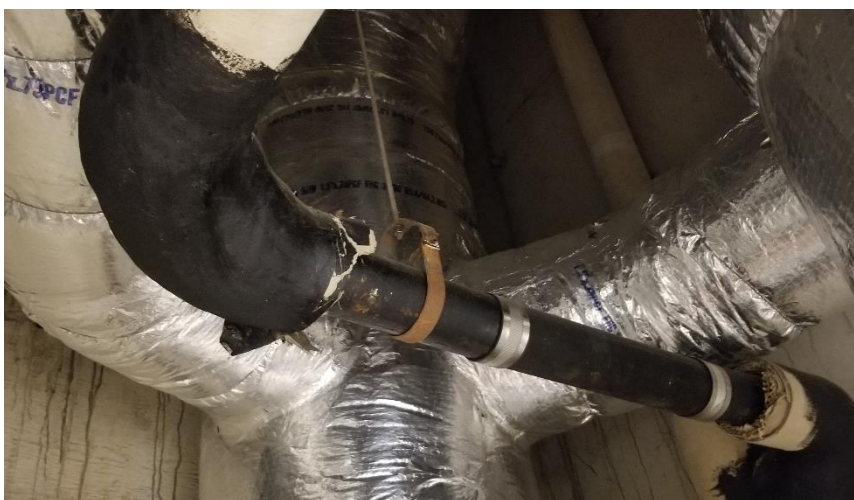
Previously identified mechanical pipe straight insulation was observed in Rooms 0042D, 0048, 010A, 027A, 037, 0046, 047A, 051, 103A, 128B, 132A, 152A, 164E, 204A, 214, 241A, 304A, 306A, 311A, 319A, 402A, 413A, 431A, 440A, 622A, 701, 703, and 704. This material **contains 30% Chrysotile asbestos** and is considered to be friable. This material was observed to be in good condition with the exception of select areas which were observed in poor condition.

Photo 30: View of the poor condition asbestos-containing pipe straight insulation observed in Room 622A.

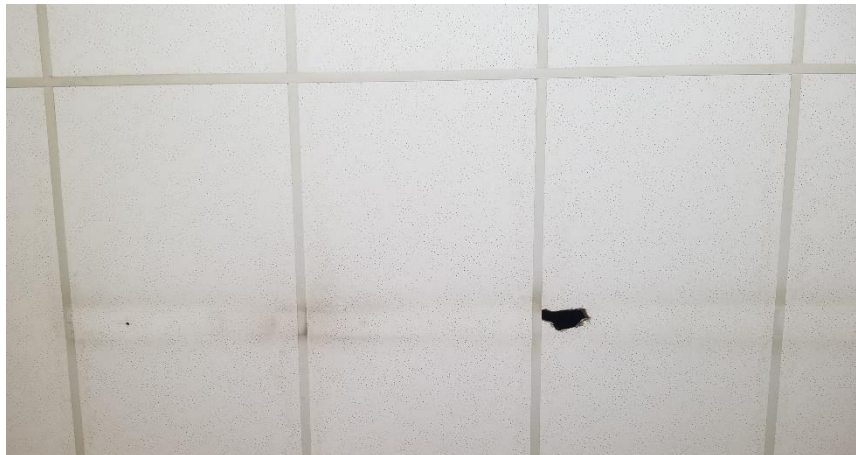
Photo 31: View of the asbestos-containing ceiling tiles (Beige w/ Varying Pinholes) observed with damages in Room 621.
