HAZARDOUS MATERIAL SURVEY AND 2022 REASSESSMENT PEREZ HALL, 50 UNIVERSITY PRIVATE, OTTAWA, ON

Project No.: Z2021101HZ / CCC-230252-00

November 15, 2022

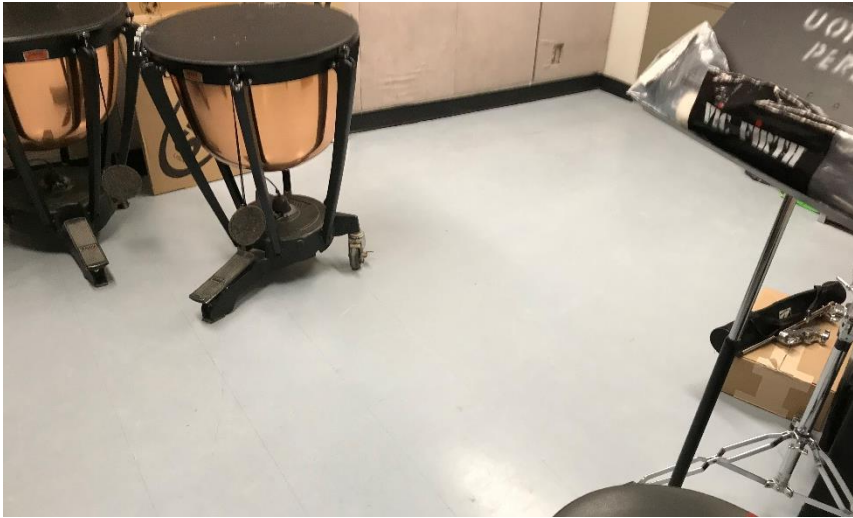
- Previously identified vinyl floor tiles (12"x12" –Plain Pattern - Green /Blue Coloured) were observed in Rooms 105, 106, 106A, 106B, 106C, 107, and 109. The laboratory analytical results of the vinyl floor tile samples collected indicate that this material contains 1% Chrysotile asbestos. This material is considered to be non-friable and material was observed to be in good condition.

Photo 1: Representative view of the previously identified asbestos-containing VFT 12"x12" Green/Blue in Room 106, 109A, containing 1% Chrysotile asbestos.

- Materials identified to contain asbestos that are in good condition and do not pose a risk to workers or occupants can be managed in place. Prior to renovation/demolition activities that may disturb the ACMs, these materials must be removed following appropriate Type 1/2/3 asbestos abatement work procedures as detailed in O. Reg. 278/05 and disposed of as asbestos waste under O. Reg. 347;

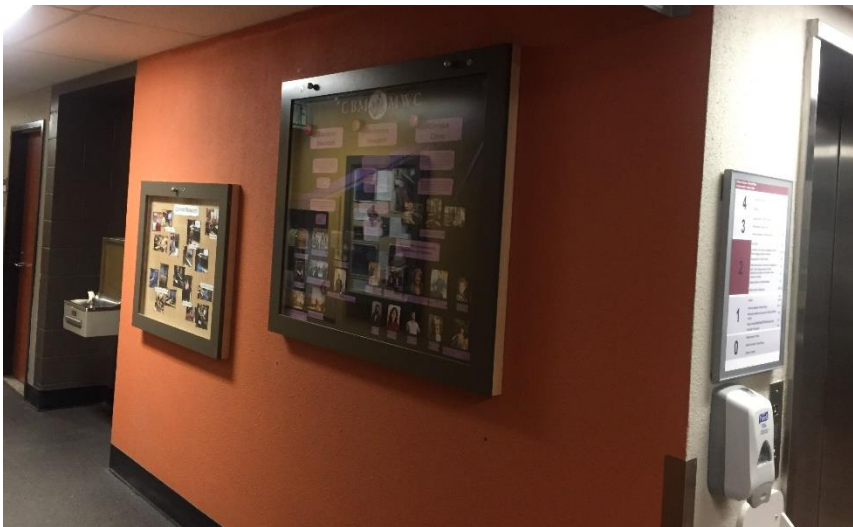
Wall texture coat was observed in Rooms 100, 104, 200, 300, 300C, 400, and 400C of the subject building. The laboratory analytical results of wall texture coat samples collected from Room 200 indicate that this material contains 10% Chrysotile asbestos. This material is considered to be friable and was observed in good condition.

Photo 2: Representative view of the wall texture coat (painted orange) in Room 200, containing 10% Chrysotile asbestos.

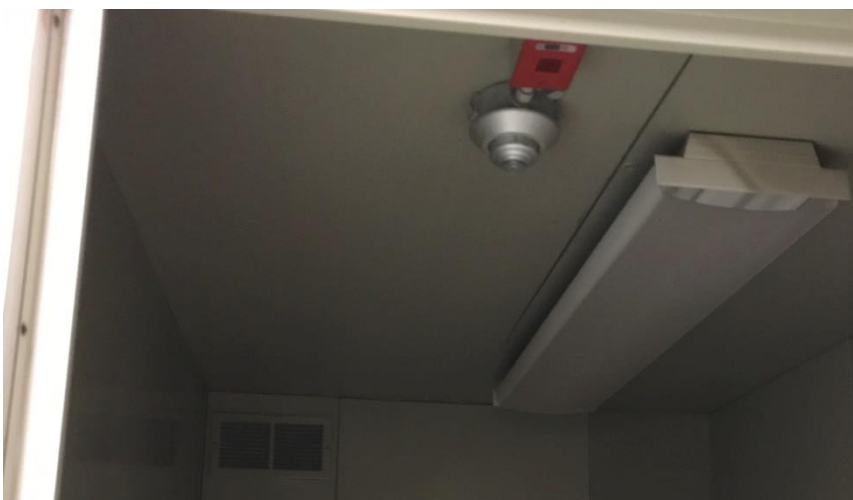
Photo 3: Typical view of the fluorescent light fixtures containing mercury vapour.

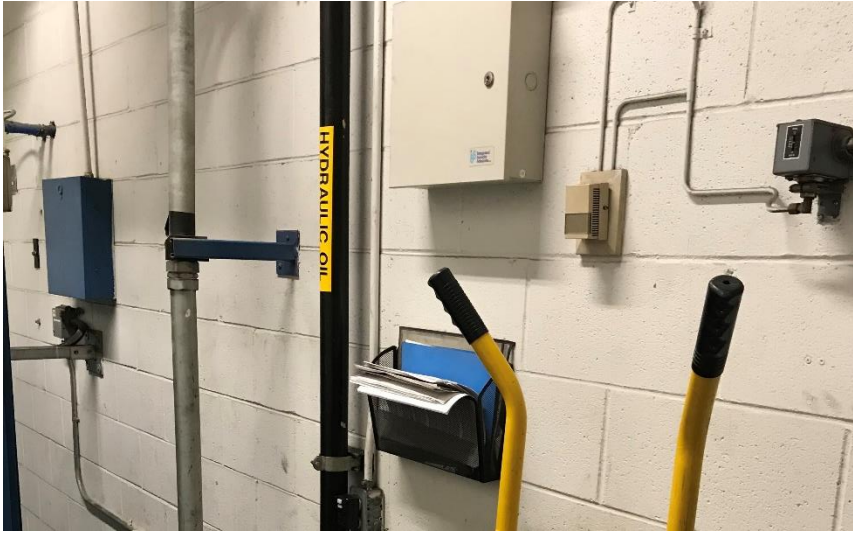
MPL observed thermostats containing liquid mercury within the subject building.

Photo 4: View of mercury-containing thermostat switches observed throughout the subject building.

Please refer to Appendix F – Hazardous Materials Checklist for equipment conditions, quantities (where applicable), and recommended actions.
