HAZARDOUS MATERIALS SURVEY AND 2022 REASSESSMENT SIMARD HALL, OTTAWA, ON

Project No.: Z1920014HZ / CCC-230252-00

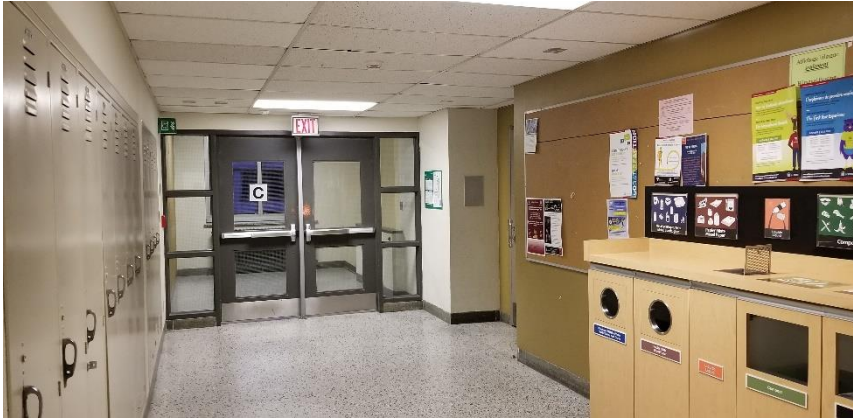
Photo 1: Representative view of the hallway finishes observed throughout the subject building.

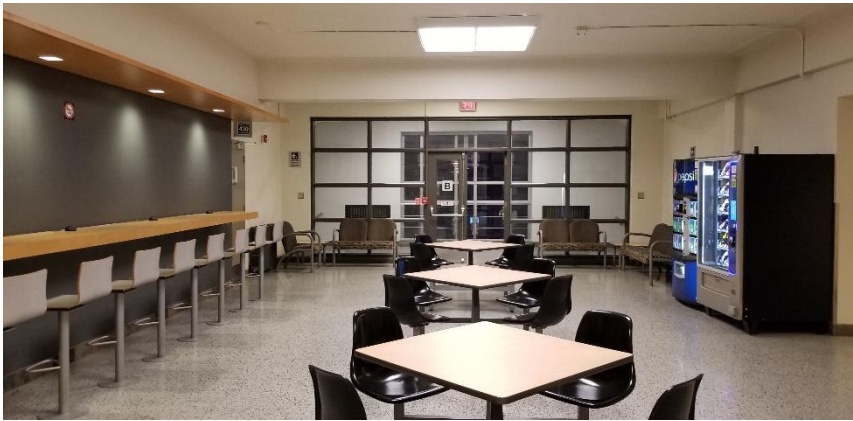
Photo 2: Representative view of the common area finishes observed throughout the subject building.

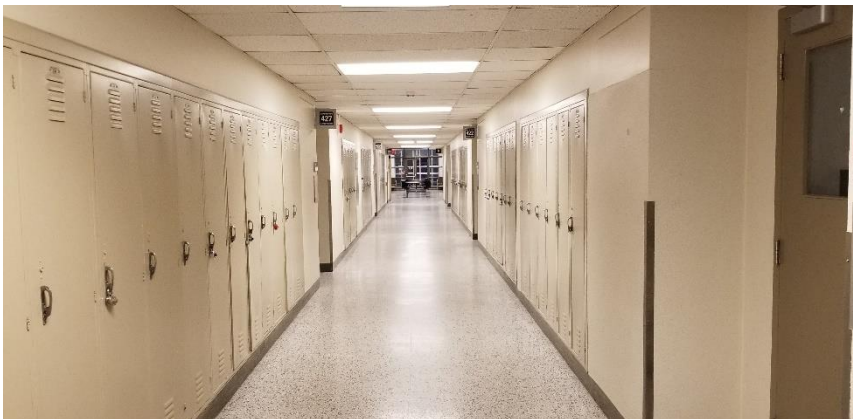
Photo 3: Representative view of the hallway finishes observed throughout the subject building.

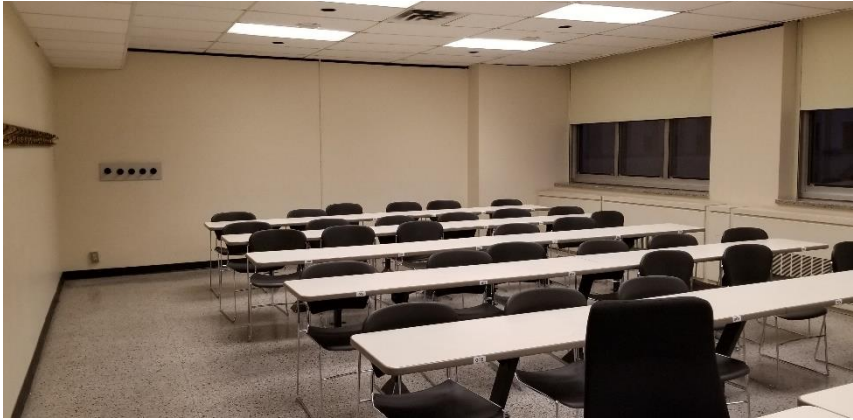
Photo 4: Representative view of the classroom finishes observed throughout the subject building.

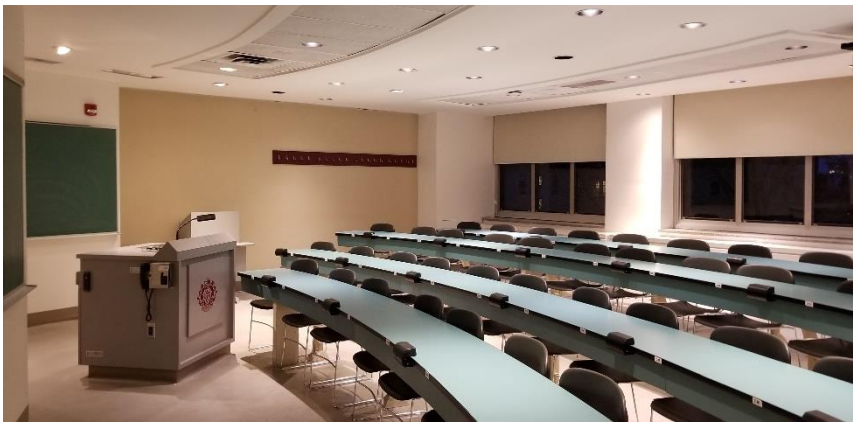
Photo 5: Representative view of the classroom finishes observed throughout the subject building.

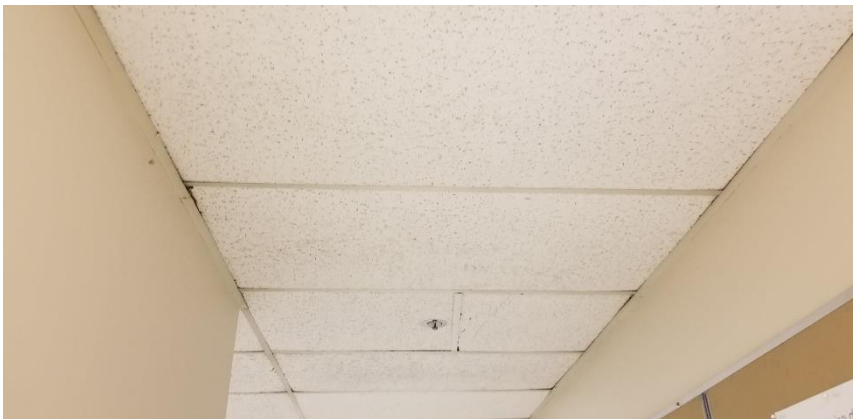
Photo 6: View of the non asbestos-containing ceiling tiles observed throughout Level 00.

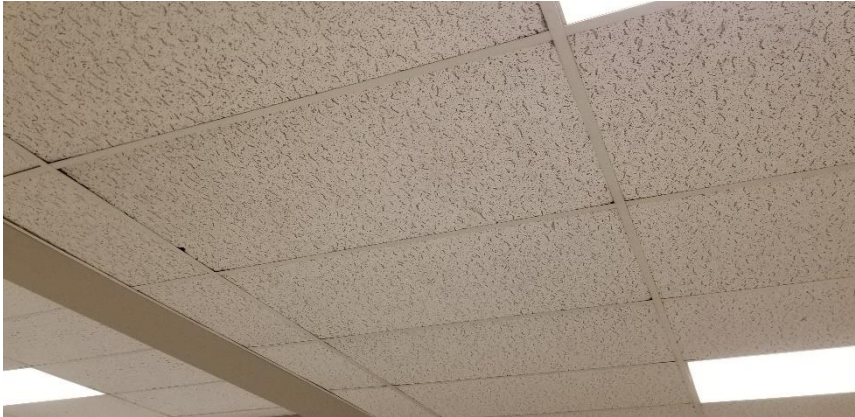
Photo 7: View of the non asbestos-containing ceiling tiles observed throughout Level 00.

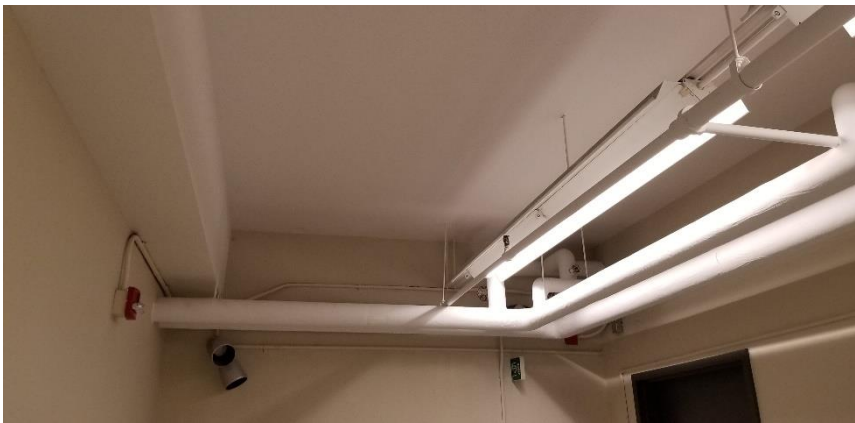
Photo 8: Representative view of the asbestos-containing parging cement elbows observed in good condition throughout Room 002.

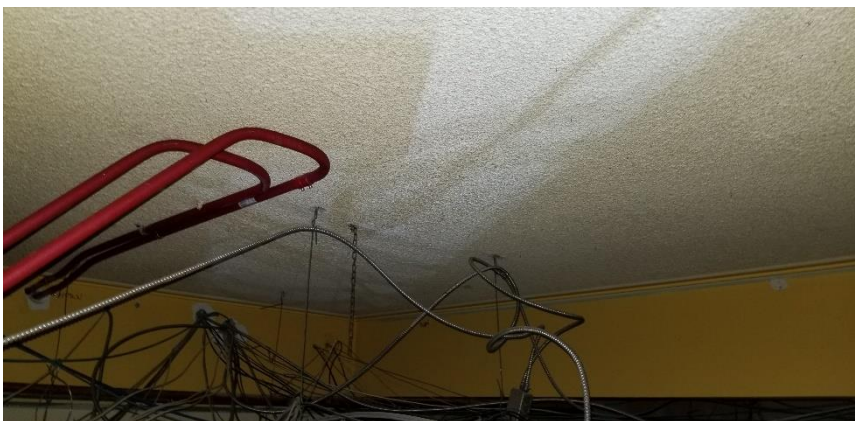
Photo 9: View of the asbestos-containing ceiling plaster observed above the suspended ceiling tiles in Room 02.

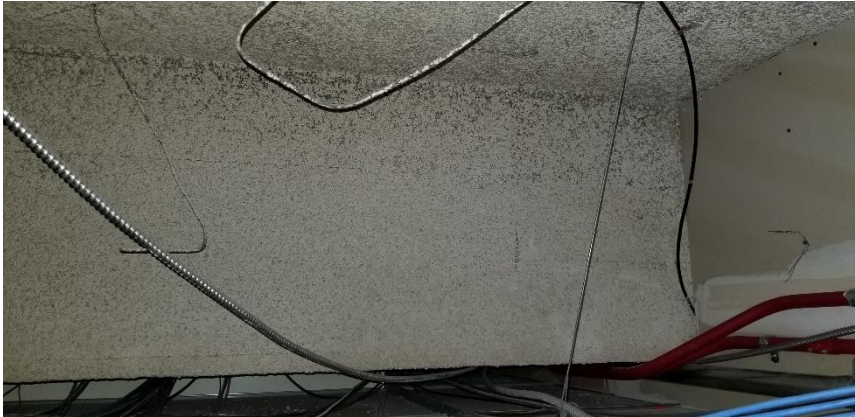
Photo 10: Representative view of the asbestos-containing sprayed-on ceiling plaster overspray observed on adjacent building materials and equipment observed throughout Room 02D.

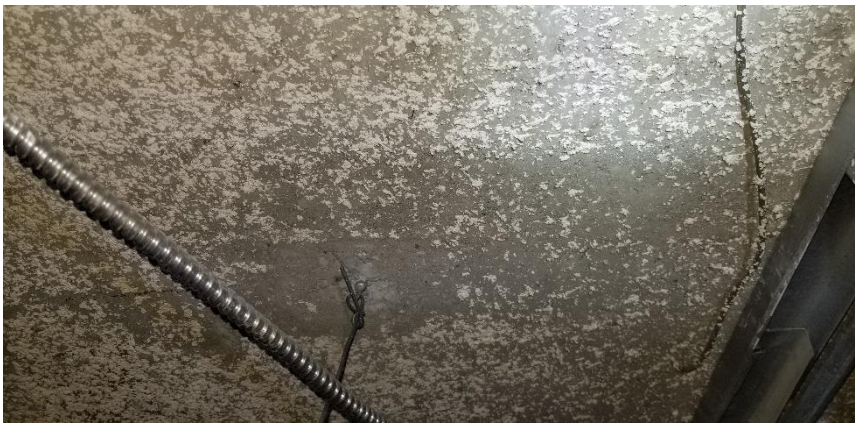
Photo 11: Representative view of the asbestos-containing sprayed-on ceiling plaster overspray observed on adjacent building materials and equipment observed throughout Room 02D.

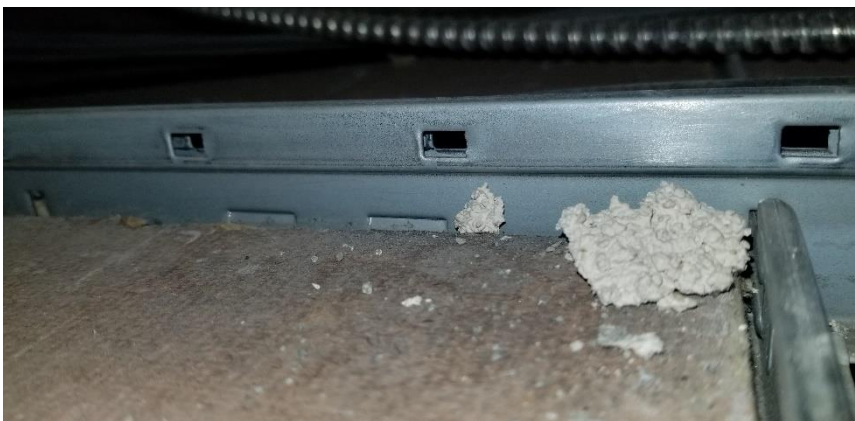
Photo 12: Representative view of the asbestos-containing ceiling plaster debris observed on suspended ceiling tiles throughout Room 02D.

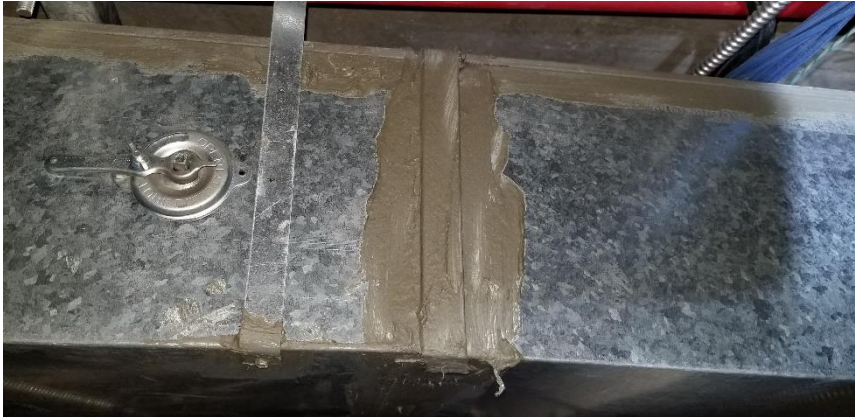
Photo 13: View of the non-asbestos-containing HVAC duct caulking observed throughout the subject building.

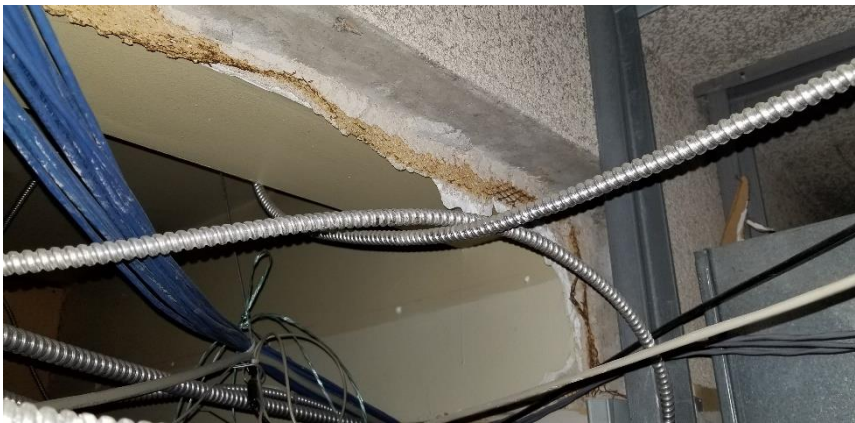
Photo 14: Representative view of the damaged asbestos-containing plaster observed throughout the subject building.

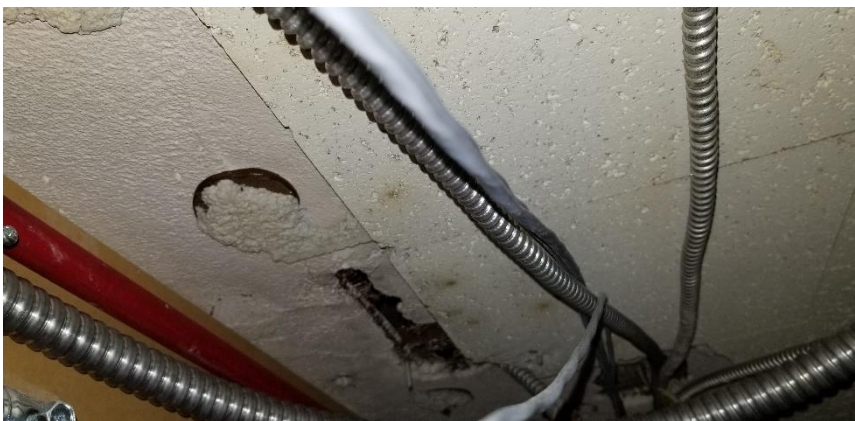
Photo 15: View of the non-asbestos acoustic glue-on tiles and mastic pucks (Dark Brown) observed overtop the ceiling plaster throughout Level 0.

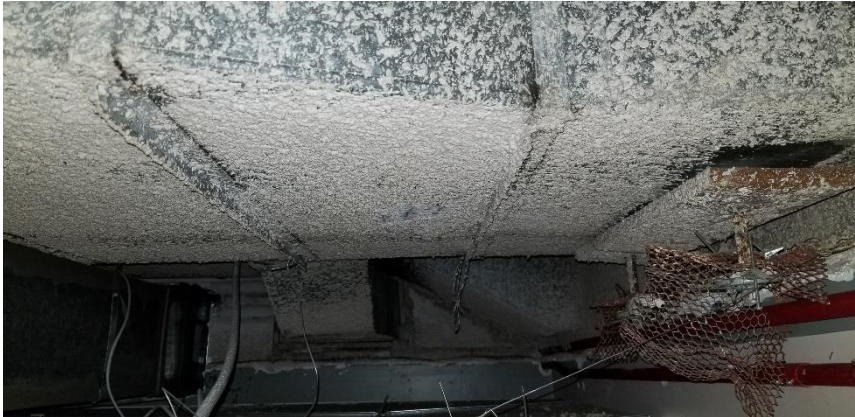
Photo 16: Representative view of the asbestos-containing sprayed-on ceiling plaster overspray observed on adjacent building materials and equipment observed throughout Room 102B.

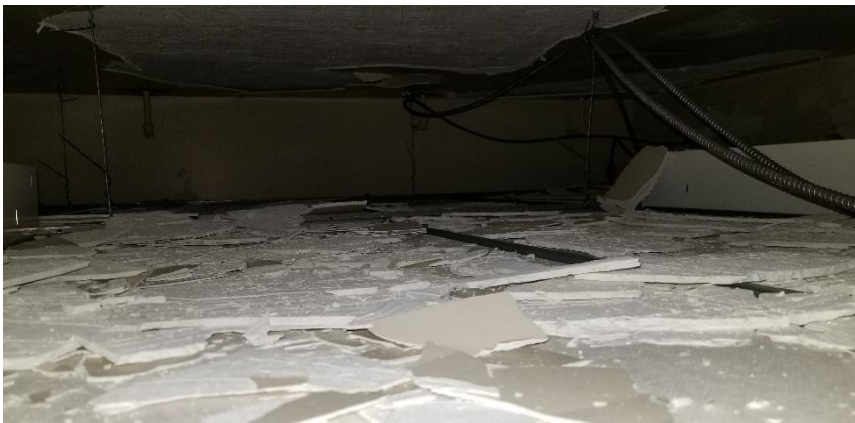
Photo 17: Representative view of the asbestos-containing ceiling plaster debris observed on suspended ceiling tiles throughout Room 206.

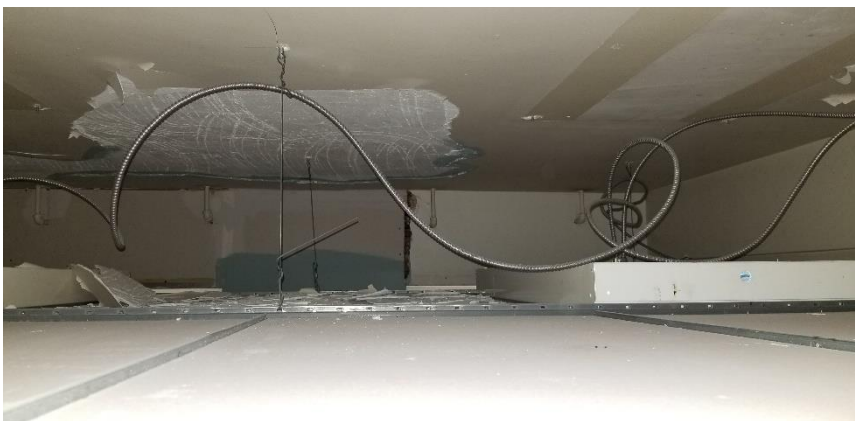
Photo 18: Representative view of the asbestos-containing ceiling plaster debris observed on suspended ceiling tiles throughout Room 212.

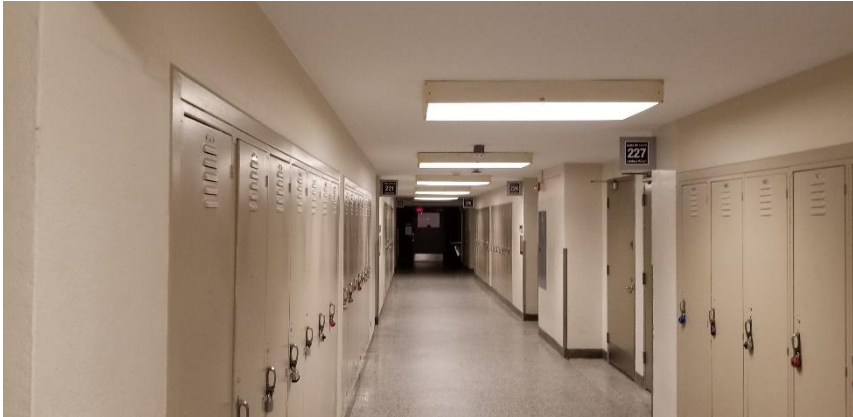
Photo 19: Representative view of the hallway finishes observed throughout Level 2.

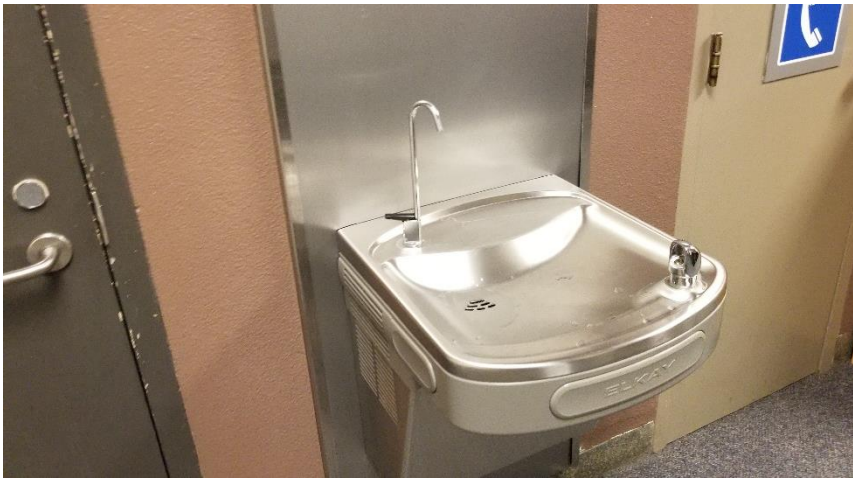
Photo 20: Representative view of water fountains observed throughout the subject building, containing ODSs (R134a).

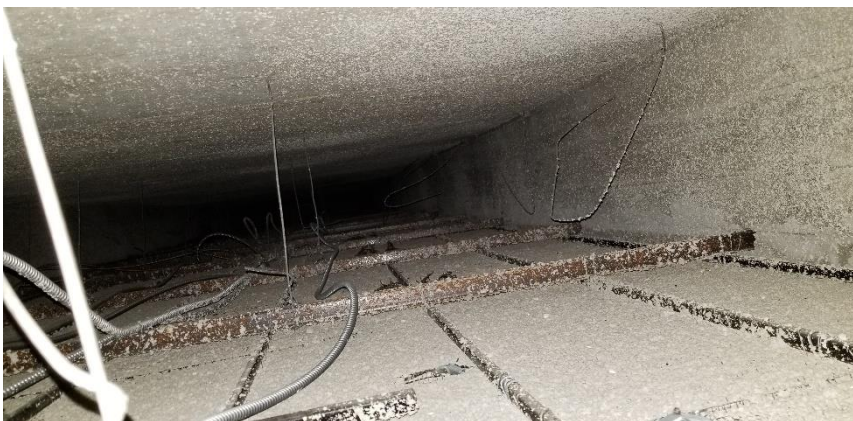
Photo 21: View of the asbestos-containing ceiling plaster and overspray observed above the suspended ceiling tiles in Room 303.

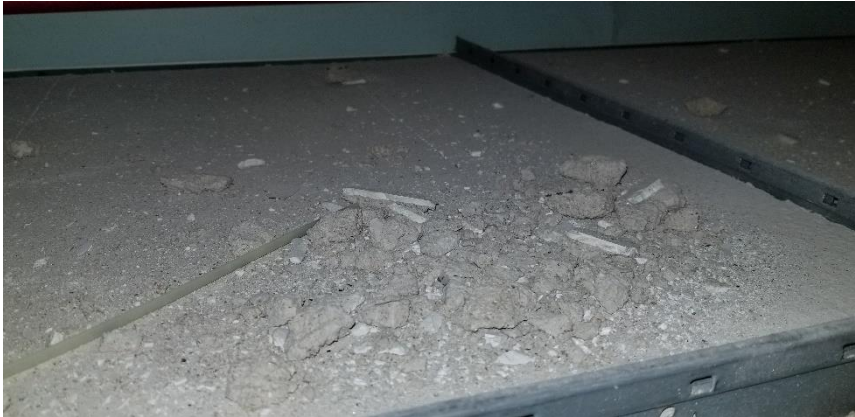
Photo 22: Representative view of the asbestos-containing ceiling plaster debris observed on suspended ceiling tiles throughout Room 303.

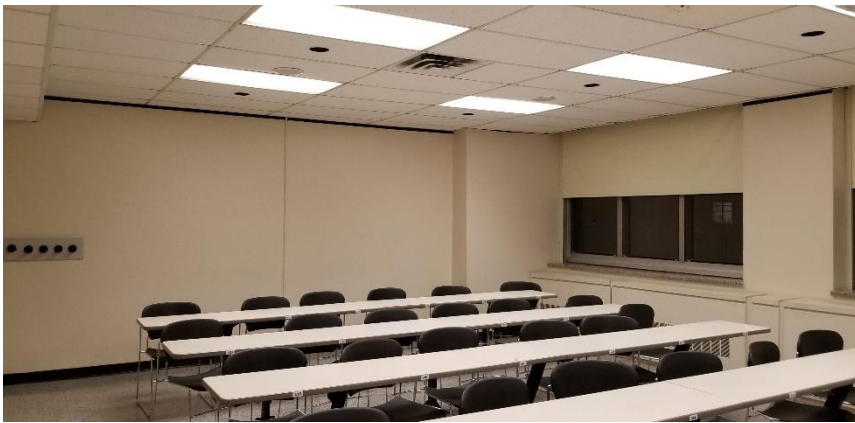
Photo 23: Representative view of the interior finishes observed throughout Room 423.

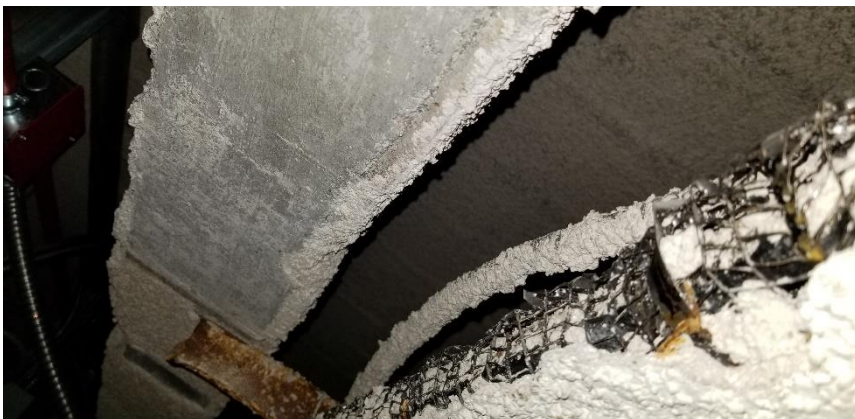
Photo 24: View of the poor condition asbestos-containing ceiling plaster and overspray observed above the suspended ceiling tiles in Room 423.

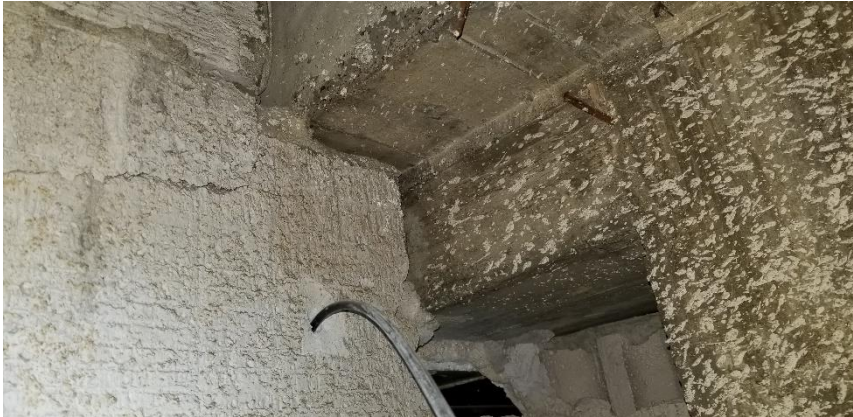
Photo 25: View of the asbestos-containing plaster overspray observed on walls along the Room 401B hallway.

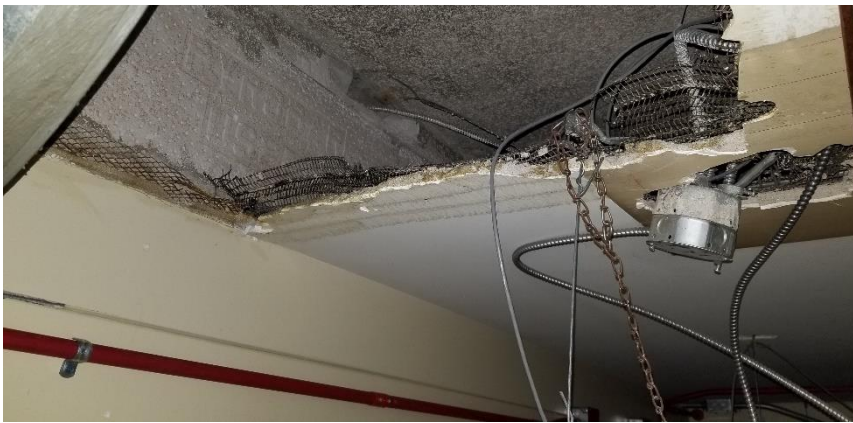
Photo 26: View of the poor condition asbestos-containing ceiling plaster and overspray observed above the suspended ceiling tiles in Room 403.

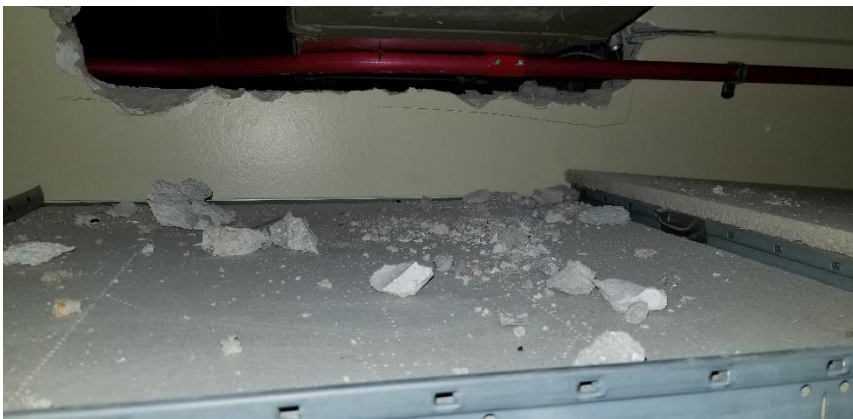
Photo 27: Representative view of the asbestos-containing ceiling plaster debris observed on suspended ceiling tiles throughout Room 403.

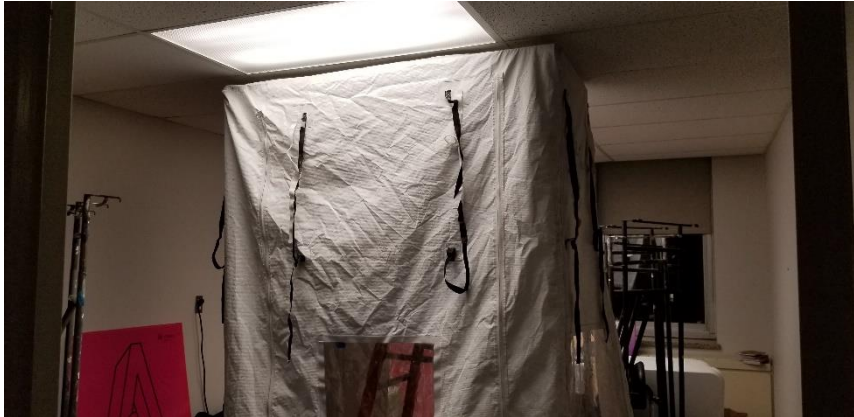
Photo 28: Representative view of the Type 2 ceiling entries performed during the site survey to access ceiling spaces.

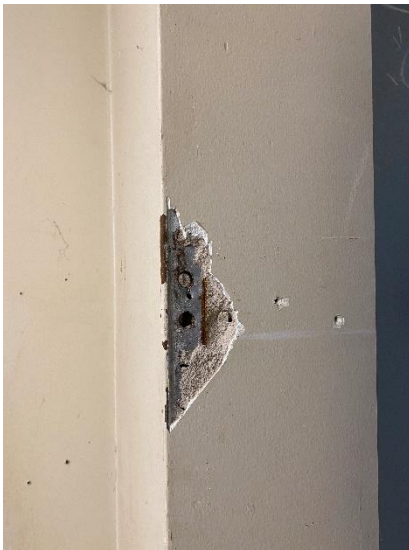
Photo 32: View of asbestos-containing plaster wall finish observed to be in poor condition in Room 006.

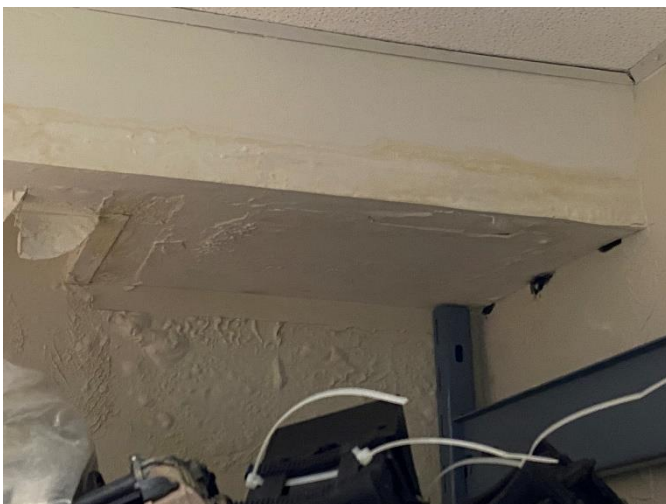
Photo 33: View of water damaged non-asbestos drywall joint compound finish observed to be in poor condition in Room 0020.

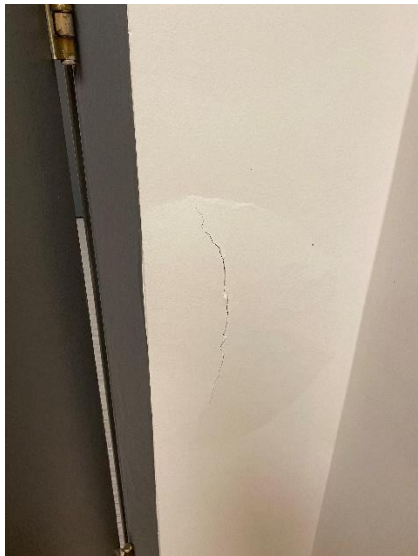
Photo 34: View of asbestos-containing plaster wall finish observed to be in fair condition in Room 115.

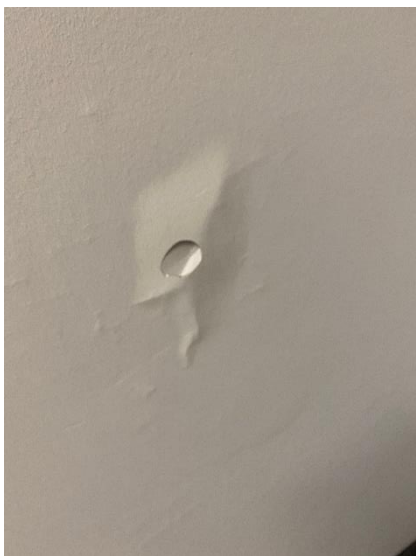
Photo 35: View of asbestos-containing plaster wall finish observed to be in fair condition in Room 116.

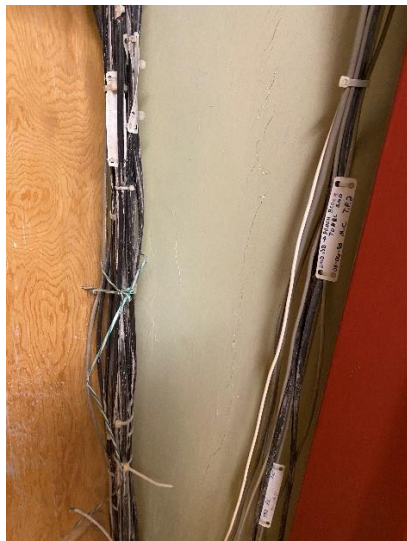
Photo 36: View of asbestos-containing plaster wall finish observed to be in fair condition in Room 128B.

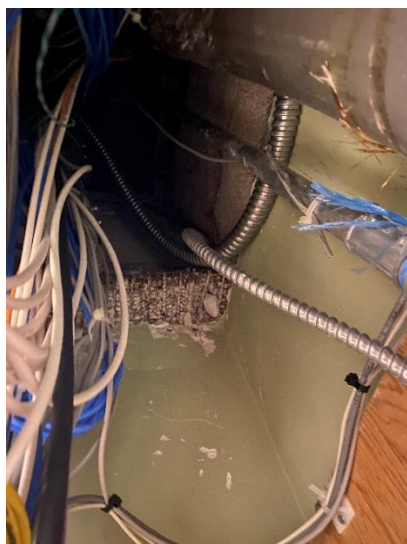
Photo 37: View of asbestos-containing plaster wall finish observed to be in fair condition in Room 128B.

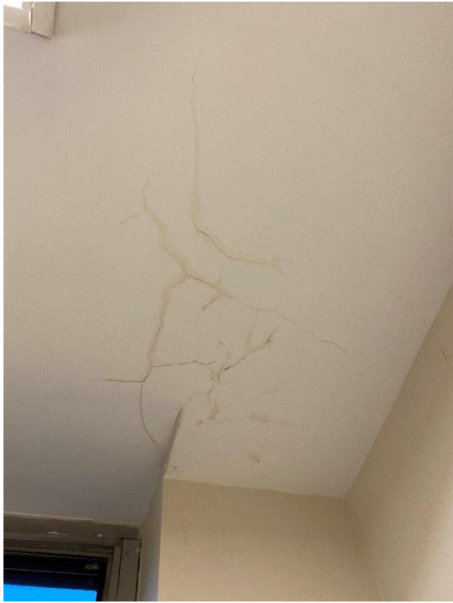
Photo 38: View of water damaged asbestos-containing plaster ceiling finish observed to be in fair condition in Room 126.

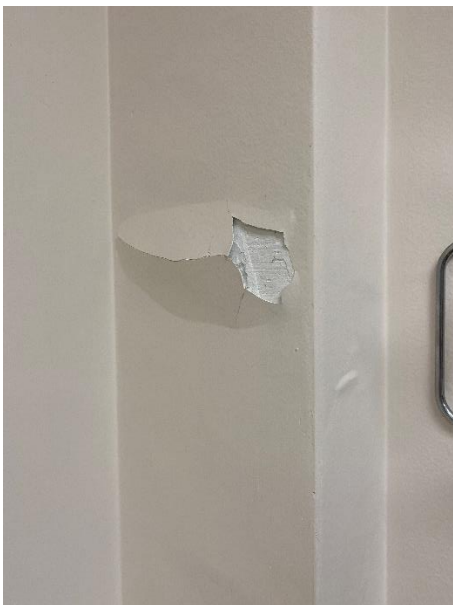
Photo 39: View of asbestos-containing plaster wall finish observed to be in poor condition in Room 204.

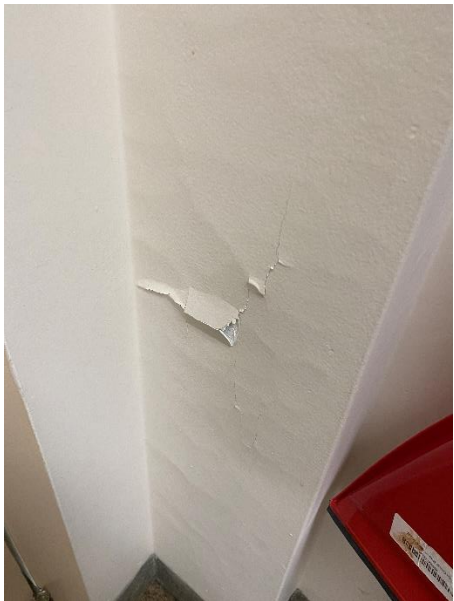
Photo 40: View of asbestos-containing plaster wall finish observed to be in poor condition in Room 206.

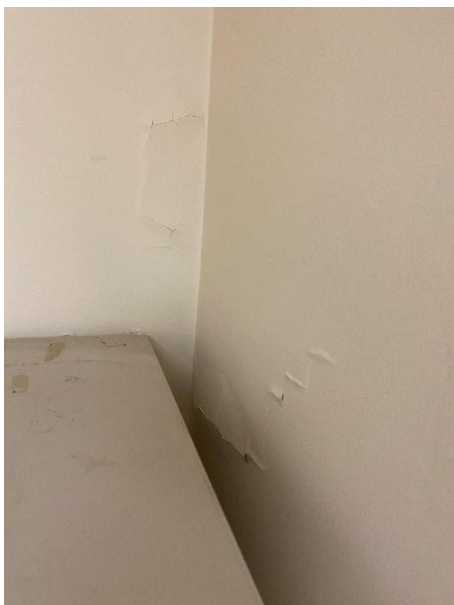
Photo 41: View of asbestos-containing plaster wall finish observed to be in poor condition in Room 207.

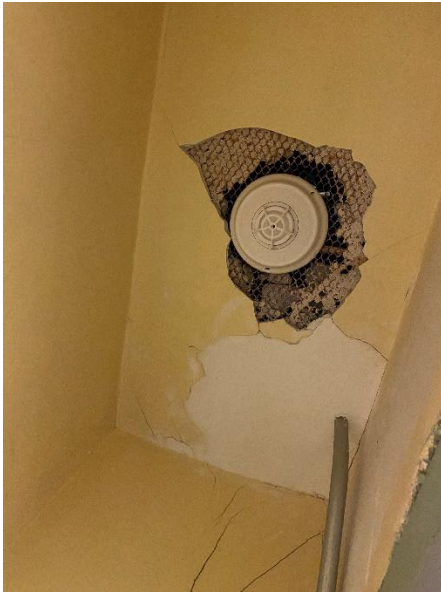
Photo 42: View of asbestos-containing plaster ceiling and wall finishes observed to be in poor condition in Room 221A.

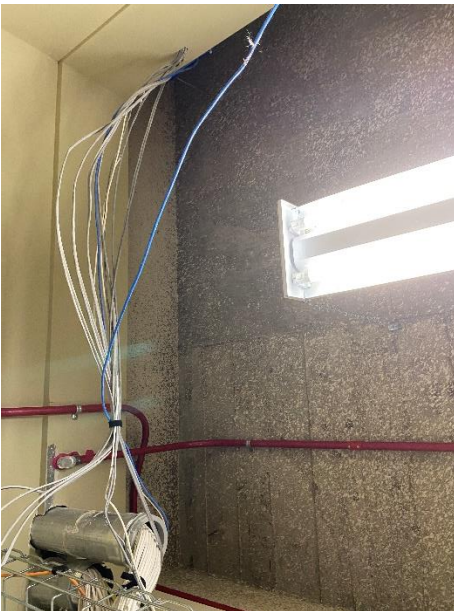
Photo 43: View of asbestos-containing plaster ceiling finish observed to be in fair condition (exposed overspray) in Room 228.

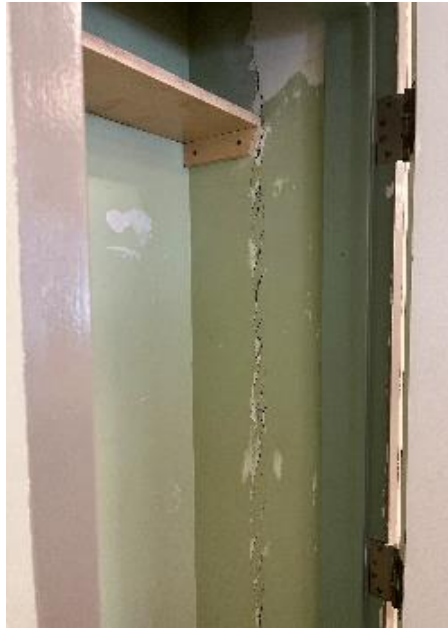
Photo 44: View of asbestos-containing plaster wall finish observed to be in fair condition in Room 226A.

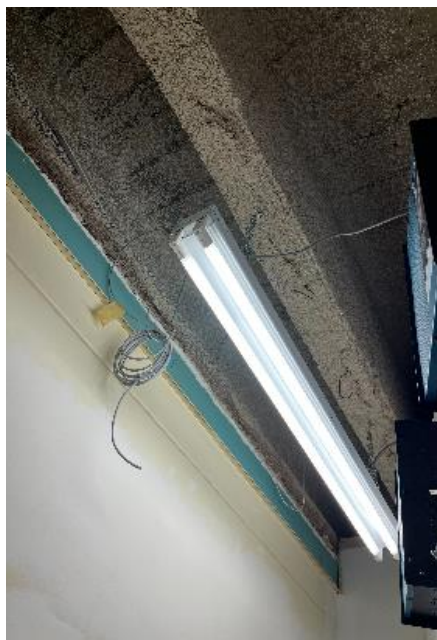
Photo 45: View of asbestos-containing plaster ceiling finish observed to be in fair condition (exposed overspray) in Room 224B.

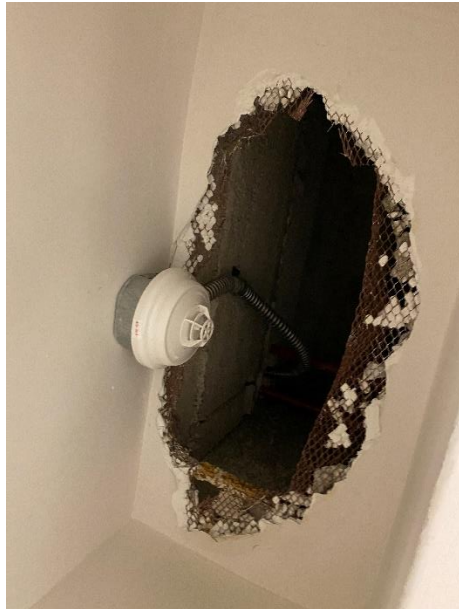
Photo 46: View of asbestos-containing plaster ceiling finish observed to be in poor condition in Room 322A.

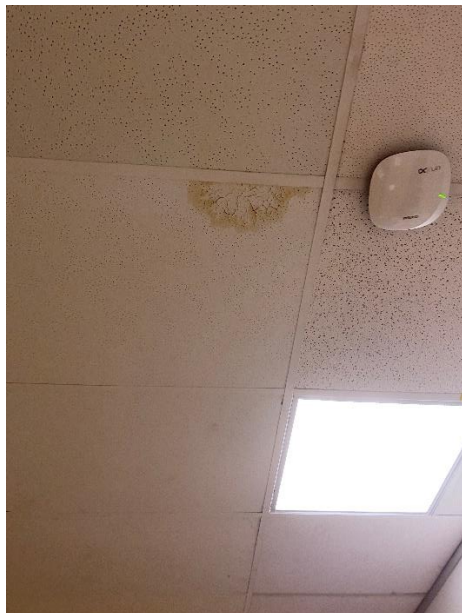
Photo 47: General View of water-damaged ceiling tile observed in select areas of the subject building.
