HAZARDOUS MATERIALS SURVEY AND 2022 REASSESSMENT STANTON RESIDENCE, OTTAWA, ON

Project No.: Z2021102HZ / CCC-230252-00

University of Ottawa

December 16, 2022

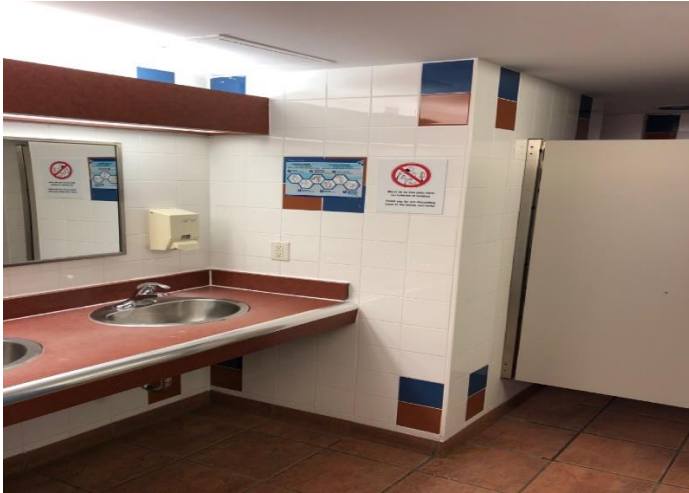
Photo 4: Typical view of ceramic floor tile grout suspected of containing asbestos.

To avoid damage and compromising the integrity of the structure, no bulk samples of the ceramic wall/floor tile grout were collected. Prior to renovation/demolition, concrete brick mortar should be examined and tested for asbestos content. Ceramic wall/floor tile grout should therefore be considered to contain asbestos until bulk samples and analysis proves otherwise.

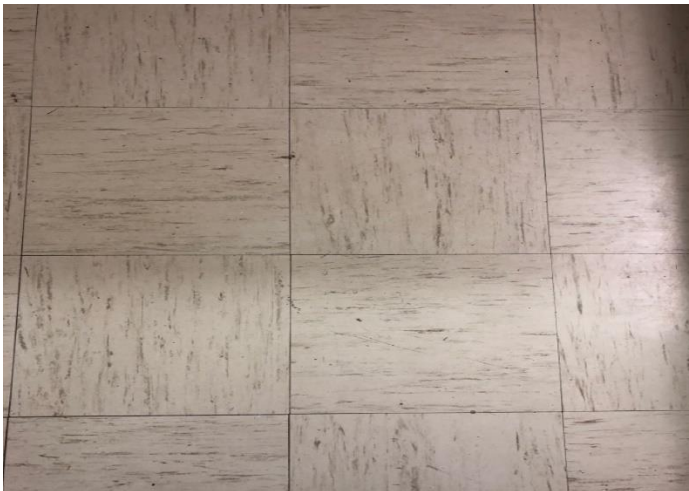
Photo 5: View of asbestos-containing vinyl floor tiles (12"x12"- white with grey streaks) observed in Room 1618A (kitchen).

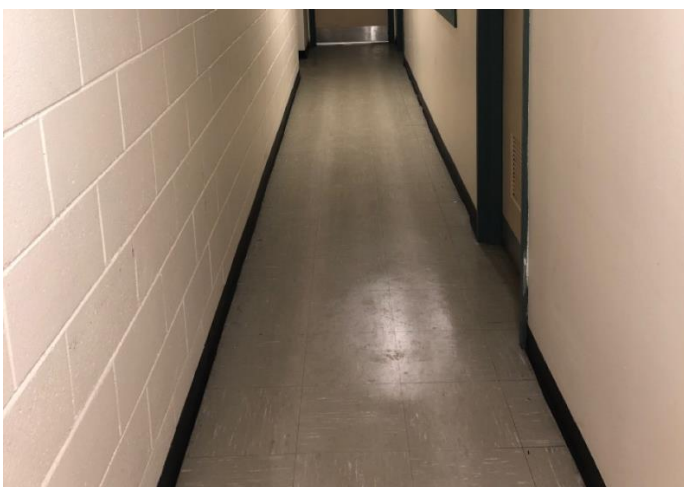
Photo 6: View of asbestos-containing vinyl floor tiles (12"x12"- grey with white streaks) observed in the basement corridor.

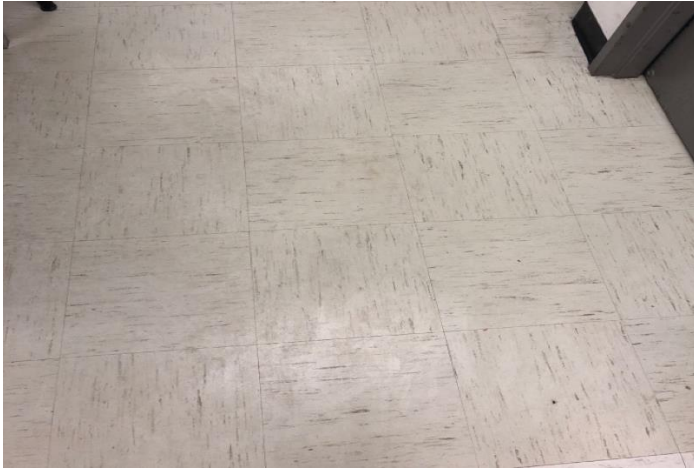
Photo 7: View of asbestos-containing vinyl floor tiles (12"x12" - white with black streaks) observed in Room 017.

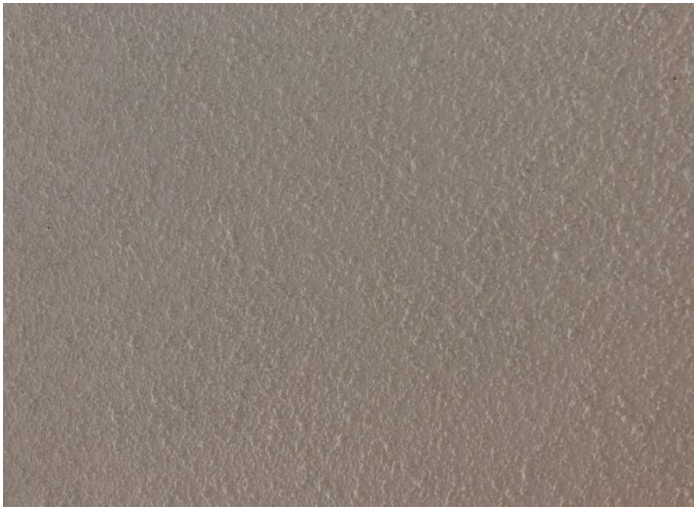
Ceiling texture coat (shallow stipple) was observed throughout the subject building. The laboratory analytical results of ceiling texture coat samples collected indicate that this material contains 3% Chrysotile asbestos. This material is considered to be friable and was observed in good condition.

Photo 8: View of asbestos-containing texture coat observed in Room 1608.

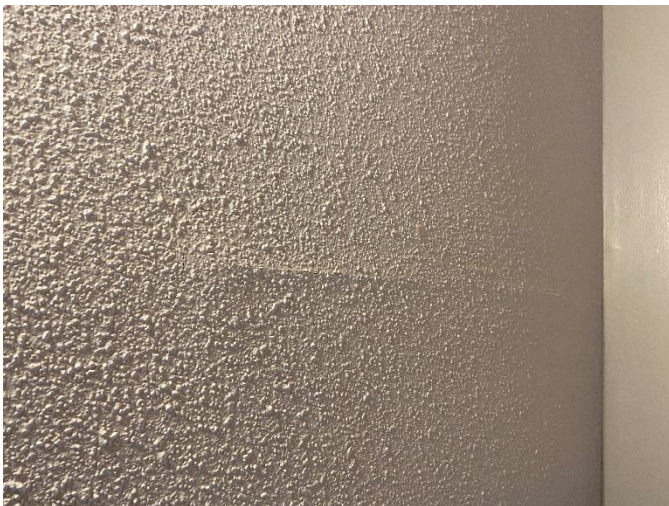
Photo 9: View of asbestos-containing texture coat observed in fair condition in Room 130F.

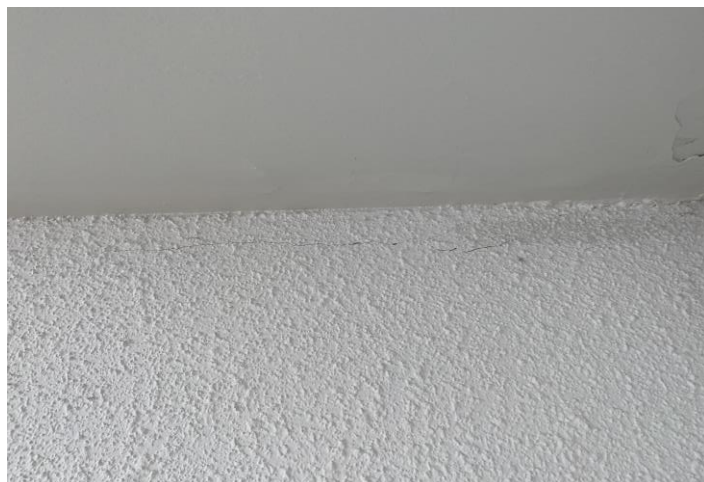
Photo 12: View of asbestos-containing texture coat observed in fair condition in Room 1607.

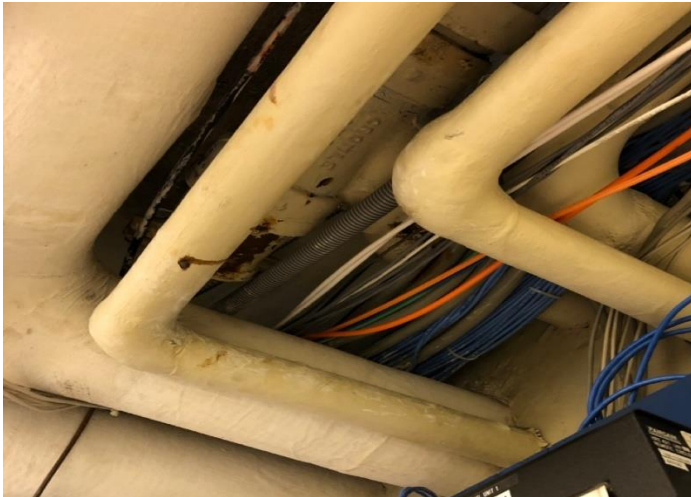
Previously identified mechanical pipe elbows/fittings insulation was observed in Rooms 03, 010B, 016, 025, R140A, penthouse level 1 and penthouse level 2. The laboratory analytical results indicate that this material contains 40-50% Chrysotile asbestos. This material is considered to be friable and was observed in good condition.

Photo 14: View of asbestos-containing pipe fitting insulation observed in Room 025.

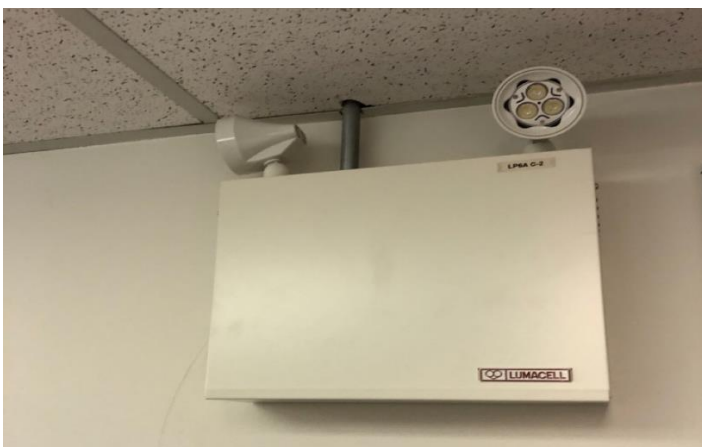
MPL identified lead-containing acid battery packs throughout the subject building. These battery packs were observed on walls and above exits throughout the surveyed building.

Photo 15: View of lead-containing battery packs observed throughout the subject building.

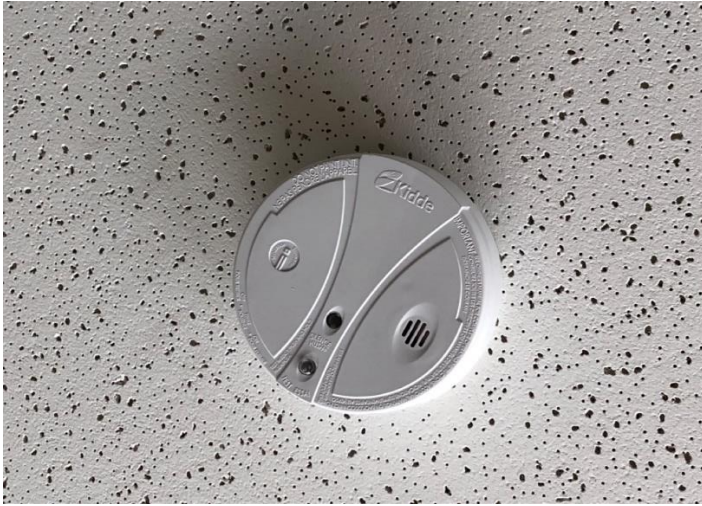
A visual assessment of the subject building was conducted to determine if any electrical components containing radioactive materials were present. MPL observed Kidde brand smoke detectors, which contains small quantities of radioactive material.

Photo 16: Typical view of smoke detectors containing radioactive materials.

The radioactive sources in smoke alarms are sealed and contained within a metal case inside the smoke detector and must not be damaged or tampered with. These materials do not pose a hazard as long as they remain contained and properly disposed at the time of removal or replacement.

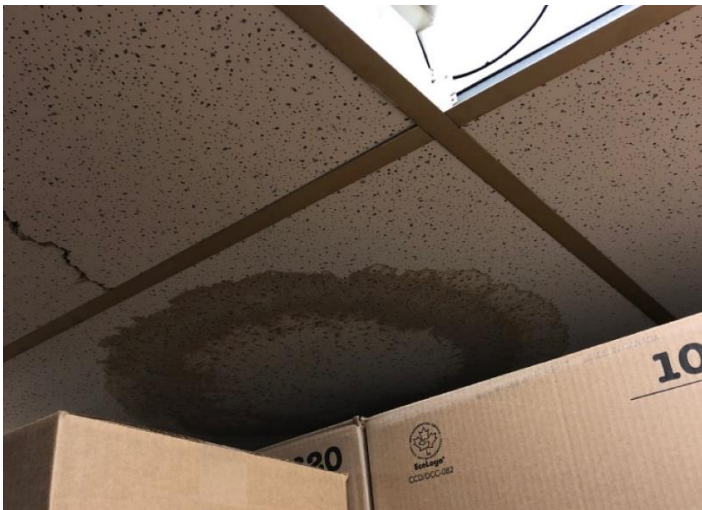
A visual survey of the subject building was conducted to determine if any water damaged was present. MPL identified select areas throughout the subject building, where materials were affected by water damage.

Photo 17: View of water damaged ceiling tiles observed in Room 100G.

Water stained/damaged ceiling tiles observed throughout the subject building should be replaced as part of regular maintenance and the underlying cause of the water leakage should be identified and repaired.
