# TABARET HALL, OTTAWA, ON HAZARDOUS MATERIALS SURVEY AND 2022 REASSESSMENT

Project No.: Z1920014HZ / CCC-230252-00

University of Ottawa

January 17, 2023

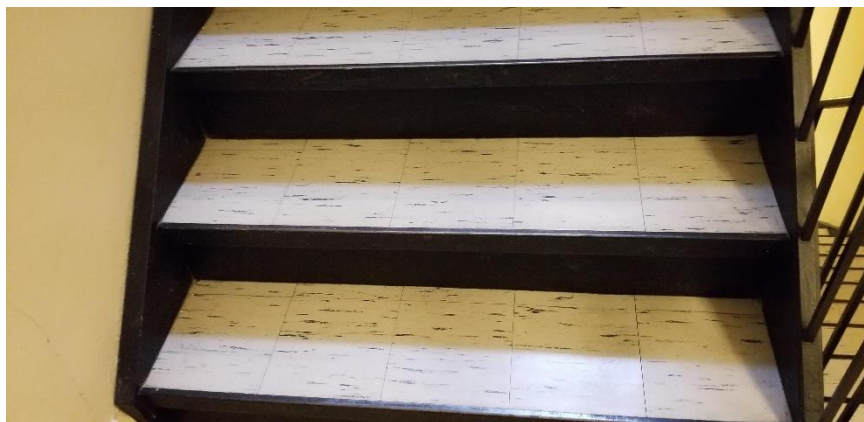
- Previously identified vinyl floor tiles (9"x9"- White and Black) were observed in Rooms C207C and C123. This material contains 2-10% Chrysotile asbestos. This material is considered to be non-friable and was observed to be in good condition.

Photo 1: View of asbestos-containing vinyl floor tiles (9"x9"-White and Black) observed to be in good condition in C207C.

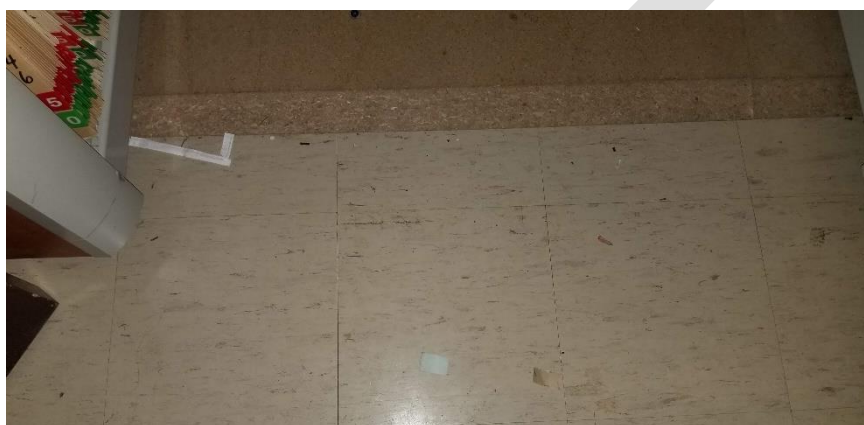
Photo 2: View of asbestos-containing vinyl floor tiles (12"x12"-Cream and Brown Coloured) observed to be in good condition in Room W0041.

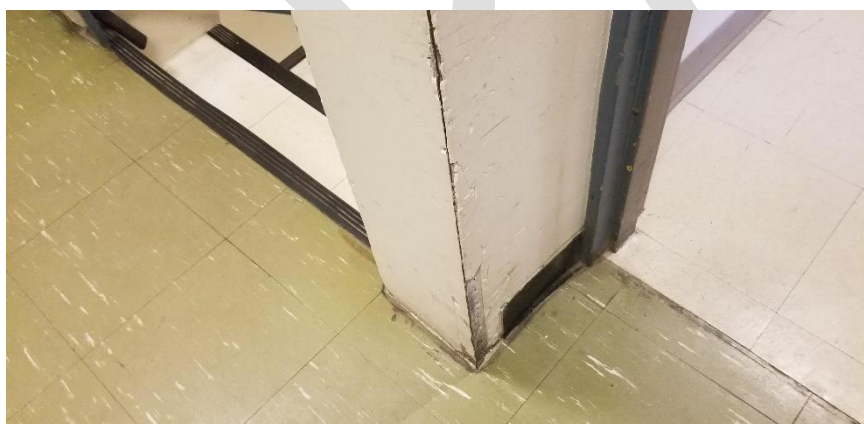
Photo 3: View of asbestos-containing vinyl floor tiles (9"x9"-Green w/ White Stripes) observed to be in good condition in Room N0130 along with asbestos-containing drywall joint compound observed to be in poor condition.

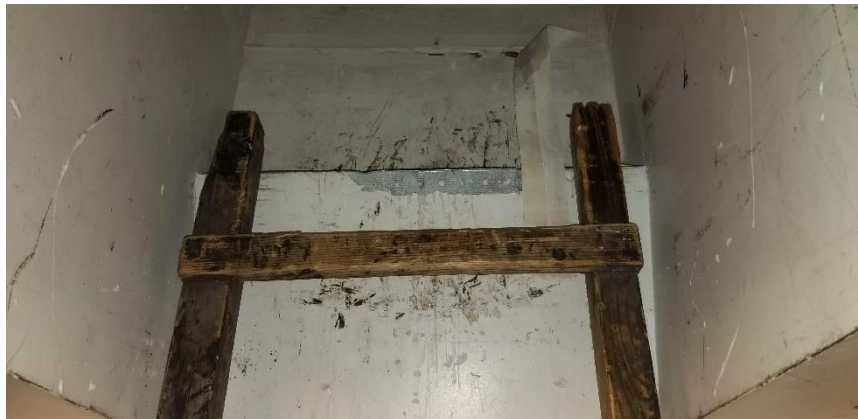
Photo 4: View of asbestos-containing drywall joint compound observed to be in poor condition in Room C452

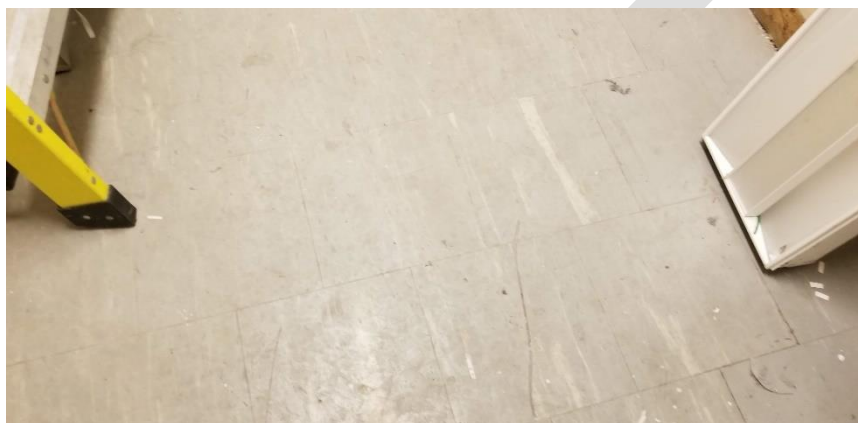
Photo 5: View of asbestos-containing vinyl floor tiles (9"x9"-Grey Coloured) observed to be in good condition in Room C08.

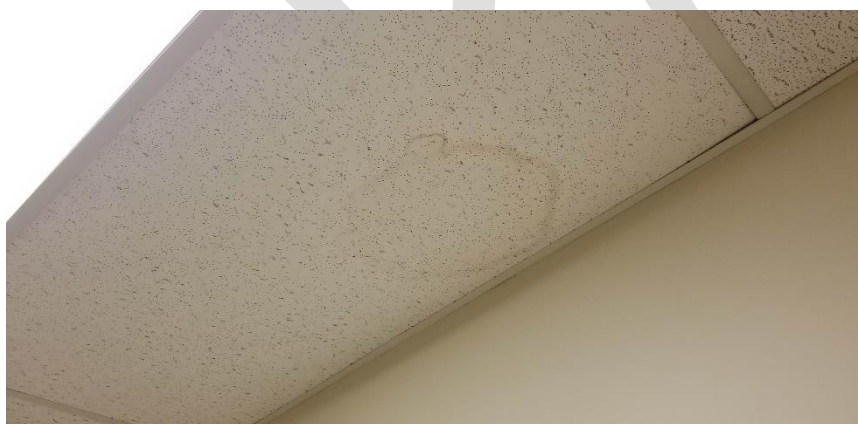
Photo 6: View of water stained asbestos-containing ceiling tiles (2'x4"-White Tone) observed in Room W0011B.

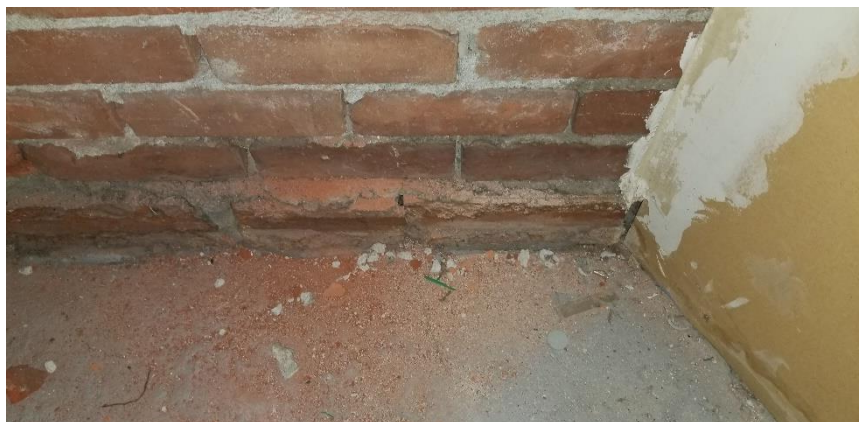
Photo 7: View of the asbestos-containing brick mortar observed to be in poor condition in Room C455.

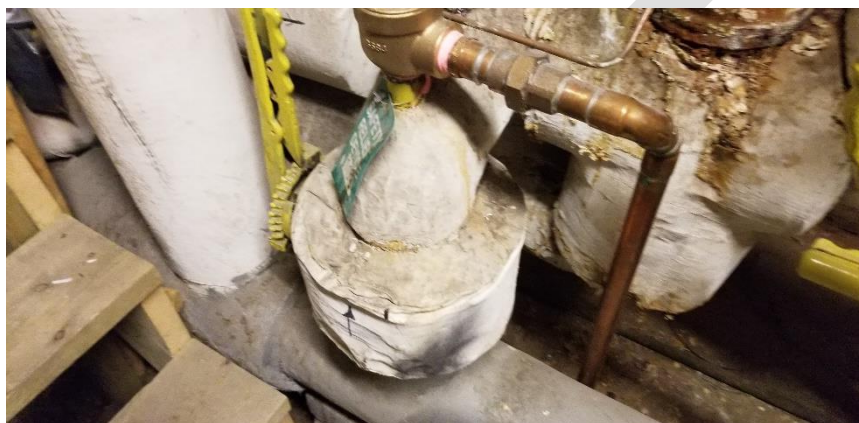
Photo 8: View of asbestos-containing mechanical pipe fitting insulation observed to be in good condition in Room C01B.

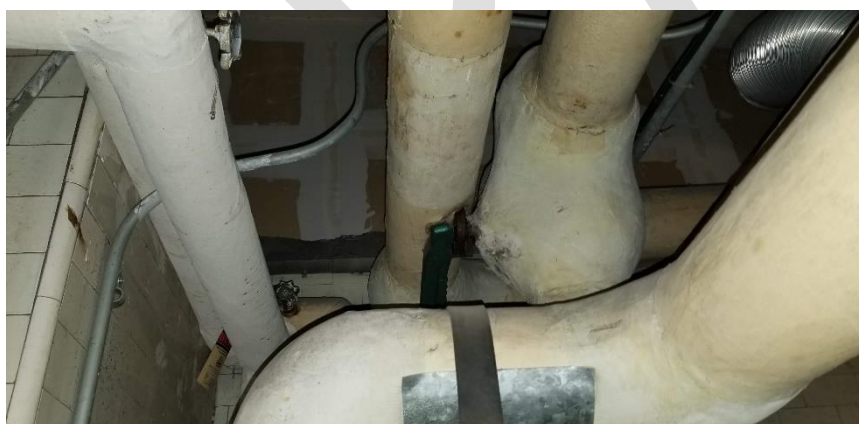
Photo 9: View of asbestos-containing mechanical pipe fitting insulation observed to be in good condition in Room C01D.

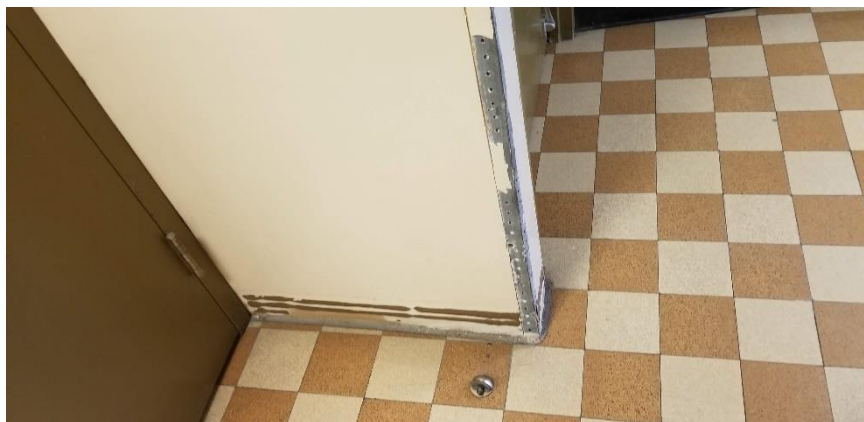
Photo 10: View of asbestos-containing drywall joint compound observed to be in poor condition outside room N120.

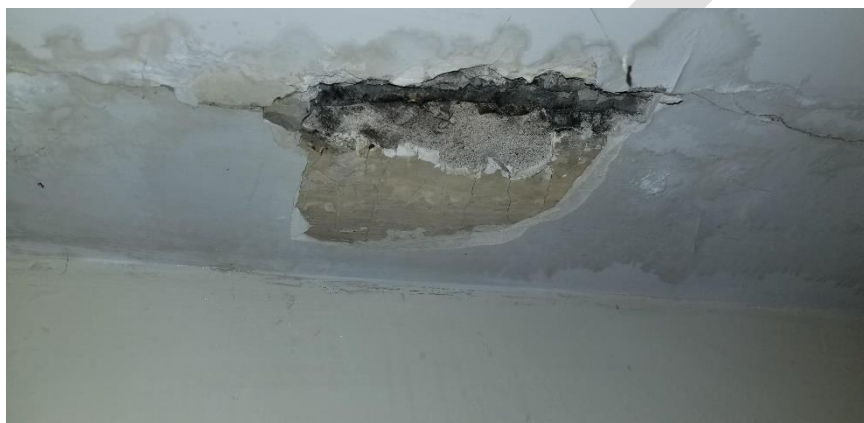
Photo 11: View of asbestos-containing ceiling plaster observed to be in poor condition in Room C401A.

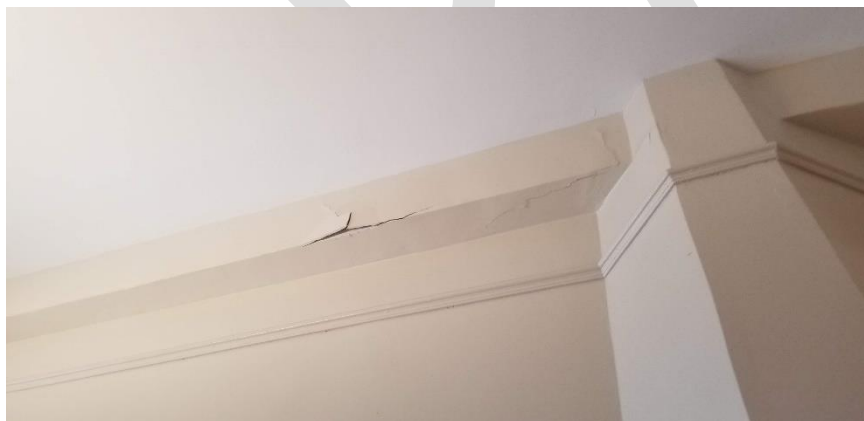
Photo 12: View of asbestos-containing ceiling plaster observed to be in poor condition in Room M386.

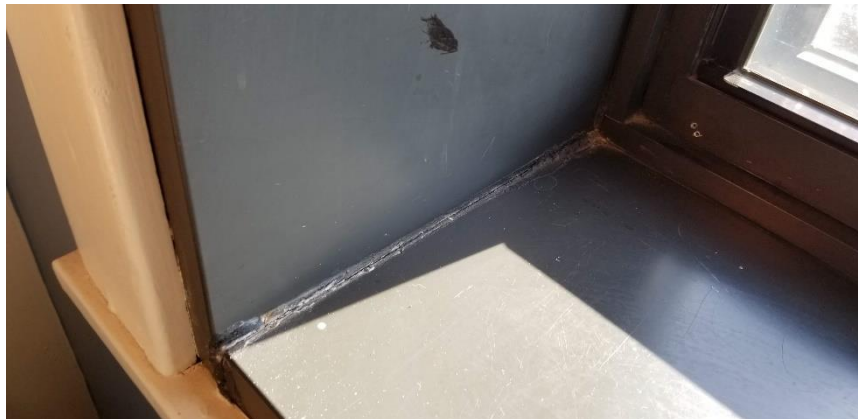
Photo 13: View of asbestos-containing window frame caulking observed to be in fair condition in Room M386F.

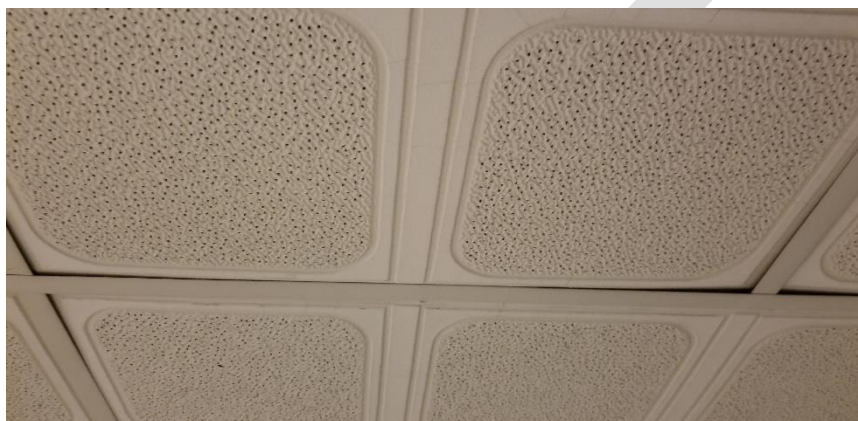
- Suspended ceiling tiles (2'x4'-Square Pattern w/ Pinholes) were observed and sampled from Room C219A. The laboratory analytical results of samples collected indicate that this material does not contain asbestos.

Photo 14: View of non-asbestos containing suspended ceiling tiles (2'x4'-Square Pattern with Pinholes) observed in Room C219.

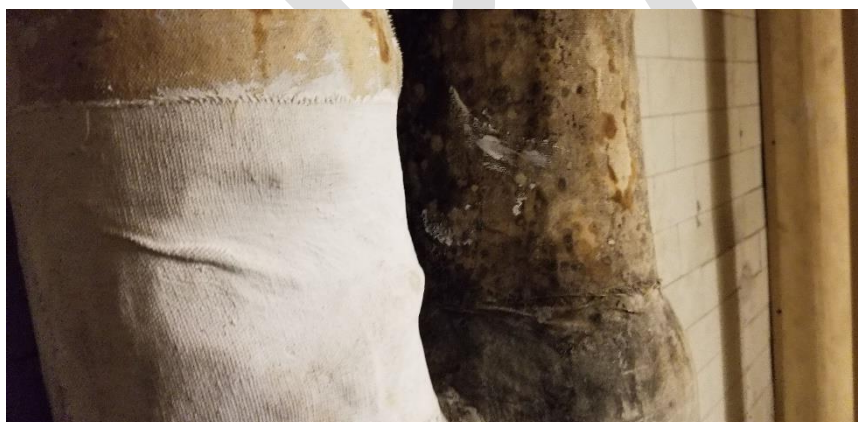
Photo 15: View of mould and water damage observed on pipe fittings and straights in Room C01D.

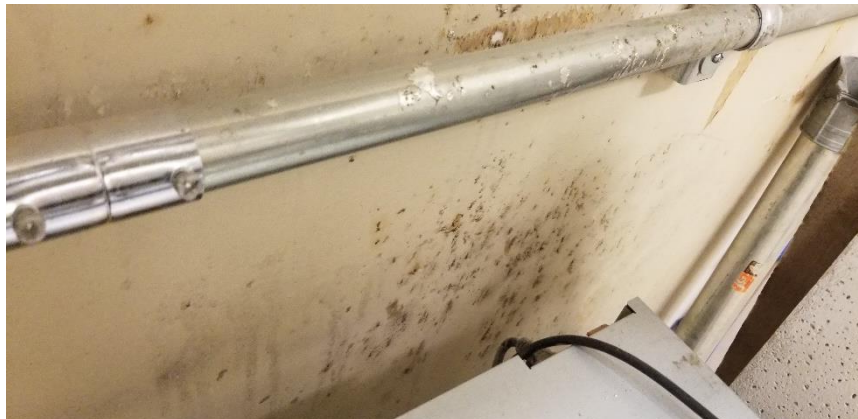
Photo 16: View of mold impacted drywall observed in Room N0109.

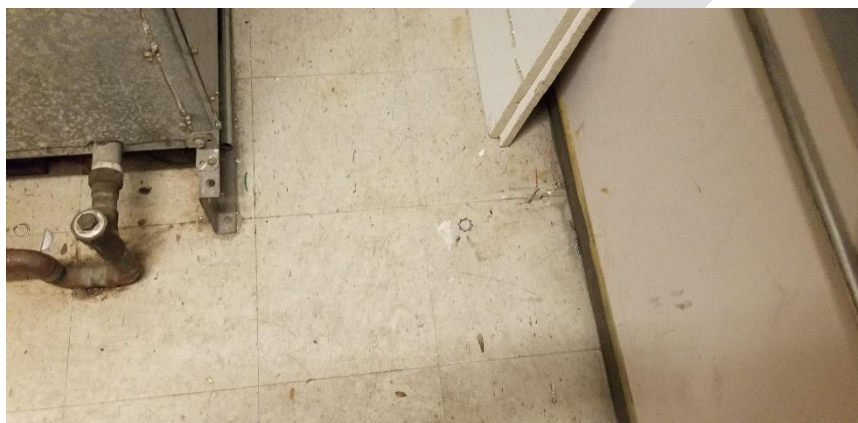
Photo 17: View of non-asbestos containing vinyl floor tiles (12"x12"-Off White with Small Grey Streaks) observed in Room N0122B.

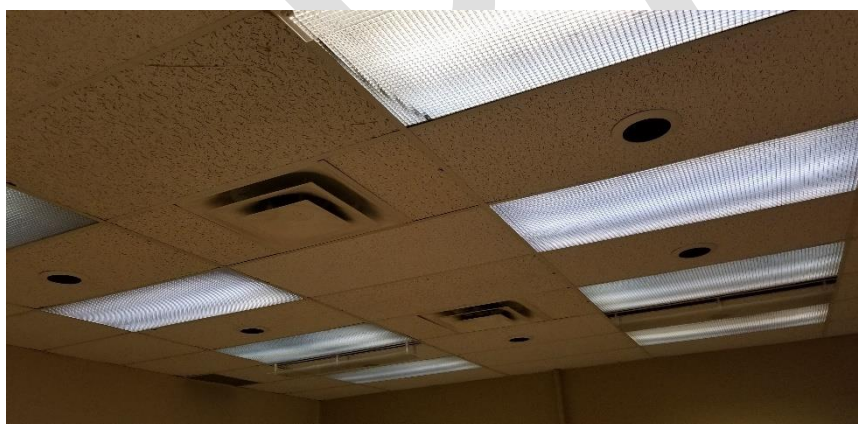
Photo 18: View of asbestos-containing suspended ceiling tiles (2'x4"-White Tone) observed to be in good condition in Room C012A.

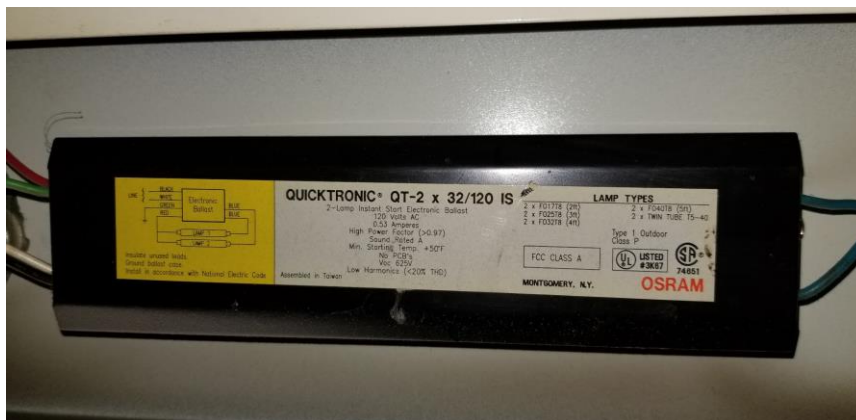
Photo 19: View of non-PCB Containing light ballasts observed in C459.

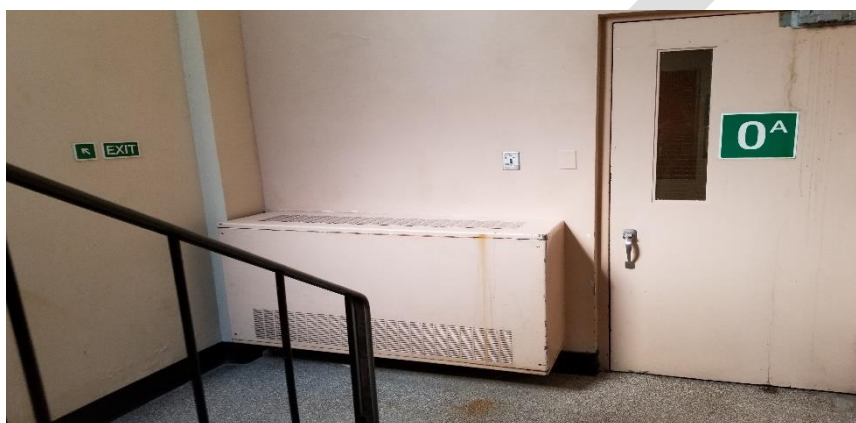
Photo 20: Typical view of low-level lead containing pink paint finish observed to be in good condition on radiators and walls throughout the subject building.

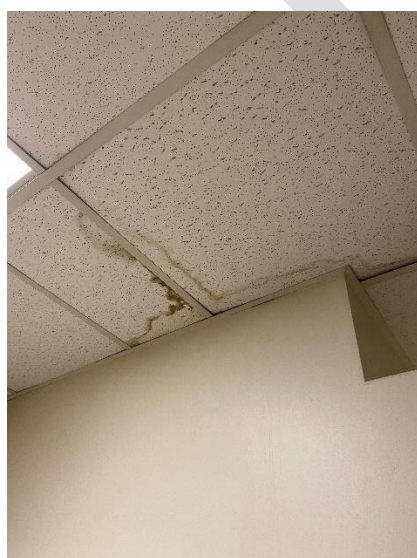
Photo 21: Typical view of water damaged ceiling tiles observed in select locations throughout the subject building.

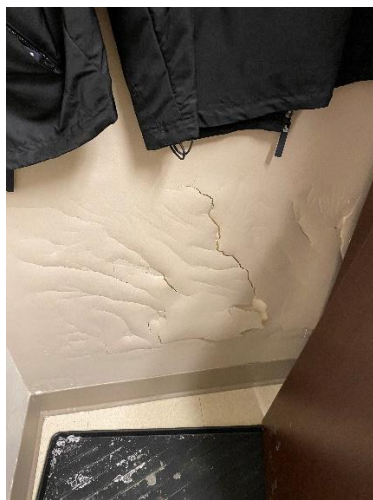
Photo 22: Typical view of poor condition (peeling) lead-containing paint observed in select locations throughout the subject building.

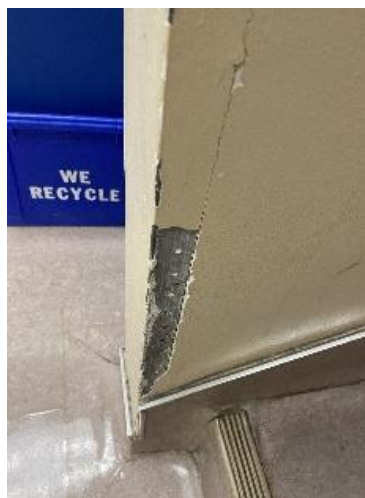
Photo 23: View of asbestos-containing drywall joint compound on wall observed to be in fair condition in Room W021C.

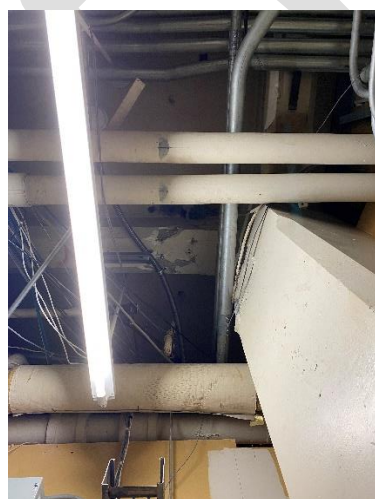
Photo 24: View of asbestos-containing plaster ceiling observed to be in poor condition in Room C09.

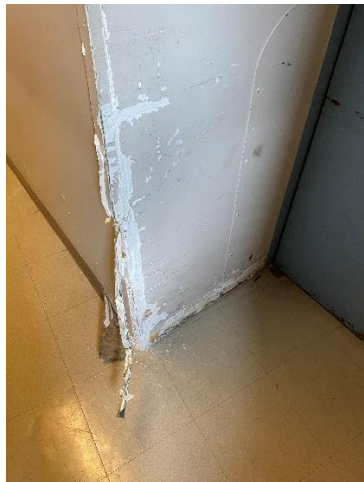
Photo 25: View of asbestos-containing drywall joint compound on wall observed to be in poor condition in Room N100E.

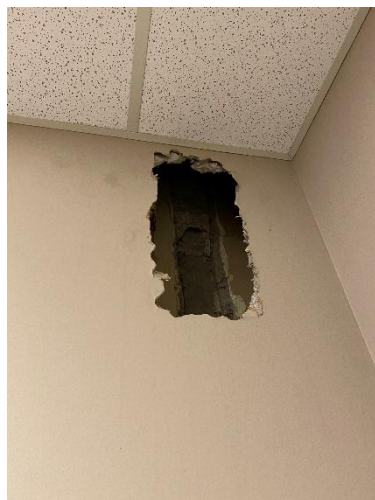
Photo 26: View of asbestos-containing drywall joint compound on wall observed to be in poor condition in Room M155.

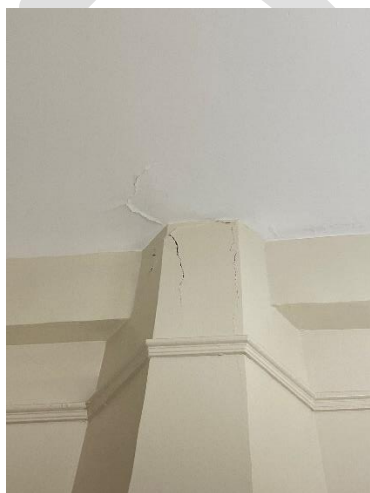
Photo 27: View of asbestos-containing plaster wall/pillar observed to be in poor condition in Room M368B.

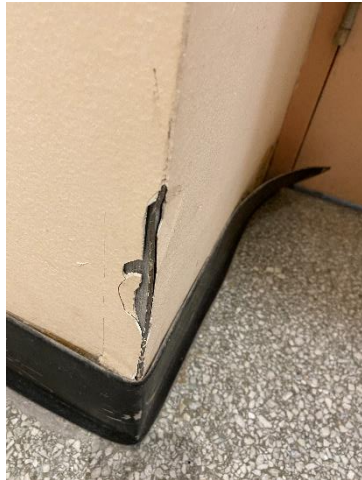
Photo 28: View of asbestos-containing drywall joint compound on wall observed to be in poor condition in Room M396.

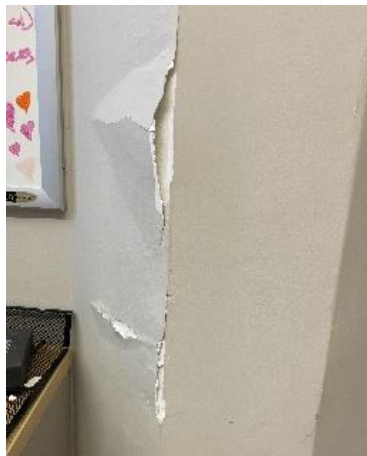
Photo 29: View of asbestos-containing plaster wall/pillar observed to be in poor condition in Room M411.
