HAZARDOUS MATERIALS SURVEY AND 2022 REASSESSMENT THOMPSON RESIDENCE, OTTAWA, ON

Project No.: OZ2021102HZ / CCC-230252-00

January 6, 2023

Re: 25, 35, and 45 University Private, Ottawa Ontario
Hazardous Materials Survey and 2022 Reassessment
McIntosh Perry Limited Reference No. OZ2021102HZ / CCC-230252-00

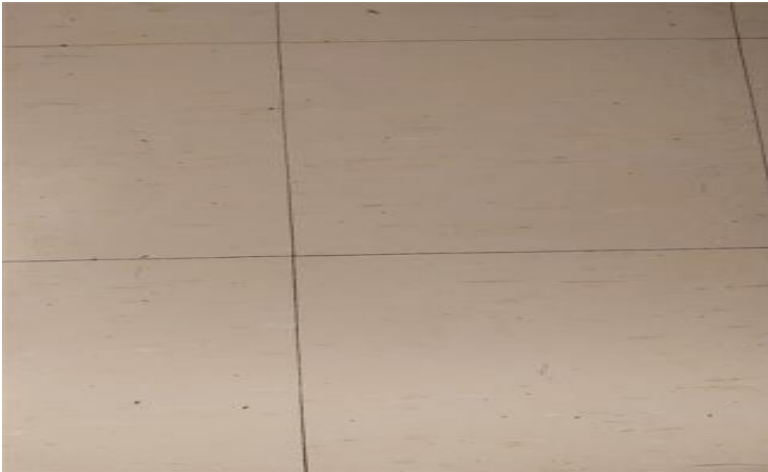
- Previously identified asbestos-containing vinyl floor tiles (12"x12" - Beige) were observed throughout the subject building. This material contains 13.9% Chrysotile asbestos and is considered to be non-friable. This material was observed to be in good condition.

Photo 4: View of asbestos-containing vinyl floor tiles (12"x12" - Beige) observed in Room 1918A.

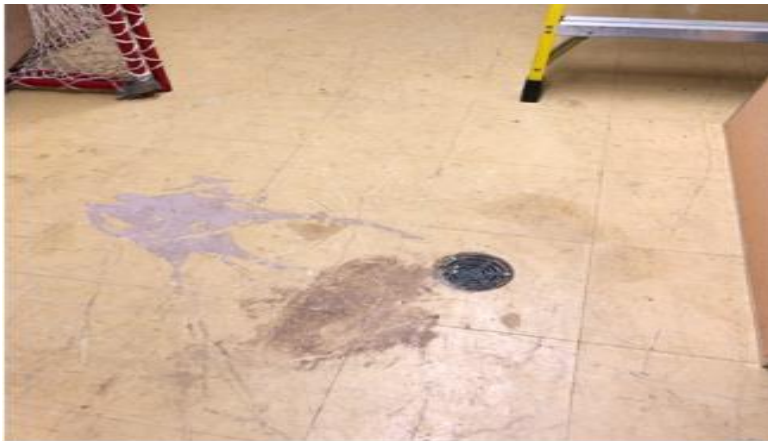
- Vinyl floor tiles (12"x12" Yellow) were observed in Room 012. The laboratory analytical results of vinyl floor tile samples collected indicate that this material contains 5% Chrysotile asbestos. This material is considered to be non-friable and was observed in good condition. The associated mastic (Black) was found not to contain asbestos.
- Vinyl floor tiles (12"x12" Beige) were observed in the residence kitchens throughout the subject building. The laboratory analytical results of vinyl floor tile samples collected from Rooms 518A, 918A and 818A indicate that this material contains 5% Chrysotile asbestos. This material is considered to be non-friable and was observed in good condition.

Photo 5: View of asbestos-containing vinyl floor tiles (12"x12" - Yellow) observed in Room 012.

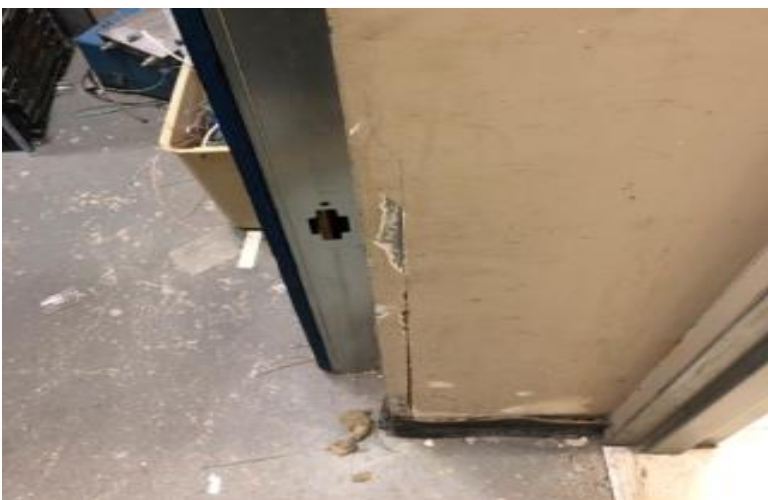
Drywall joint compound was observed throughout the building. The laboratory analytical results of drywall joint compound samples collected throughout the building indicate that this material contains 3% Chrysotile asbestos. Since drywall joint compound is a homogeneous material, all areas must be treated as asbestos-containing unless additional bulk sampling and analysis proves otherwise. This material was observed in good and poor condition during the 2022 Reassessment.

Photo 6: View of asbestos-containing drywall joint compound observed to be in poor condition in Room 03.

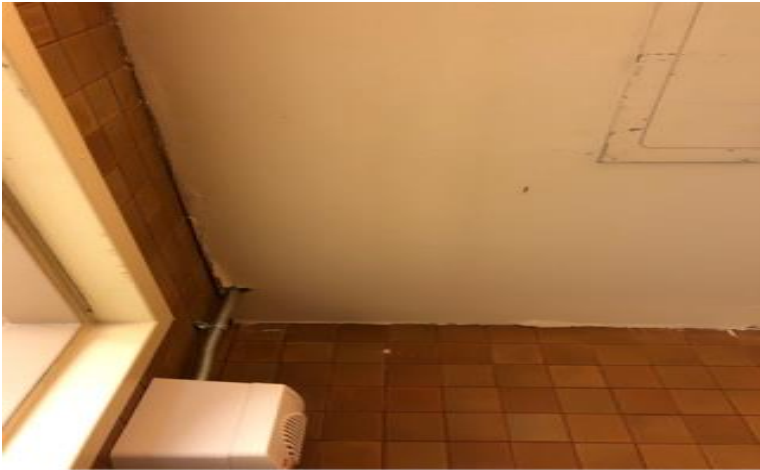
Photo 7: View of asbestos-containing drywall joint compound observed to be in poor condition in Room 047.

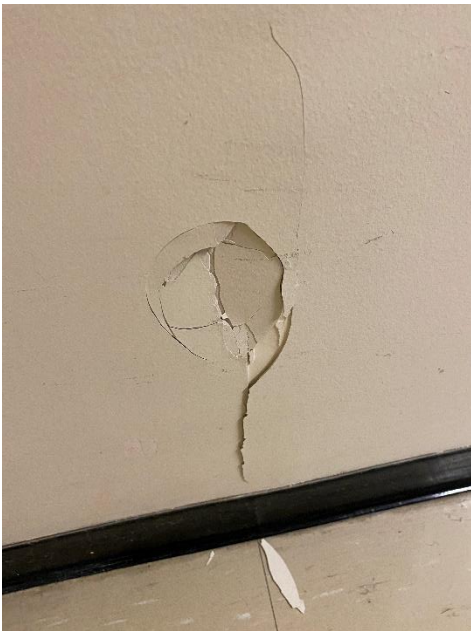
Photo 8: View of asbestos-containing drywall joint compound observed to be in poor condition in Room 115B.

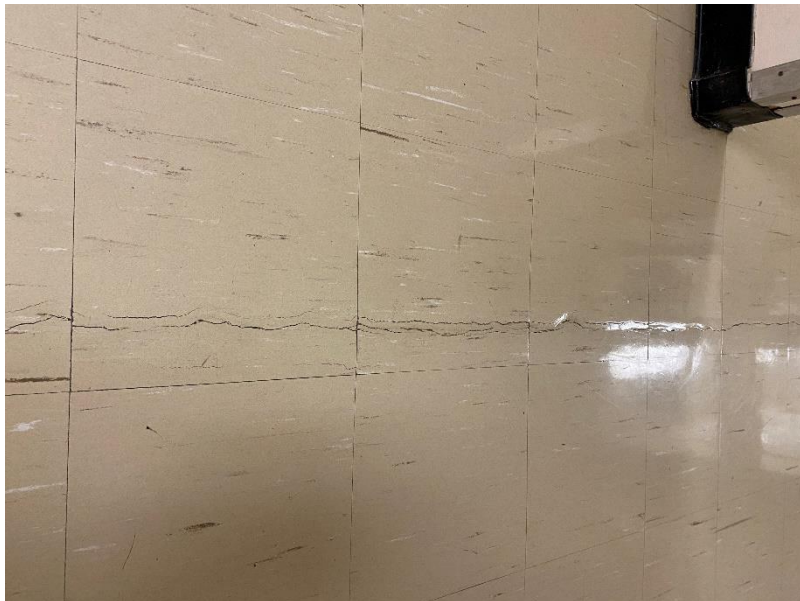
Photo 9: View of asbestos-containing vinyl floor tiles observed to be in fair condition in Room 122.

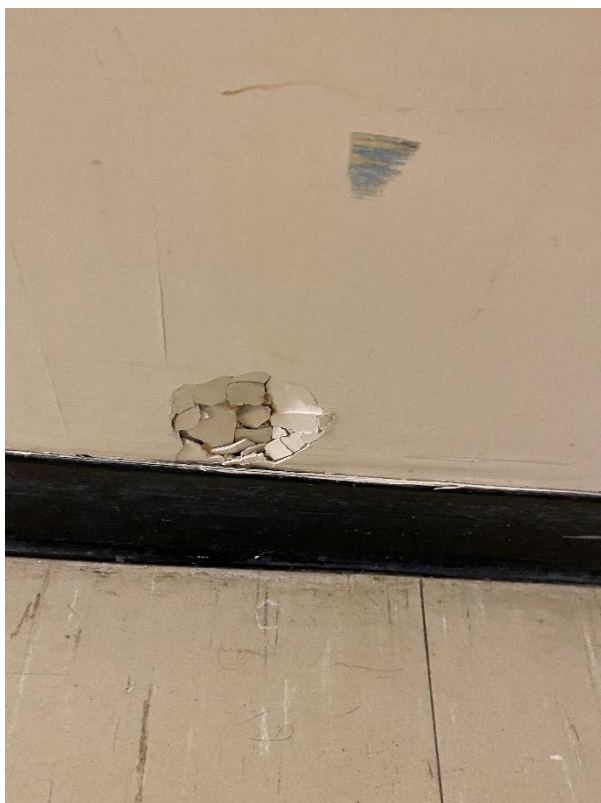
Photo 10: View of asbestos-containing drywall joint compound observed to be in poor condition in Room 131.

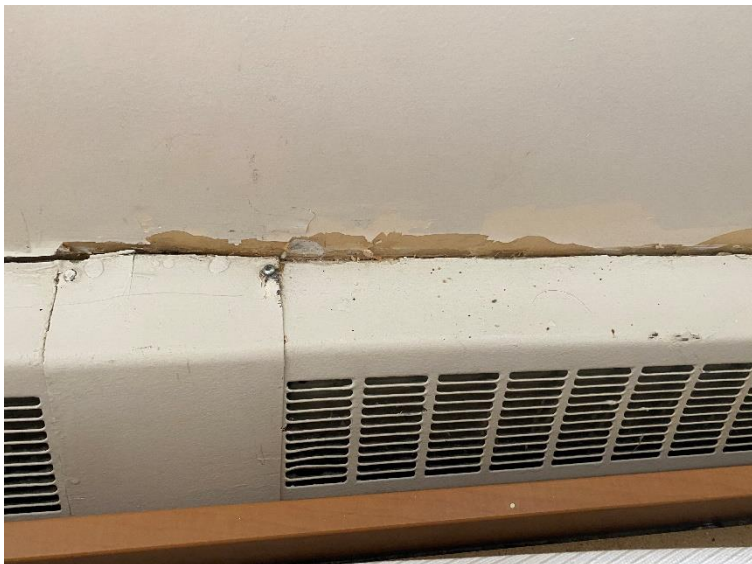
Photo 11: View of asbestos-containing drywall joint compound observed to be in poor condition in Room 315.

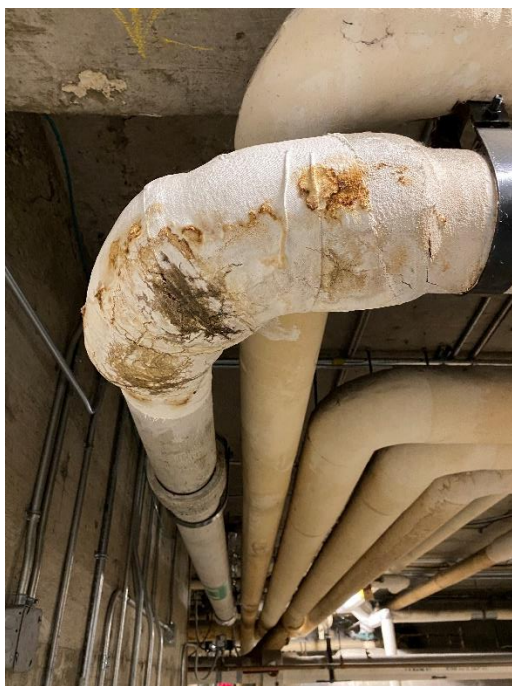
Transite rainwater leaders were observed throughout the subject building. To avoid possible damage, no bulk samples of the transite piping were collected. However, this material is known to contain asbestos. This material is considered to be non-friable and was observed in good and poor condition in select locations during the 2022 Reassessment.

Photo 12: View of asbestos-containing transite pipe observed to be in fair condition in Room PM3.

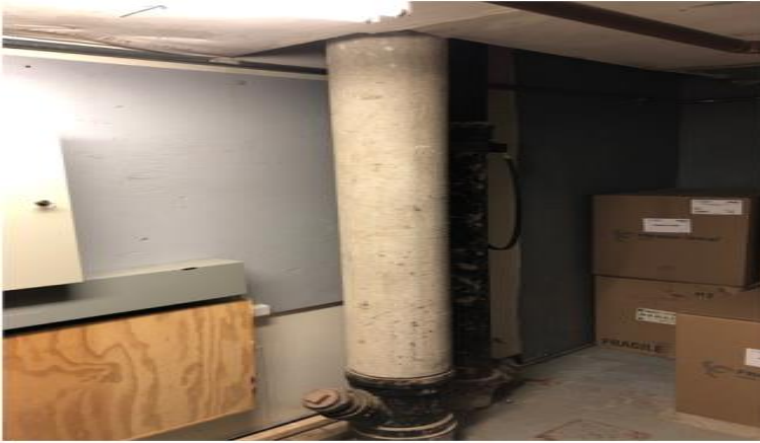
Photo 13: View of asbestos-containing transite pipe observed in Room 045.

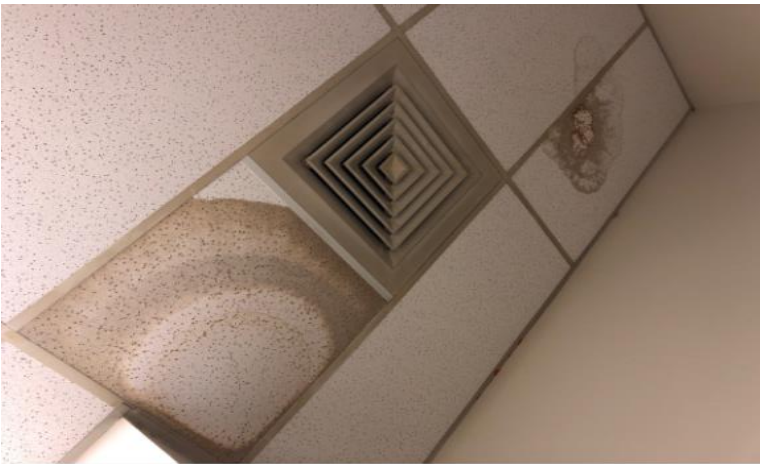
Photo 14: View of water damaged ceiling tiles observed in Room 09.

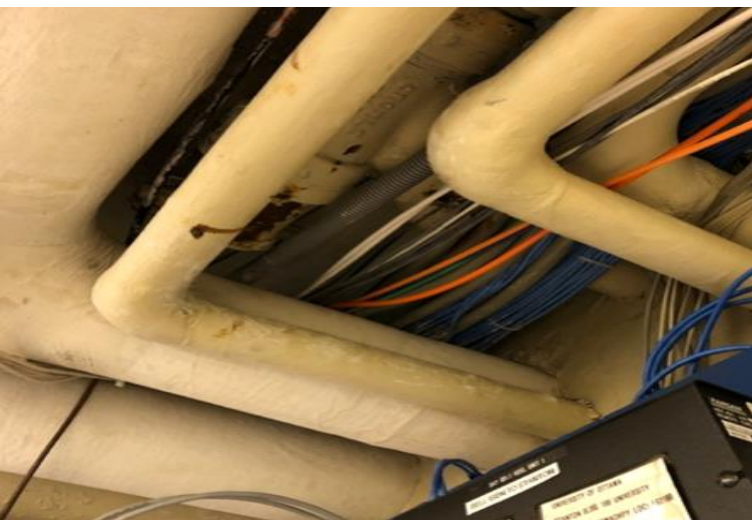
Previously identified mechanical pipe elbows/fittings insulation was observed throughout the subject building. The laboratory analytical results indicate that this material contains 40-65% Chrysotile asbestos. This material is considered to be friable and was observed in good and fair condition.

Photo 15: Typical view of asbestos-containing pipe fitting insulation observed throughout the subject building.

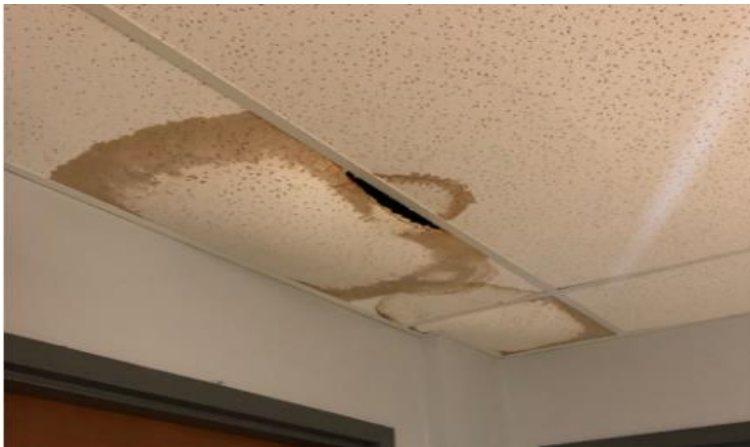
Photo 16: View of water damaged ceiling tiles observed in Room 104.

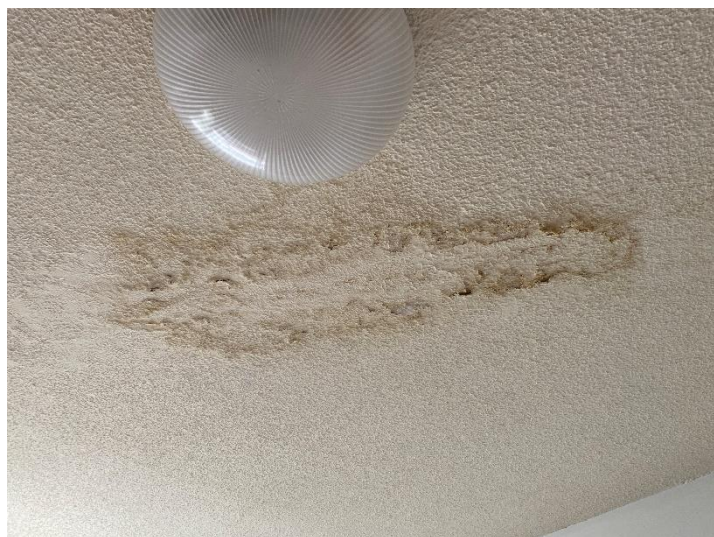
Photo 17: View of water damaged texture finish on ceiling observed to be in fair condition in Room 1222.

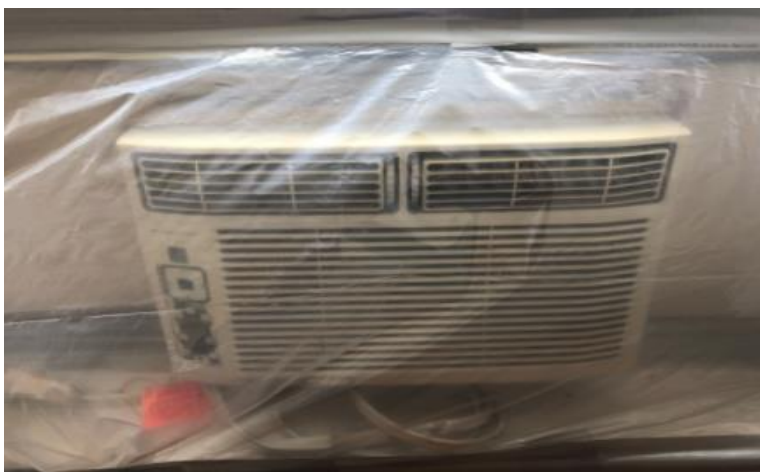
Photo 18: View of ODS containing air-conditioning unit in Room 126E.
