HAZARDOUS MATERIALS SURVEY AND 2022 REASSESSMENT TUNNEL SYSTEM, OTTAWA, ON

Project No.: Z2021101HZ / CCC-230252-00

University of Ottawa

McIntosh Perry Limited (MPL)

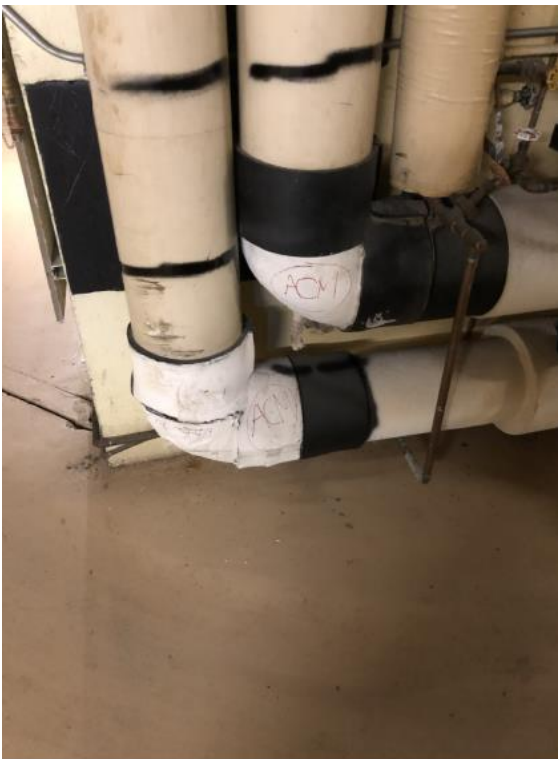
Mechanical pipe elbow/fitting insulation was observed throughout the surveyed area. The laboratory analytical results of mechanical piping insulation samples collected indicate that this material contains 60% Chrysotile asbestos. This material is considered to be friable and was observed in good, fair and, in select areas, poor condition.

Photo 2: View of asbestos-containing mechanical pipe elbow insulation observed in Tunnel 6-4.

- Materials identified to contain asbestos that are in good condition and do not pose a risk to workers or occupants can be managed in place. Prior to renovation/demolition activities that may disturb the ACMs, these materials must be removed following appropriate Type 1/2/3 asbestos abatement work procedures as detailed in O. Reg. 278/05 and disposed of as asbestos waste under O. Reg. 347;

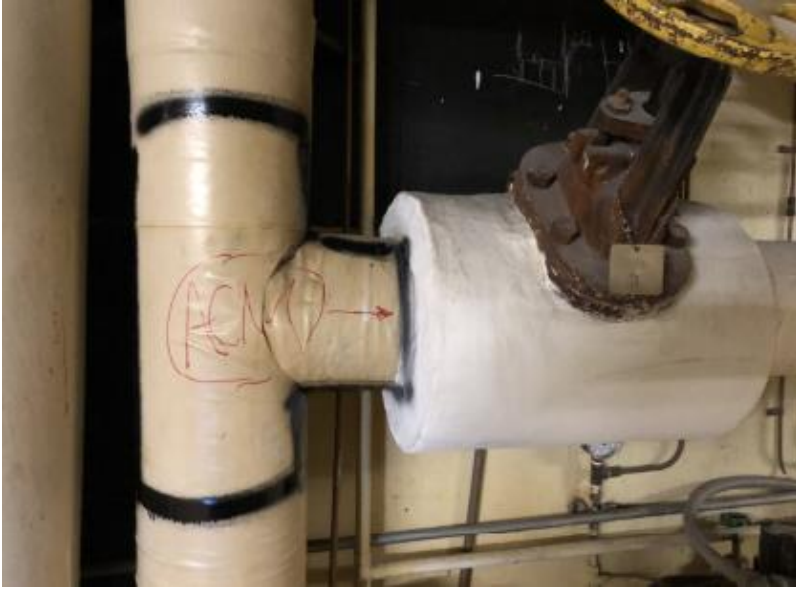
Photo 3: View of asbestos-containing mechanical fitting insulation observed in Tunnel 6-5.

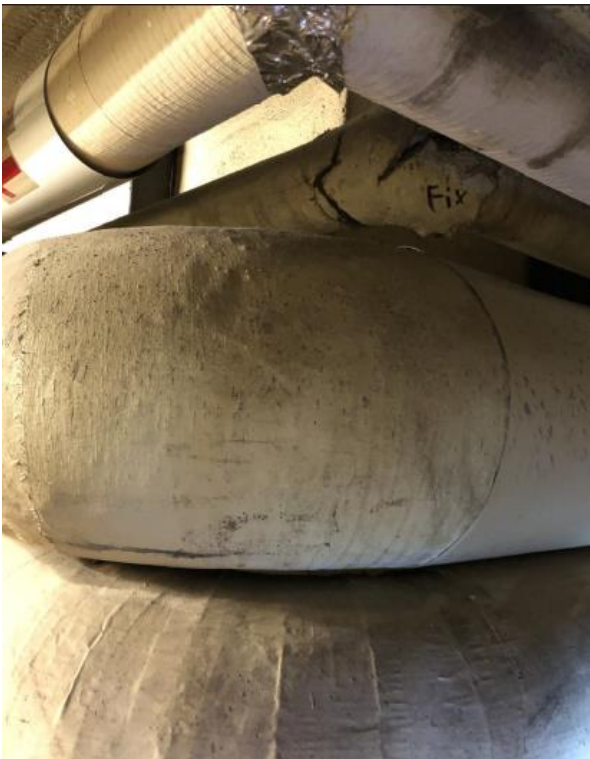
Photo 4: View of asbestos-containing mechanical pipe elbow insulation in Tunnel 3-2, observed to be in poor condition.

- Asbestos-containing materials identified to be in poor condition must be repaired/removed immediately, following Type 2 asbestos abatement work procedures as detailed in O. Reg. 278/05 and disposed of as asbestos waste under O. Reg. 347;

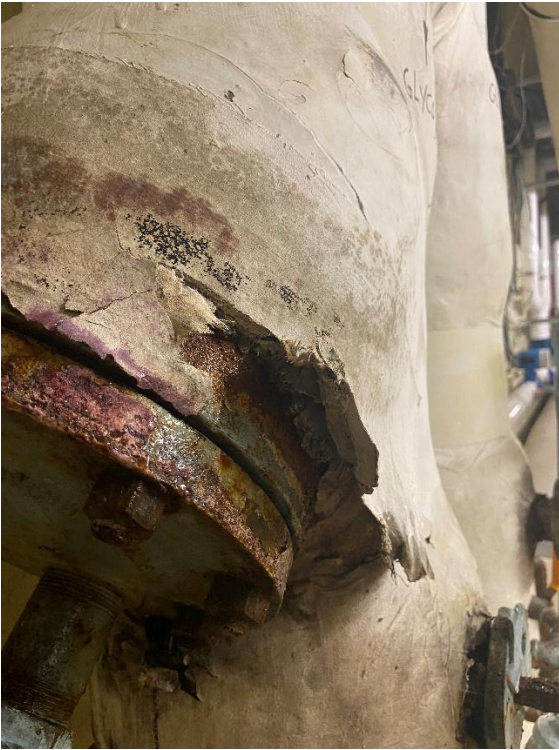
Photo 5: View of asbestos-containing mechanical pipe insulation in Tunnels 2-7, observed to be in poor condition.

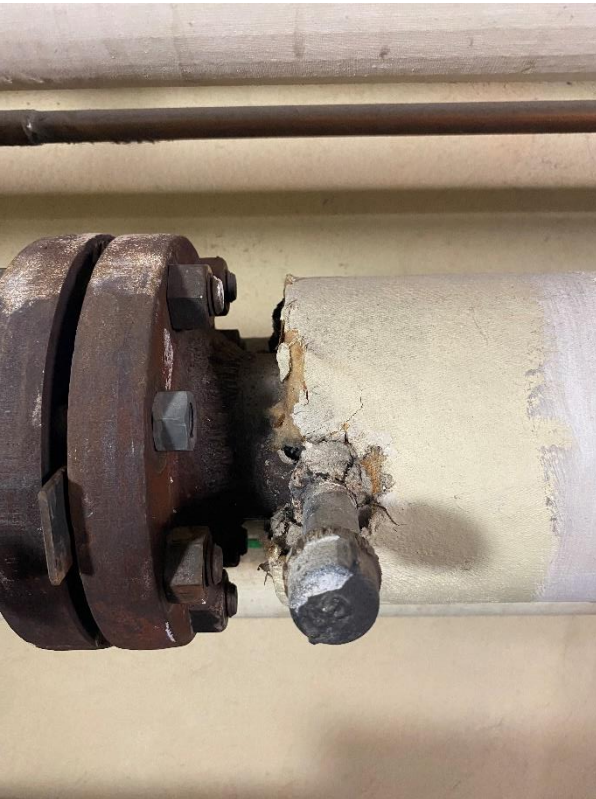
Photo 6: View of asbestos-containing mechanical pipe insulation in Tunnels 9-3, observed to be in poor condition.

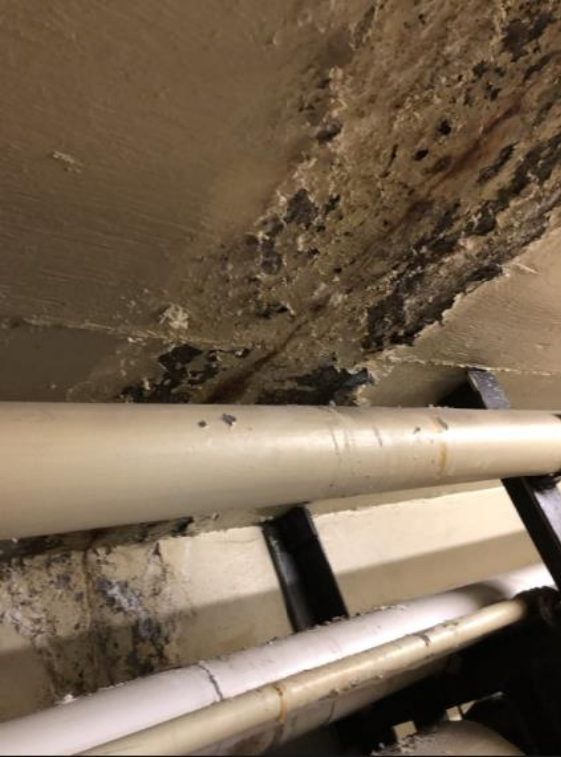
A visual survey of the surveyed area was conducted to determine if any water damaged was present. MPL identified select areas throughout the surveyed area, where materials were affected by water damage.

Photo 7: View of water damage observed on the ceiling in Tunnel 3-2.

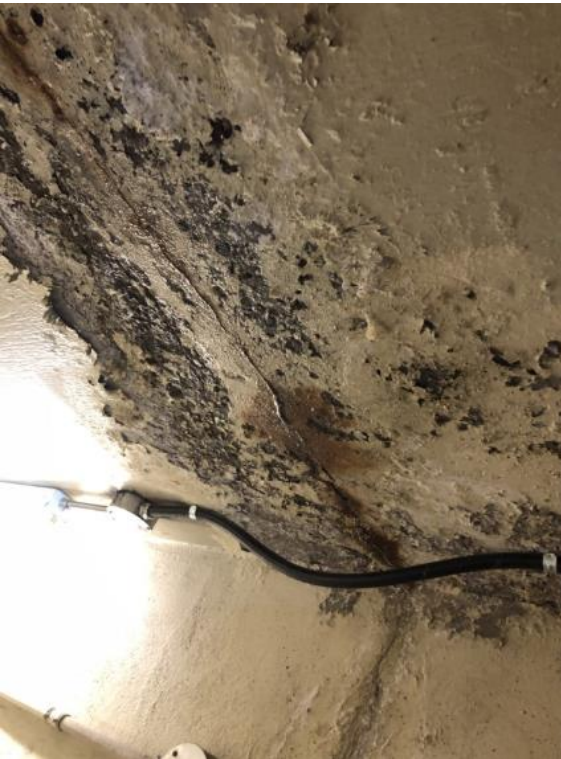
Photo 8: View of water damage observed on the ceiling in Tunnel 3-2.

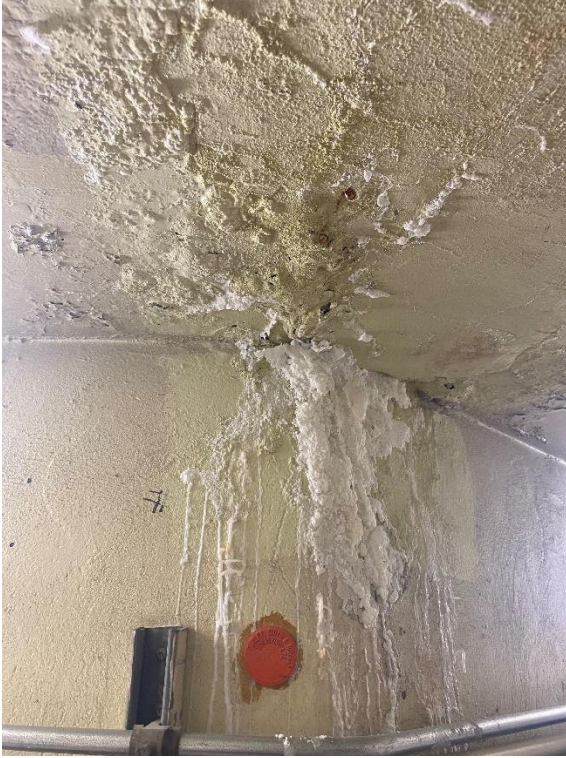
Photo 9: View of water damage observed on the ceiling in the Tunnels during 2022 Reassessment.

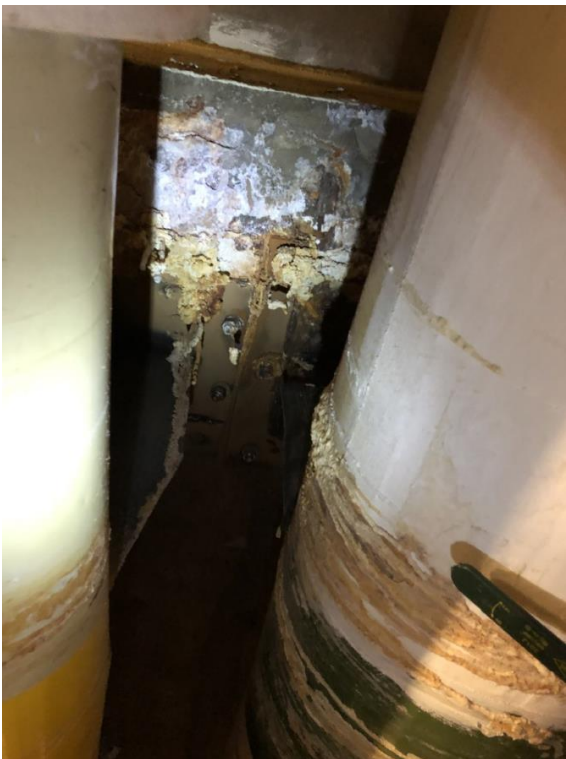
Photo 10: View of water damage observed on the ceiling in Tunnel 10-2.

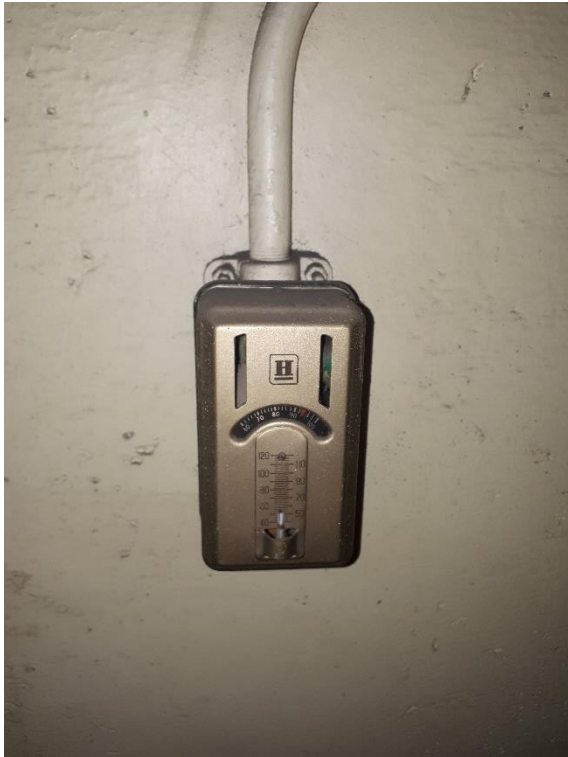
MPL observed thermostats suspected of containing liquid mercury throughout the surveyed area.

Photo 11: View of mercury containing thermostats observed throughout the tunnel system.

Please refer to Appendix F – Hazardous Materials Checklist for equipment conditions, quantities (where applicable), and recommended actions.
