HAZARDOUS MATERIALS SURVEY AND 2022 REASSESSMENT VANIER HALL, OTTAWA, ON

Project No.: Z1920014HZ / CCC-230252-00

University of Ottawa

McIntosh Perry Limited (MPL)

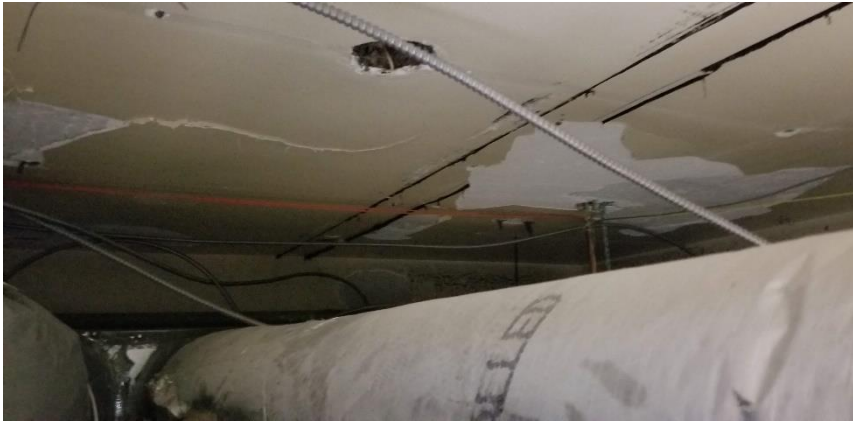
- Tar (Black) was sampled and observed on the ceiling in Room 1021. The laboratory analytical results indicate that this material contains 2% Chrysotile asbestos. This material is considered non-friable and was observed to be in fair condition.
- Tar paper debris was sampled and observed from Room 7028. The laboratory analytical results indicate that this material contains <0.5% Chrysotile asbestos. Under O. Reg.278/05 this material is less than the stated regulatory limit and is considered to be non-asbestos containing.
- Tar adhesive (Black) was observed and previously sampled in Rooms 0141B and 0141E. The laboratory analytical results indicate that this material does not contain asbestos.

Photo 1: View of asbestos-containing tar (Black) observed to be in fair condition on the plaster ceiling in Room 1021.

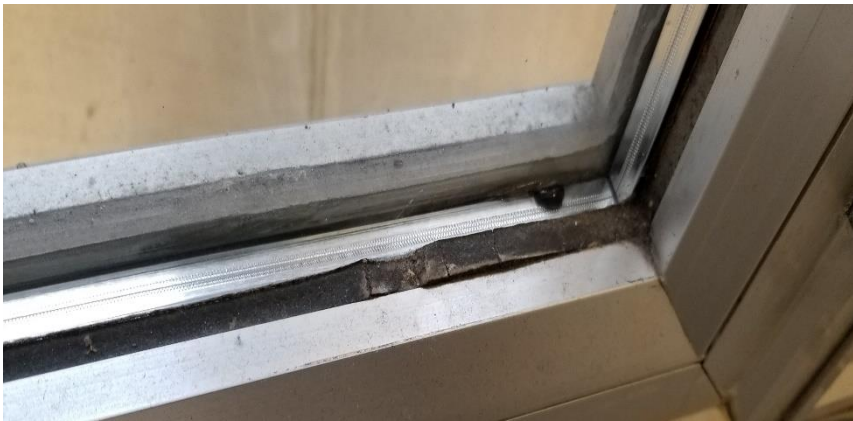
Window caulking (Black) was observed and sampled from Room 1070 and all stairwells throughout the subject building. The laboratory analytical results indicate that this material contains 1% Chrysotile asbestos. This material is considered to be non-friable and was observed in good condition.

Photo 2: View of asbestos-containing window caulking observed to be in good condition in Room 1070 and other stairwells throughout the subject building.

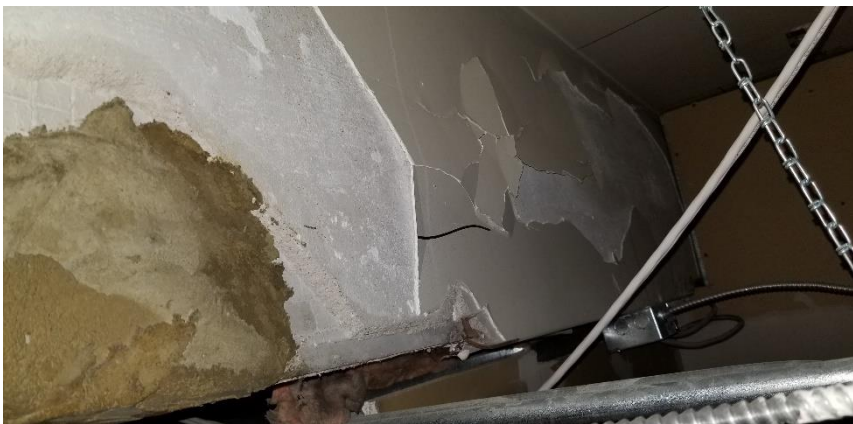
Ceiling and wall plaster were observed and sampled from Room 1026, 5040, 5076, and 5082. The laboratory analytical results for the samples collected indicate that this material contains 0.5% Chrysotile. Since plaster is a homogeneous material, all areas must be treated as asbestos-containing unless additional testing confirms otherwise. This material is considered friable and observed to be in good condition with the exception of select areas that were observed to be in fair and poor condition during the 2022 Reassessment.

Photo 3: View of asbestos-containing wall plaster observed to be in poor condition in Room 5082.

- Asbestos-containing materials identified to be in poor condition must be repaired/removed immediately, following Type 1/2/3 asbestos abatement work procedures as detailed in O. Reg. 278/05 and disposed of as asbestos waste under O. Reg. 347;
- Asbestos-containing materials that have been identified to be in fair condition should be either repaired (where possible) and/or closely monitored for signs of further deterioration. Depending on

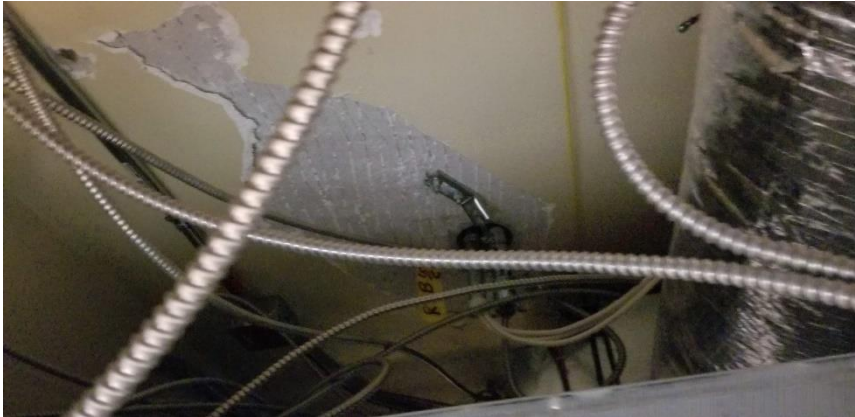
Photo 4: View of asbestos-containing ceiling plaster observed to be in poor condition above the suspended ceiling tiles in Room 1026.

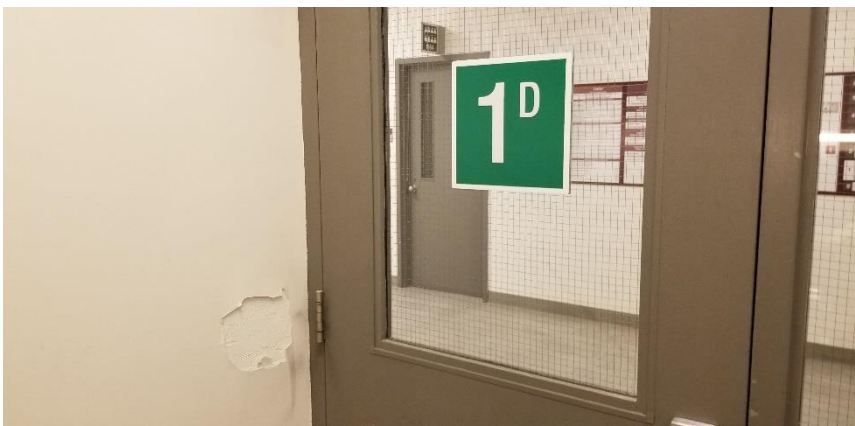
Photo 5: View of asbestos-containing wall plaster observed to be in poor condition in Room 1070.

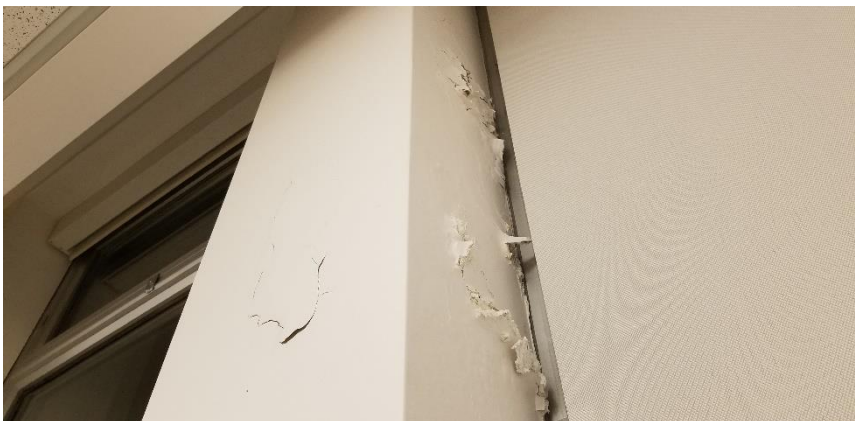
Photo 6: View of asbestos-containing wall plaster observed to be in poor condition Room 1076.

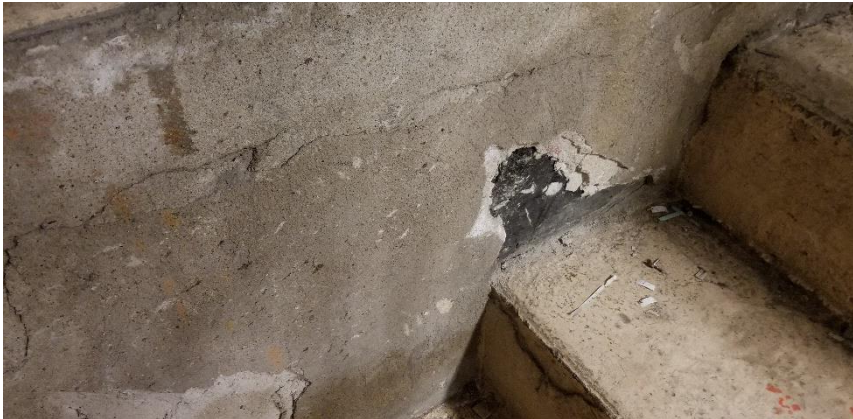
Photo 7: View of asbestos-containing wall plaster observed to be in poor condition in Room 0189.

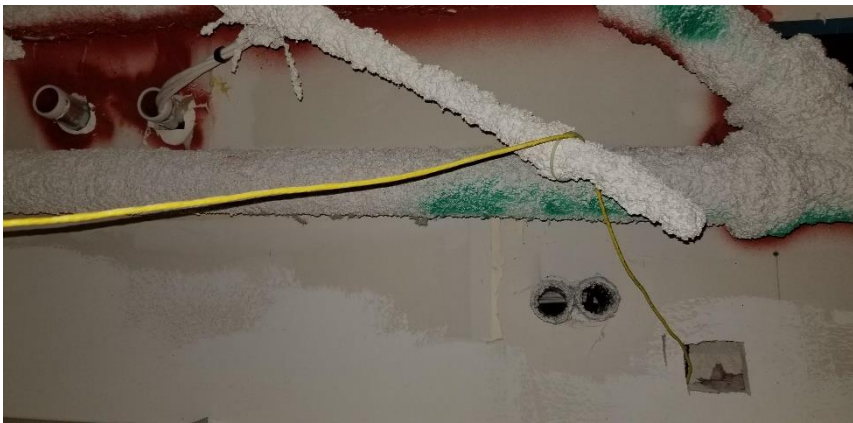
Transite rainwater leaders are suspected to be present in Room 5068 and 5069. The condition of the material could not be visually assessed in these areas due to the presence of fireproofing insulation covering the transite. To avoid possible damage, no bulk samples of the transite piping were collected. However, this material is known to contain asbestos. This material is considered to be non-friable and was observed in good condition.

Photo 8: View of suspect transite pipe observed to be in good condition in Room 5068.

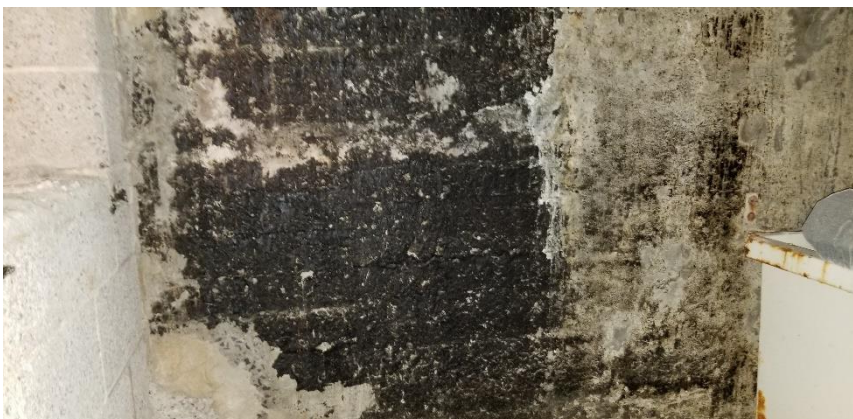
Wall mastic (Black) observed and sampled on the walls of Room 0140. The laboratory analytical results for the samples collected indicate that this material does not contain asbestos.

Photo 9: View of non-asbestos containing wall mastic (Black) observed in Room 0140.

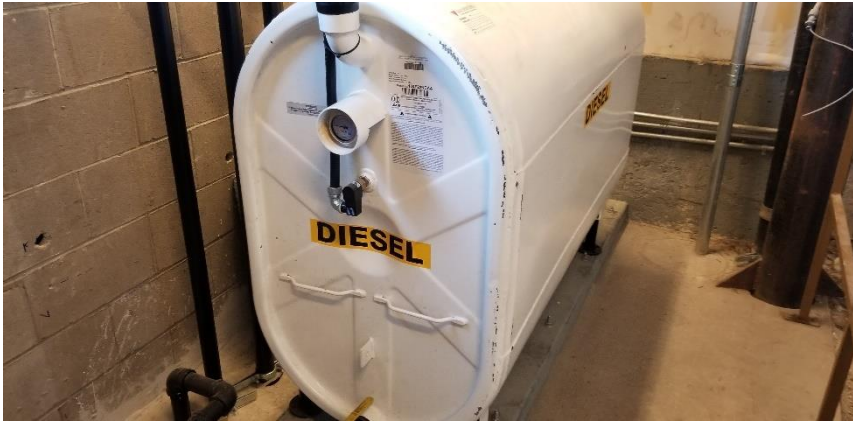
A visual survey of the subject building was conducted to determine if any USTs and ASTs were present. MPL observed one (1) diesel Storage Tanks located in Rooms 0140 and 7028A.

Photo 10: View above ground storage tank observed to be in good condition in Room 7028A.

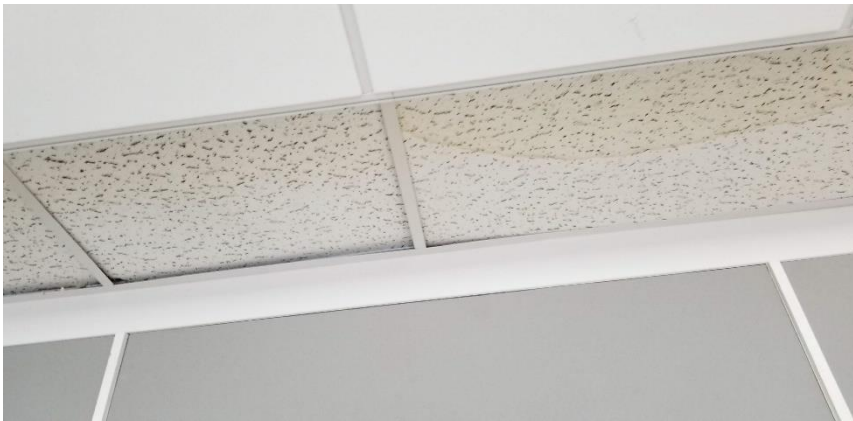
Photo 11: View of water-staining observed on suspended ceiling tiles in Room 5069A.

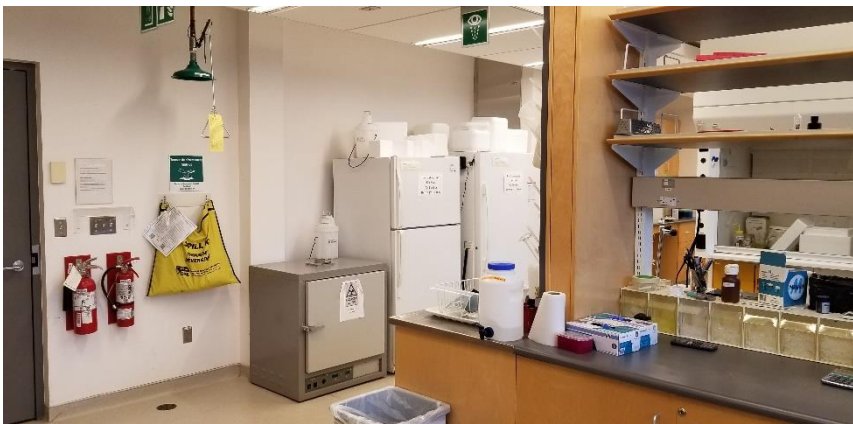
Photo 12: View of storage unit containing radioactive materials observed to be in good condition in Room 2041.

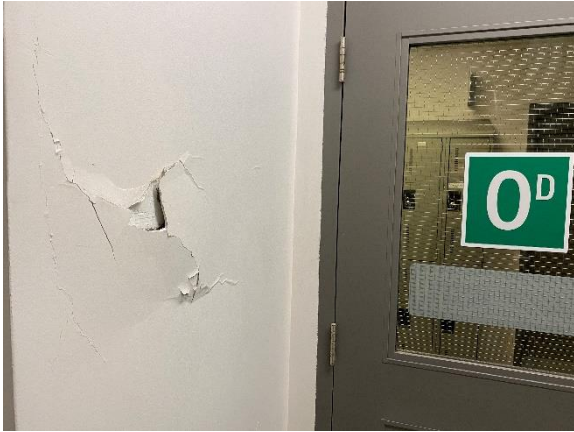
Photo 13: View of asbestos-containing plaster wall observed to be in poor condition in Room 0170 during the 2022 Reassessment.

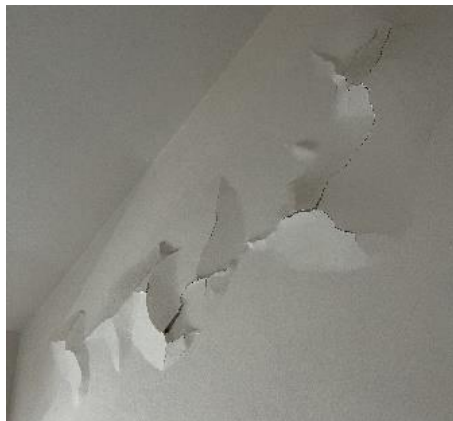
Photo 14: View of asbestos-containing plaster wall observed to be in poor condition in Stairwell 1E during the 2022 Reassessment.

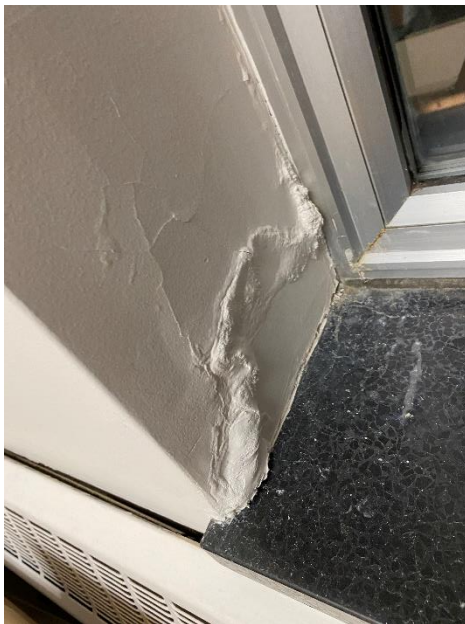
Photo 15: View of asbestos-containing plaster wall observed to be in poor condition in Room 3065 during the 2022 Reassessment.

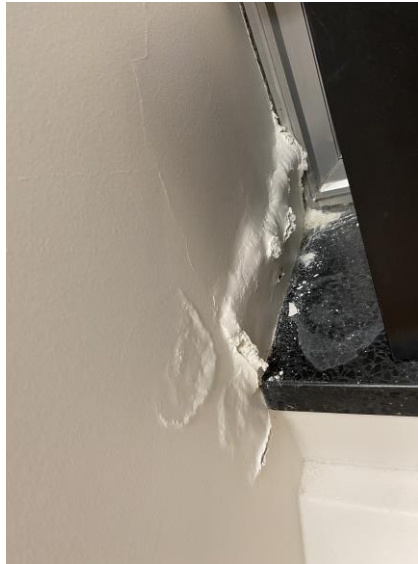
Photo 16: View of the water damaged asbestos-containing plaster wall observed to be in poor condition in Room 3079 during the 2022 Reassessment.

Water stained/damaged wall and ceiling plaster that is also determined to contain asbestos must be replaced following appropriate asbestos abatement procedures as outlined in O.Reg. 278/05.
