HAZARDOUS MATERIALS SURVEY AND 2023 REASSESSMENT 15-17 COPERNICUS STREET, OTTAWA, ON

Project No.: Z2021101HZ/ CCC-230252-00

University of Ottawa

McIntosh Perry Limited (MPL)

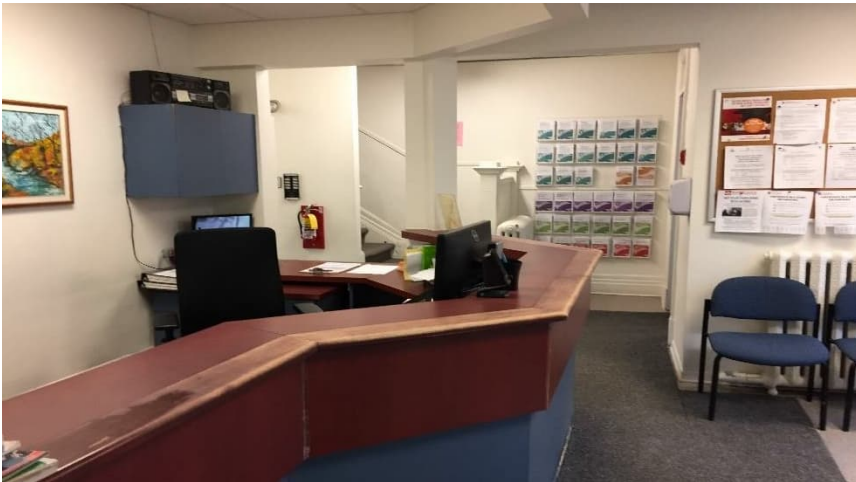
Photo 1: Representative view of the finishes observed throughout the subject building.

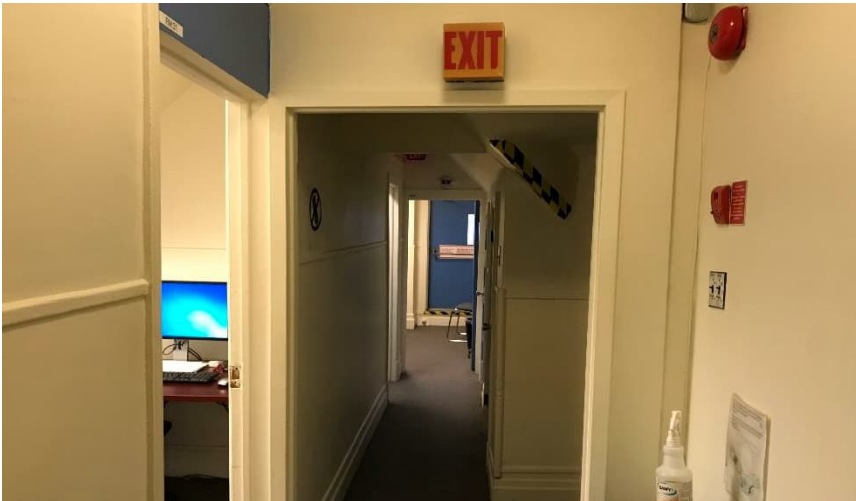
Photo 2: Representative view of the finishes observed throughout the subject building.

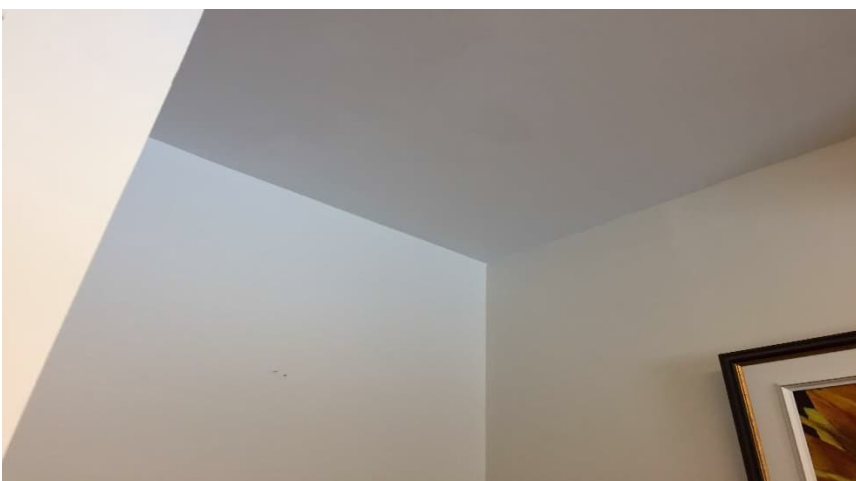
Wall and ceiling plaster was observed and sampled throughout the subject building. The laboratory analytical results indicate that this material **contains 4% Chrysotile asbestos**. Since plaster is a homogeneous material, all areas must be treated as asbestos-containing unless additional bulk sampling and analysis until proven otherwise. This material was observed to be in good condition.

Photo 3: Representative view of asbestos-containing plaster observed throughout the subject building.

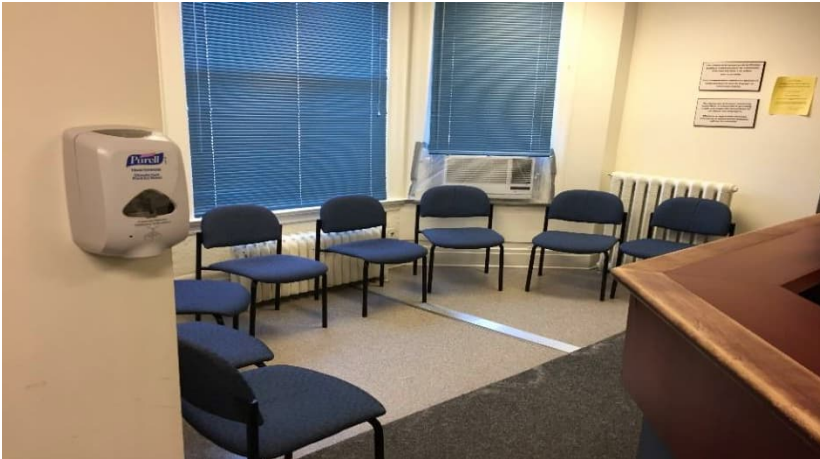
Drywall joint compounds were observed and sampled throughout the subject building. The laboratory analytical results indicate that this material **contains 2% Chrysotile asbestos**. Since drywall joint compound is a homogeneous material, all areas must be treated as asbestos-containing unless additional bulk sampling and analysis until proven otherwise. This material was observed to be in good and poor condition.

Photo 4: Representative view of asbestos-containing drywall joint compound observed throughout the subject building.

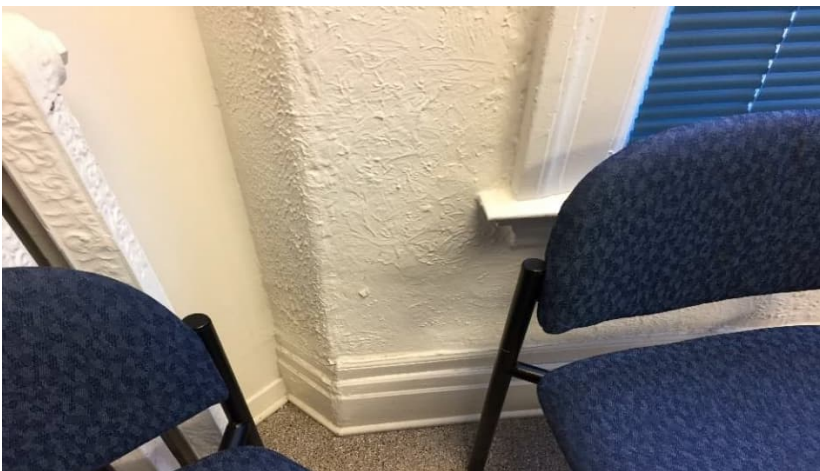
Wall texture coat was observed and sampled in Room 18. The laboratory analytical results indicate that this material does not contain asbestos.

Photo 5: View of the non-asbestos-containing texture coat observed on the walls in Room 18.

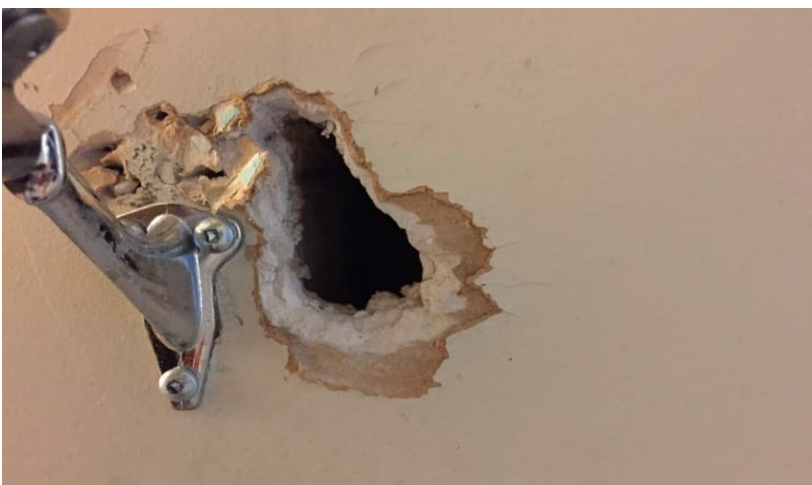
Photo 6: View of damaged asbestos-containing drywall joint compound observed in Room K.

- ACMs identified to be in poor condition must be repaired/removed immediately, following Type 1/2/3 asbestos abatement work procedures as detailed in O. Reg. 278/05 and disposed of as asbestos waste under O. Reg. 347;

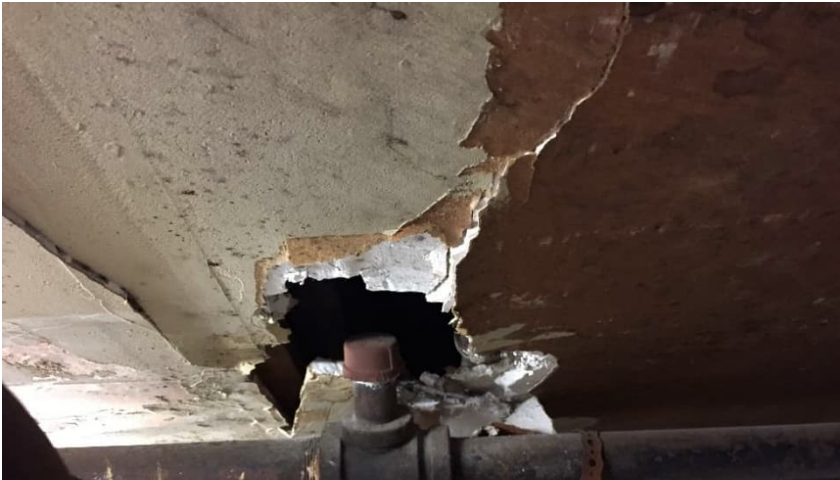
Photo 7: View of damaged asbestos-containing drywall joint compound observed on the basement ceiling.

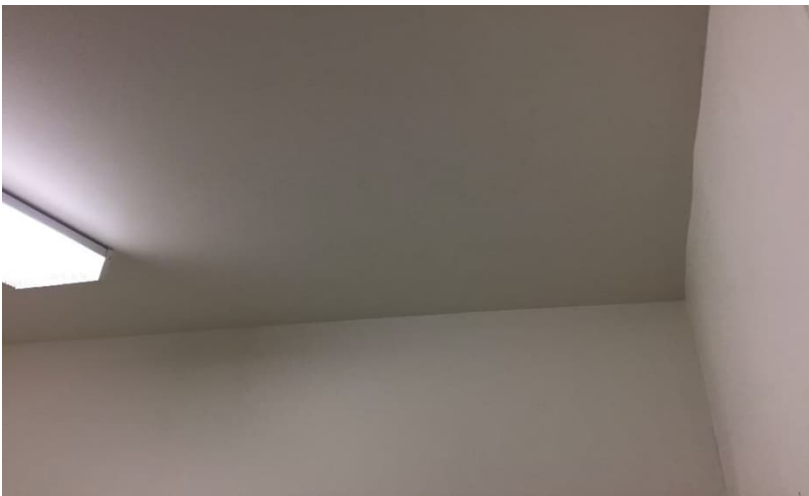
Photo 8: View of lead wall and ceiling paint (White) observed to be in good condition in Room 17.

Paints identified to contain lead that are in good condition and do not pose a risk to workers or occupants can be managed in place.

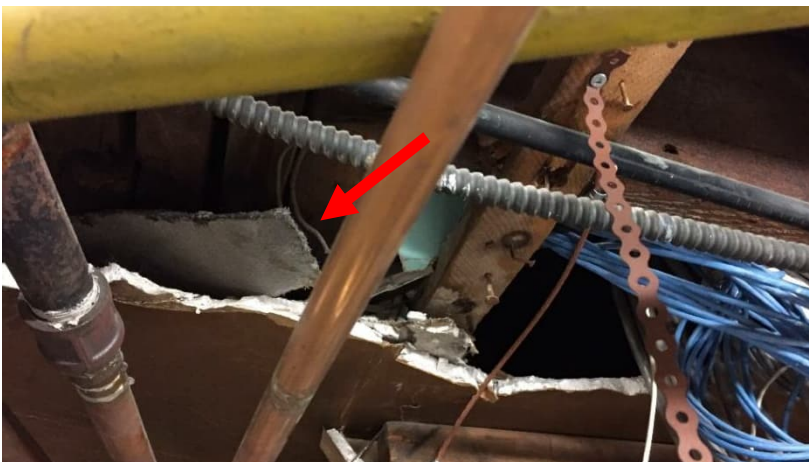
Paper insulation (Grey) was observed and sampled in Room B. The laboratory analytical results indicate that this material **contains 55% Chrysotile asbestos**. This material is considered to be friable and was observed to be in poor condition.

Photo 9: View of the asbestos-containing paper insulation (Grey) observed in poor condition in Room B.

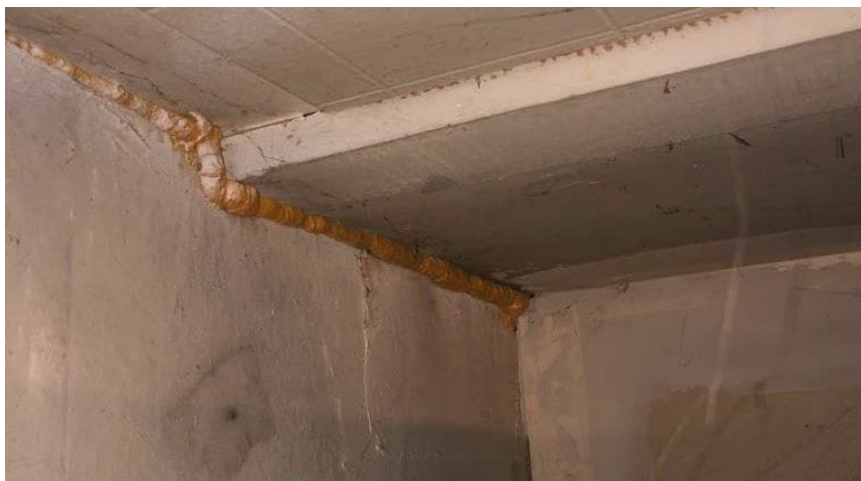
Spray foam insulation (Yellow) was observed and sampled in Room H. The laboratory analytical results indicate that this material does not contain asbestos. However, fibrous material was present in the sample collected. This material was found to **contain between 80-90% Chrysotile asbestos**. As such, the spray foam insulation in this room shall be considered a friable asbestos-containing material and in good condition. Prior to renovation/demolition, additional sampling should be completed to confirm the presence of asbestos and to delineate the locations of this material.

Photo 10: View of the spray foam insulation (Yellow) in which an asbestos-containing fibrous material was identified in Room H.
