HAZARDOUS MATERIALS SURVEY AND 2023 REASSESSMENT 34-36 STEWART STREET, OTTAWA, ON

Project No.: 0Z2021101HZ / CCC-230252-00

University of Ottawa

McIntosh Perry Limited (MPL)

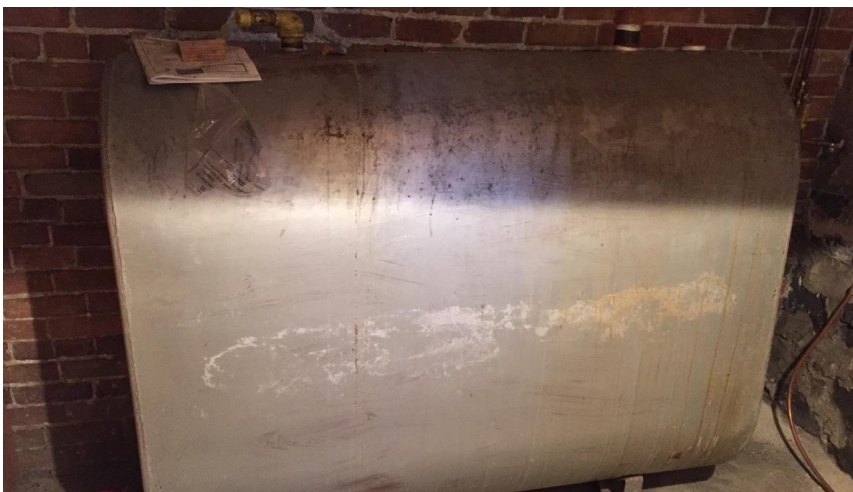
A visual survey of the subject building was conducted to determine if any USTs and ASTs were present. MPL observed a Diesel Storage Tank in Room B1.

Photo 5: View of the above ground diesel storage tank observed in Room B1.

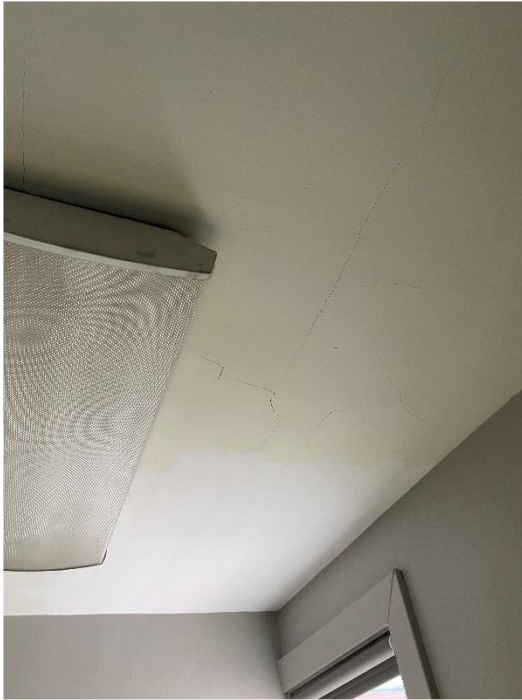
Photo 9: View of asbestos-containing drywall joint compound (ceiling) observed to be in fair condition in Room 203 during the 2022 Reassessment.

- Materials identified to contain asbestos that are in good condition and do not pose a risk to workers or occupants can be managed in place. Prior to renovation/demolition activities that may disturb the ACMs, these materials must be removed following appropriate Type 1/2/3 asbestos abatement work procedures as detailed in O. Reg. 278/05 and disposed of as asbestos waste under O. Reg. 347;
