HAZARDOUS MATERIALS SURVEY AND 2023 REASSESSMENT 38 STEWART STREET, OTTAWA, ON

Project No.: Z2021101HZ / CCC-230252-00

University of Ottawa

McIntosh Perry Limited (MPL)

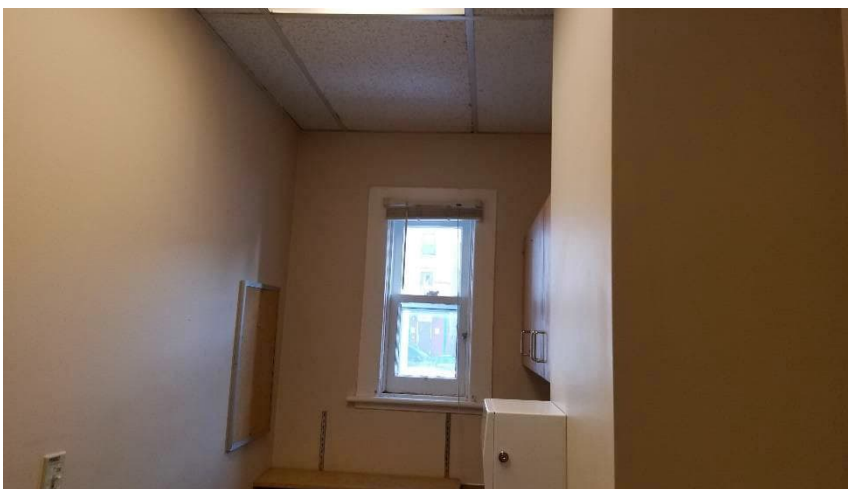
Photo 3: Typical view of finishes on the ground floor including asbestos-containing plaster.

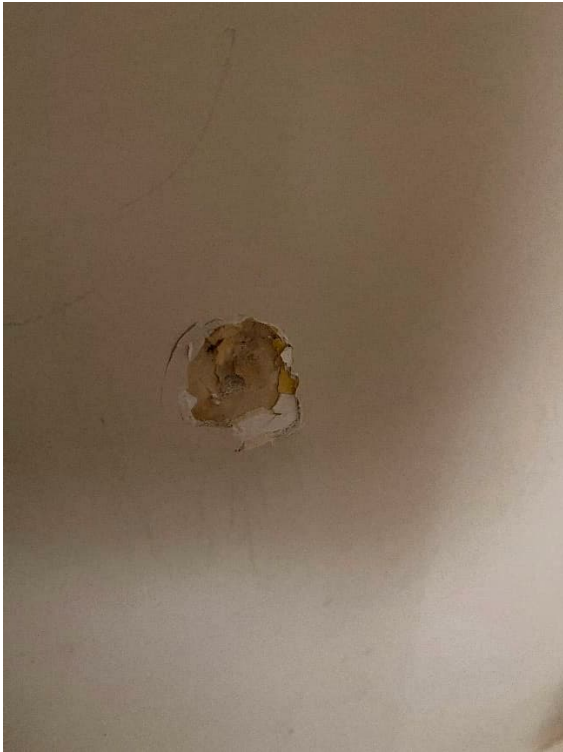
Ceiling/Wall plaster was observed throughout the subject building. The laboratory analytical results of ceiling/wall plaster samples collected from the skim coat on the walls and ceilings of Room 204 (orange paint) indicate that this material **contains 2% Chrysotile asbestos**. Since plaster is a homogeneous material, all areas must be treated as asbestos-containing unless additional testing confirms otherwise. **This material is considered to be friable and was observed in good condition, except for select areas observed to be in fair condition during the 2022 Reassessment.**

Photo 4: View of asbestos-containing plaster wall observed to be in fair condition in Room 100A.

- ACMs identified as in fair condition should be either repaired (where possible) and/or closely monitored for signs of further deterioration. Depending on the type of material and location, these materials should be scheduled for removal if there is a potential risk of exposure to workers and/or occupants;

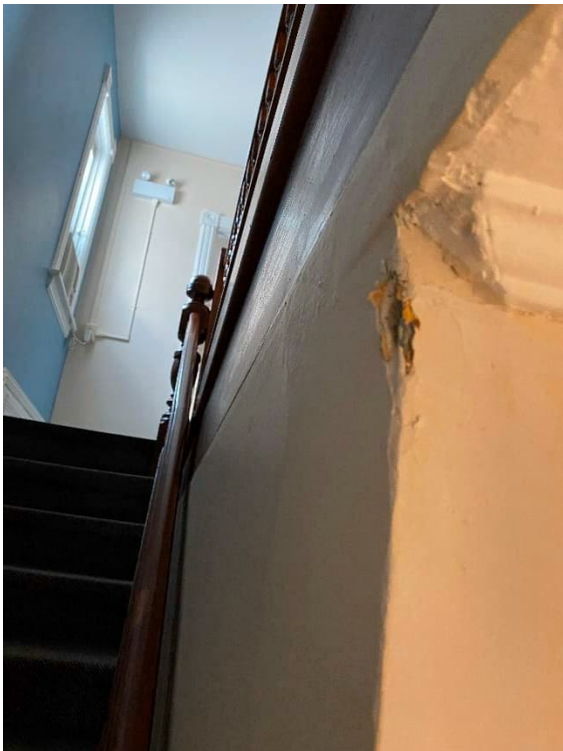
Photo 5: View of asbestos-containing plaster wall observed to be in fair condition in Room 106.

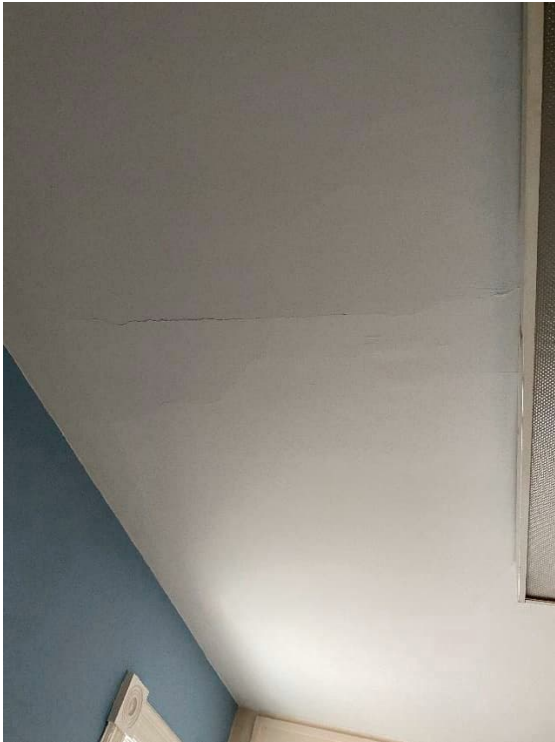
Photo 6: View of asbestos-containing plaster ceiling observed to be in fair condition in Room 201.

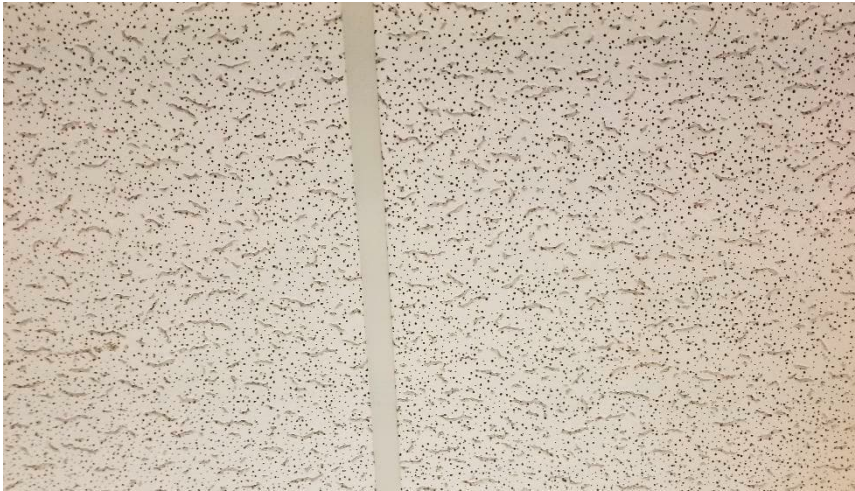
- Suspended ceiling tiles with small pinholes and large fissures were observed in Room 103. The laboratory analytical results of ceiling tile samples collected from Room 103 indicate that this material does not contain asbestos.
- Suspended ceiling tiles with pinholes of varying sizes were observed in Room 103A. The laboratory analytical results of ceiling tile samples collected from Room 103A indicate that this material does not contain asbestos.

Photo 8: Typical view of non-asbestos suspended ceiling tiles observed throughout the subject building.

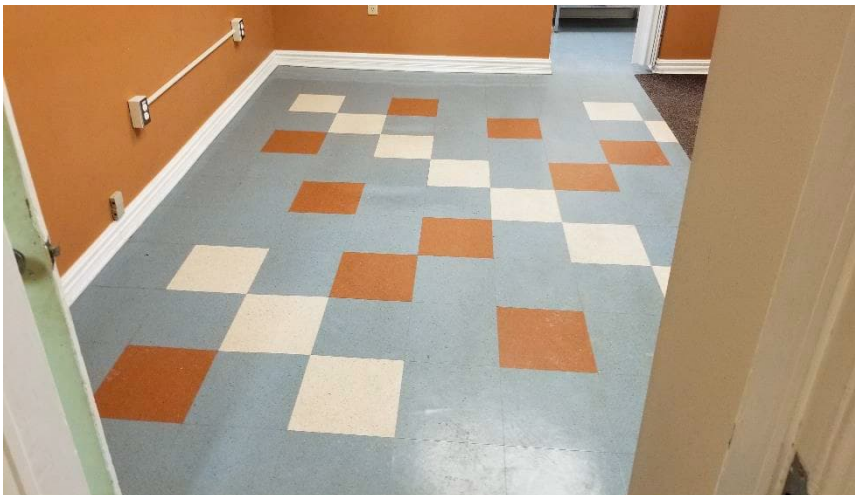
- Vinyl floor tiles (12" x 12", white with red and blue) were observed in Room 201. The laboratory analytical results of the vinyl floor tile samples collected from Room 201 indicate that this material does not contain asbestos.
- Vinyl floor tiles (12" x 12", blue with black) were observed in Room 201A. The laboratory analytical results of the vinyl floor tile samples collected from the LOCATION(S) indicate that this material does not contain asbestos.
- Vinyl floor tiles (12" x 12", red with black) were observed in Room 201. The laboratory analytical results of the vinyl floor tile samples collected from Room 201 indicate that this material does not contain asbestos.

Photo 9: Typical view of non-asbestos vinyl floor tiles (12"x12"- White w/ Red & Blue) observed throughout the subject building.

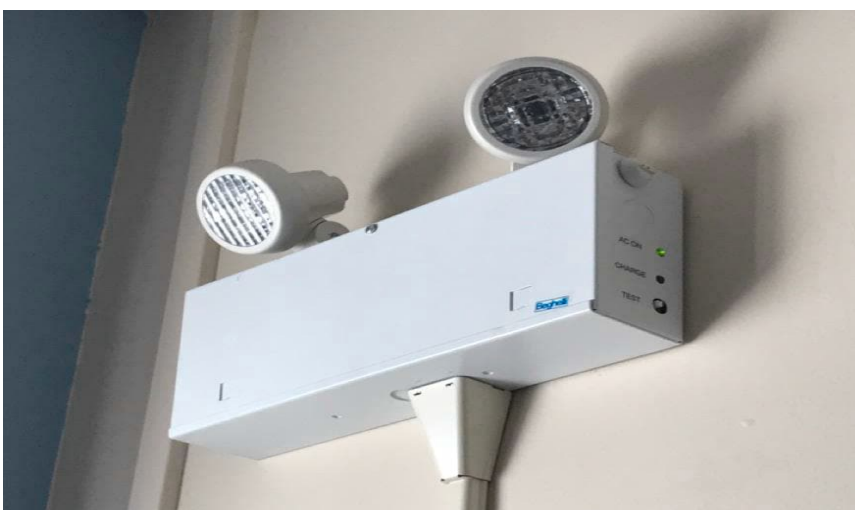
Lead-containing acid battery packs were identified throughout the subject building. These battery packs were observed on walls and above exits throughout the surveyed building.

Photo 10: View of lead-containing emergency battery pack observed in Room 206.

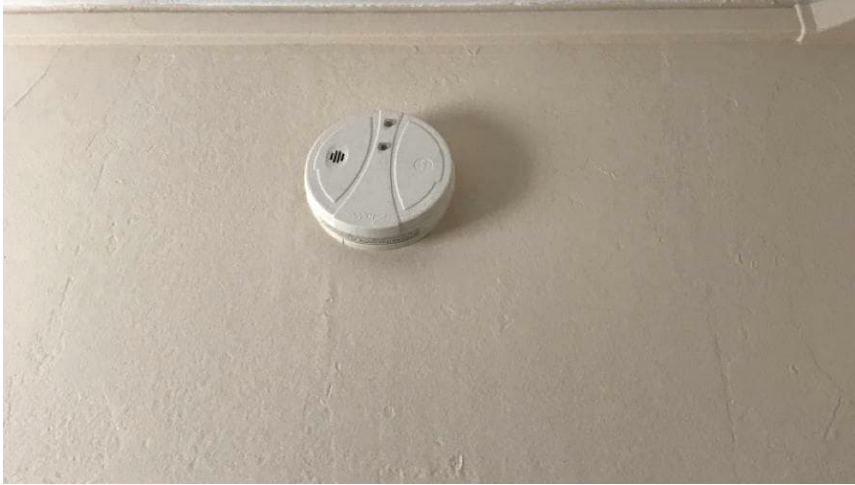
A visual assessment of the subject building was conducted to determine if any electrical components containing radioactive materials were present. A smoke detector was observed in Room 206, which contained small quantities of radioactive material.

Photo 11: View of radioactive-containing smoke detector observed in Room 206.

The radioactive sources in smoke alarms are sealed and contained within a metal case inside the smoke detector and must not be damaged or tampered with. These materials do not pose a hazard as long as they remain contained and properly disposed of at the time of removal or replacement.

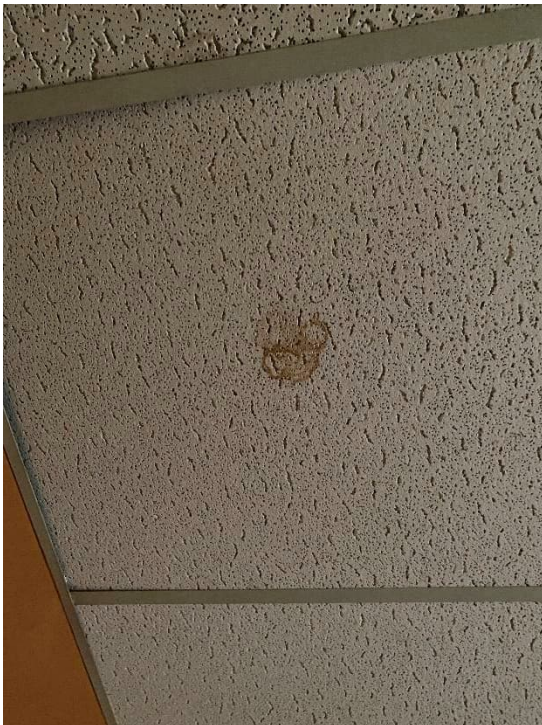
Photo 12: View of water damaged suspended ceiling tile observed in Room 103.

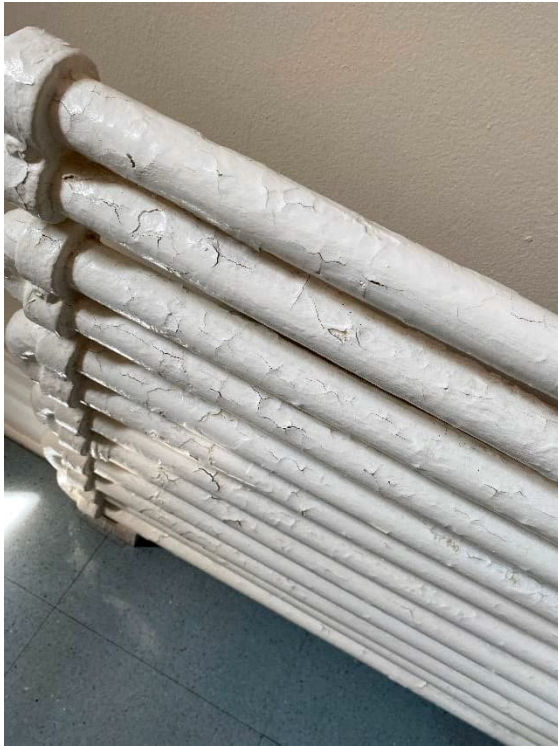
Photo 13: View of lead-containing paint determined to be in poor condition observed on the radiator in Room 205.

Paints identified to contain lead that is in poor condition must be immediately repaired and/or stabilized following a minimum Type 1/2 lead abatement procedures as per OMOL “Lead on Construction Project” dated April 2011.
