# HAZARDOUS MATERIALS SURVEY AND 2023 REASSESSMENT 40 STEWART STREET, OTTAWA, ON

Project No.: Z2021101HZ / CCC-230252-00

University of Ottawa

McIntosh Perry Limited (MPL)

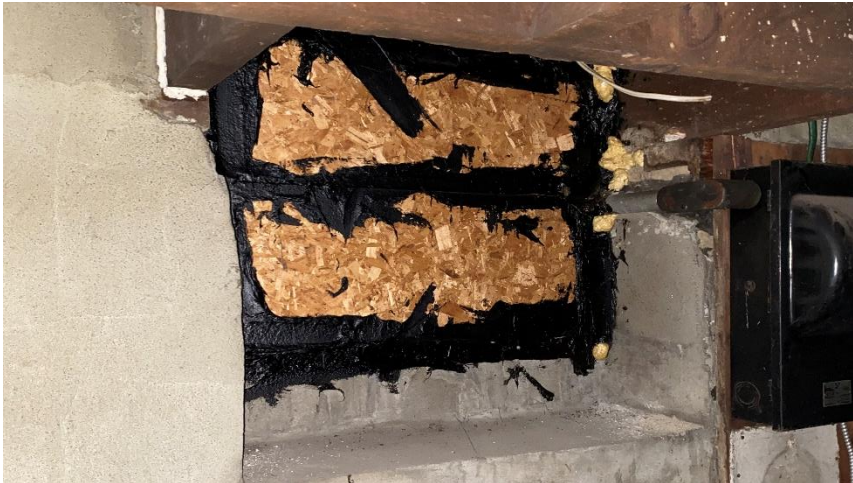
Mastic (black) was observed on plywood window coverings in the basement of the subject building (room B1). The laboratory analytical results of samples collected from the basement window indicate that this material **contains 10% Chrysotile asbestos**. This material is considered to be non-friable and was observed in fair condition.

**Photo 2:** View of asbestos-containing black mastic **containing 10% Chrysotile** on basement window plywood.

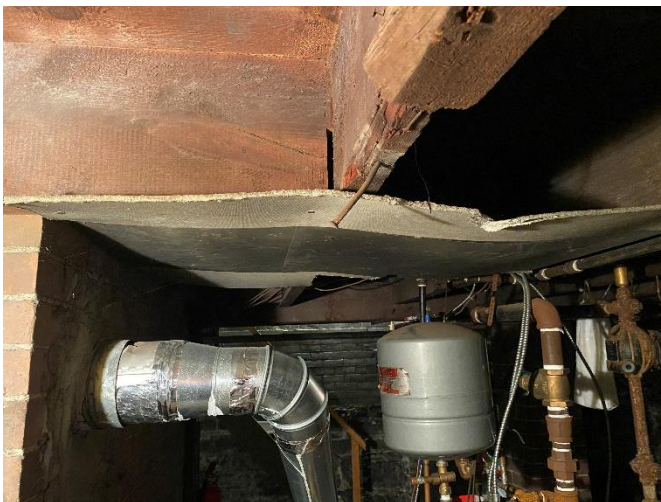
Duct Insulation Paper was observed throughout the subject building's Basement (Room 01)subject building. The laboratory analytical results of samples collected from the basement during the 2022 Reassessment indicate that this material **contains 10% Chrysotile asbestos. This material is considered to be friable and was observed to be in fair condition during the 2022 Reassessment.**

**Photo 3:** View of asbestos-containing duct insulation paper **containing 10% Chrysotile** in the basement.

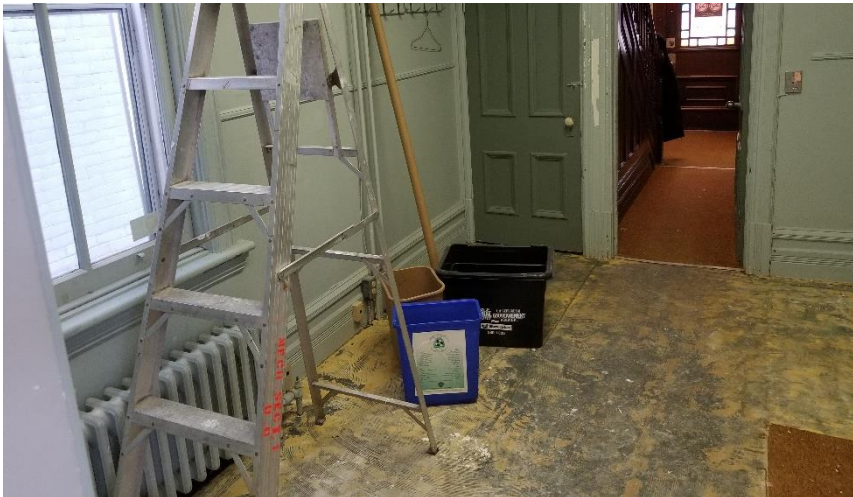
**Photo 5:** View on non-asbestos carpet mastic (yellow) on the main floor.

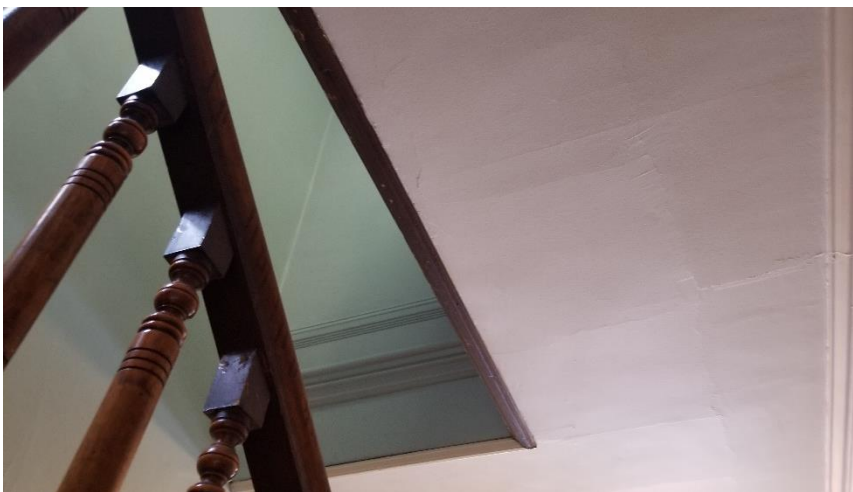
**Photo 6:** Typical new non-asbestos wall and ceiling plaster on the first floor and stairwell.

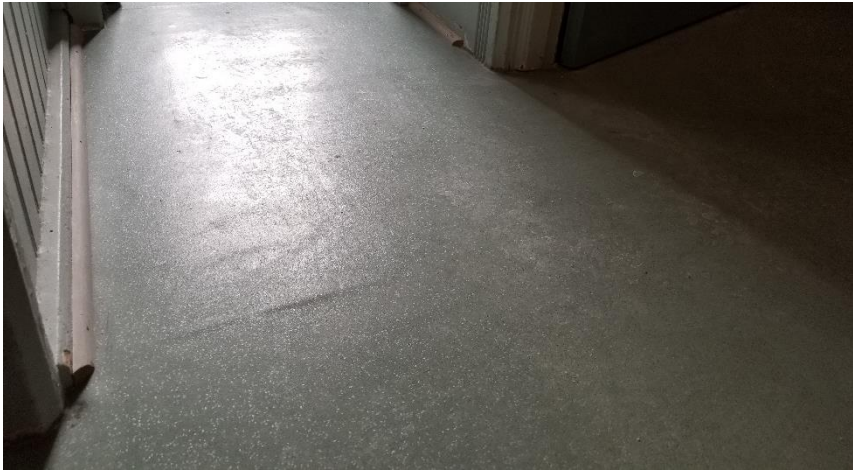
Vinyl Sheet Flooring (Blue/Green) was observed in Rooms 203, 203A, and 203C. The laboratory analytical results of the Vinyl Sheet Flooring samples collected from Room 203C indicate that this material does not contain asbestos. The associated mastic (Beige) was also found not to contain asbestos.

**Photo 7:** View of non-asbestos vinyl sheet flooring (blue-green) observed in room 203C.

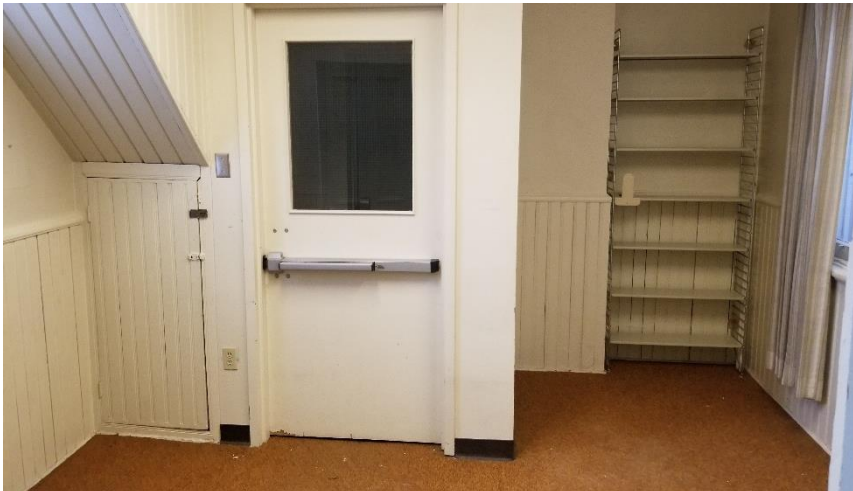
**Photo 8:** View of lead-containing white paint observed on the wall in Room 105.

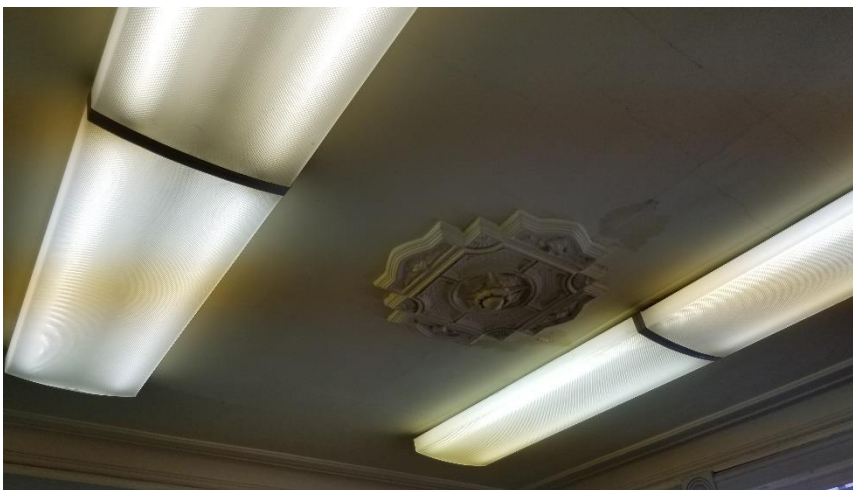
**Photo 9:** View of lead-containing beige paint observed on the ceiling in Room 102.

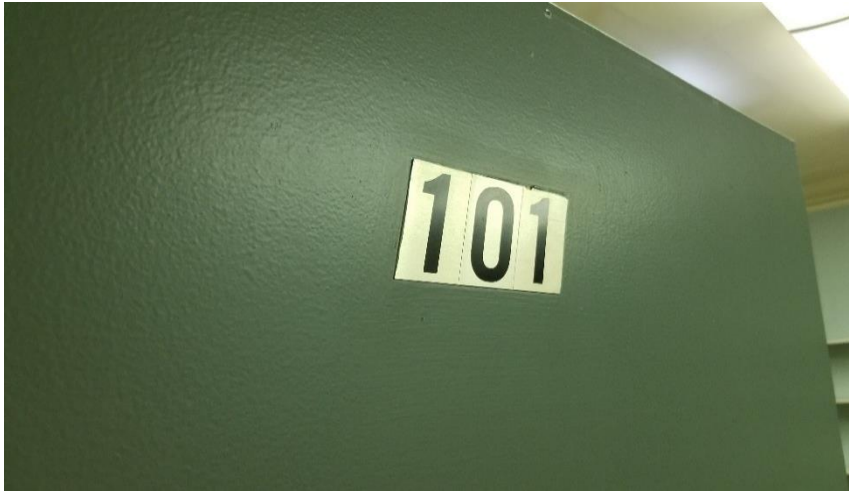
**Photo 10:** View of lead-containing green paint observed on the door of Room 101.

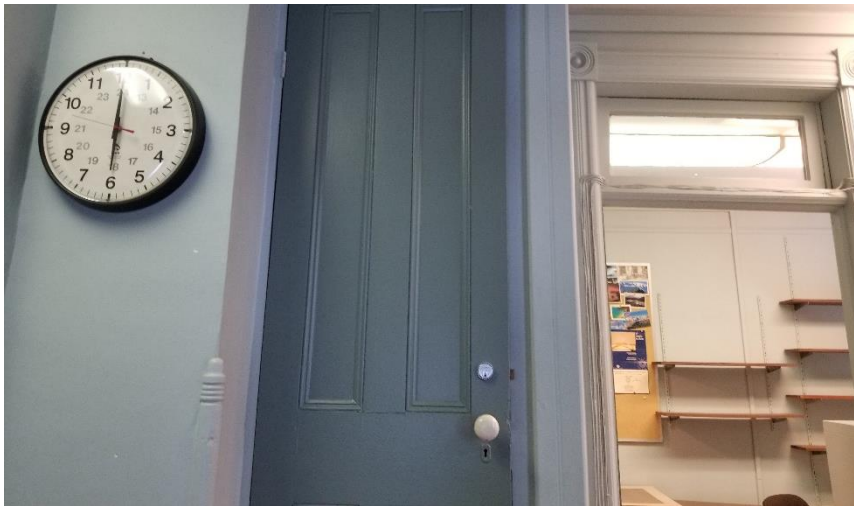
**Photo 11:** View of lead-containing light blue paint observed on the door of Room 203C

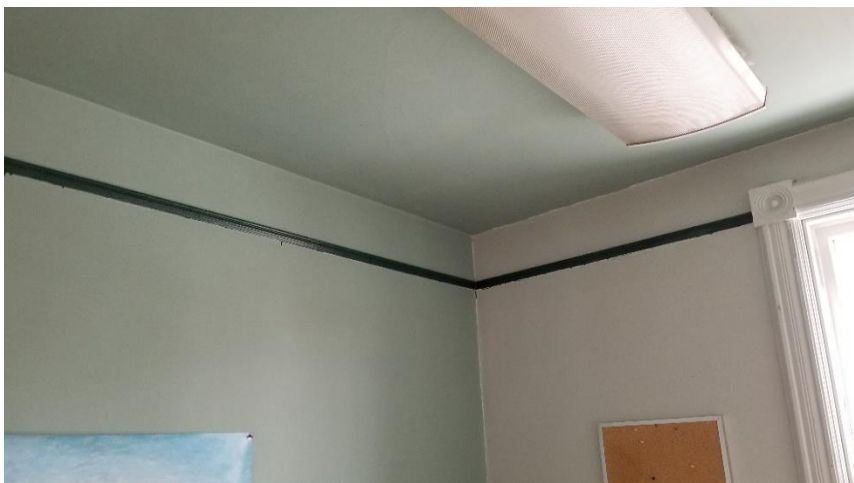
**Photo 12:** View of lead-containing light green paint observed on the wall in Room 206.

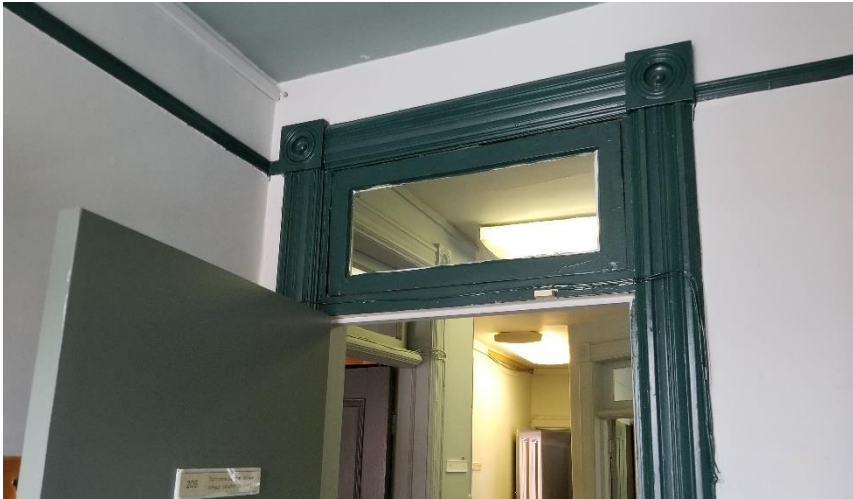
**Photo 13:** View of lead-containing dark green paint observed on the doorframe of Room 206.

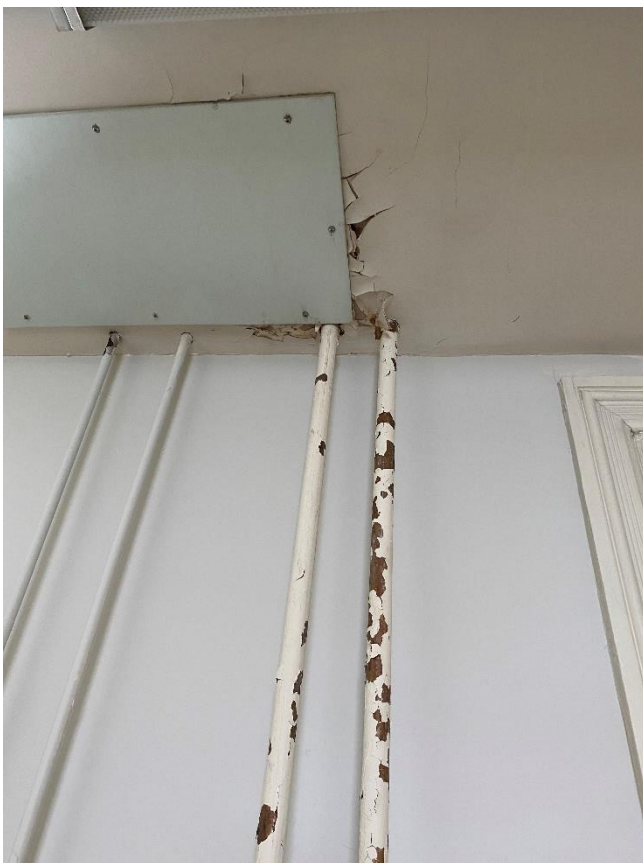
**Photo 14:** View of lead-containing beige paint on ceiling and white paint on the piping observed to be in poor condition in Room 105.

Paints identified to contain lead that is in poor condition must be immediately repaired and/or stabilized following a minimum Type 1/2 lead abatement procedures as per OMOL “Lead on Construction Project” dated April 2011.

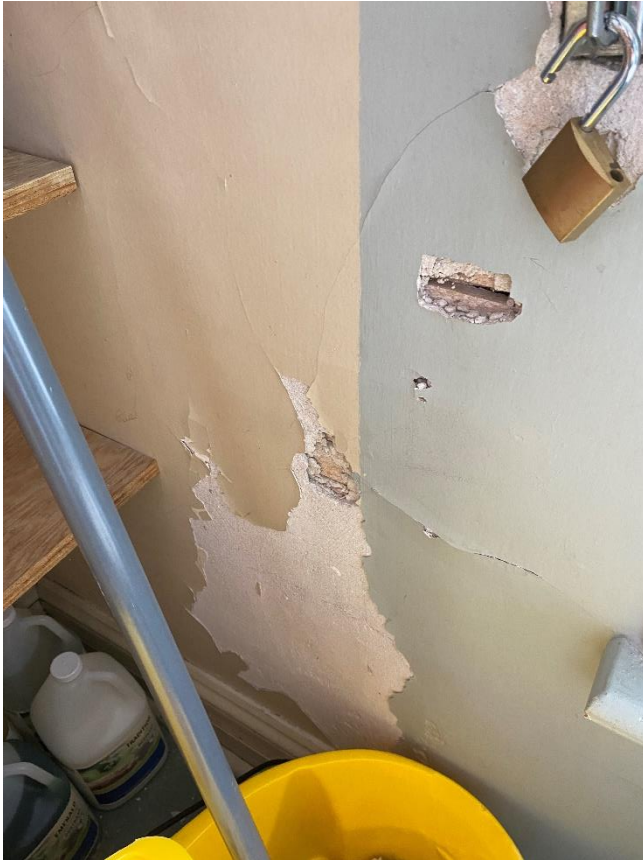
**Photo 15:** View of lead-containing blue paint on walls observed to be in poor condition in Room 205.

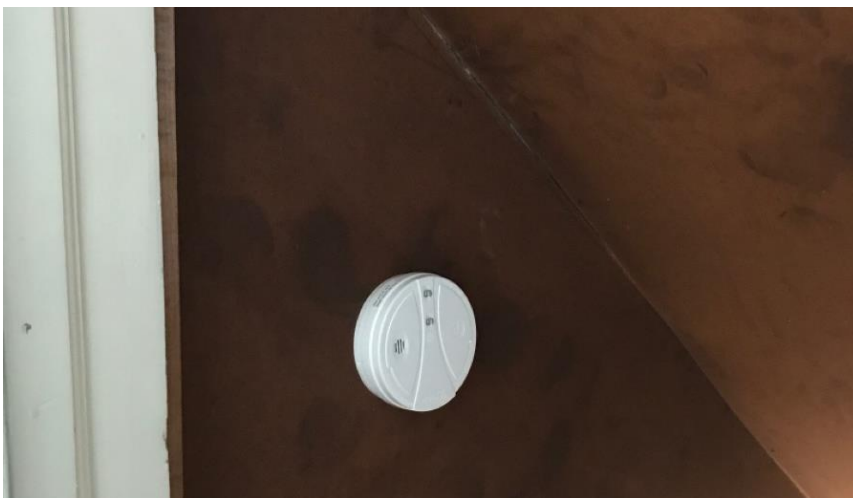
**Photo 16:** View of radioactive-containing smoke detector observed in Room B3.

The radioactive sources in smoke alarms are sealed and contained within a metal case inside the smoke detector and must not be damaged or tampered with. These materials do not pose a hazard as long as they remain contained and properly disposed of at the time of removal or replacement.

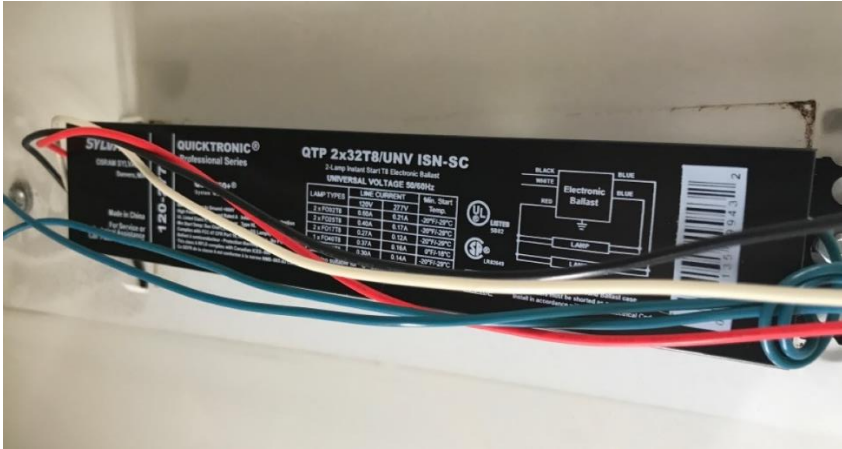
**Photo 17:** View of non-PCB containing Sylvania light ballast observed in Room 105.

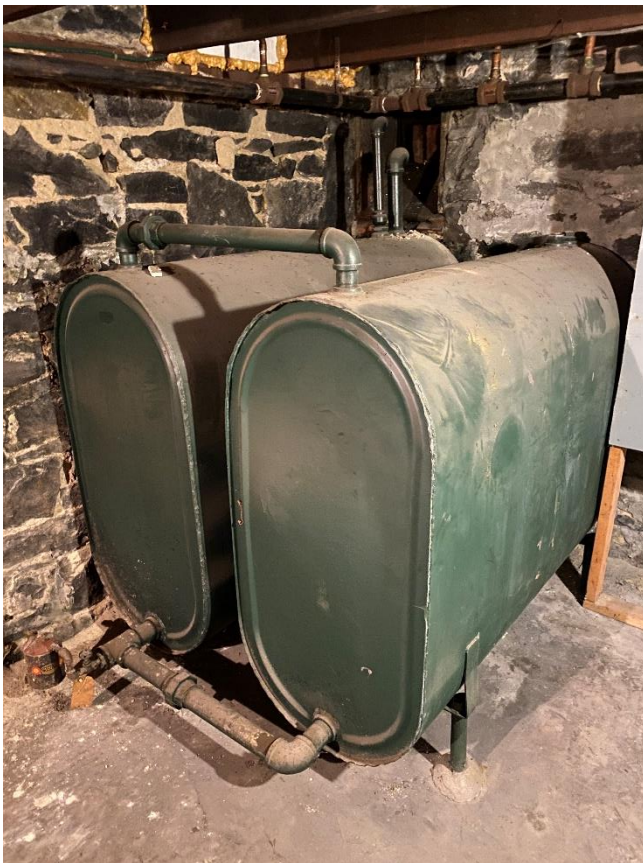
A visual survey of the subject building was conducted to determine if any USTs and ASTs were present. Two (2) ASTs were observed to be present in the basement of the surveyed area.

**Photo 18:** View of Above-ground Storage Tank (AST) observed to be present in the basement.
