# HAZARDOUS MATERIALS SURVEY AND 2023 REASSESSMENT 45 MANN AVENUE, OTTAWA, ON

Project No.: CCC-214243-00 / CCC-230252-00

University of Ottawa

December 06, 2023

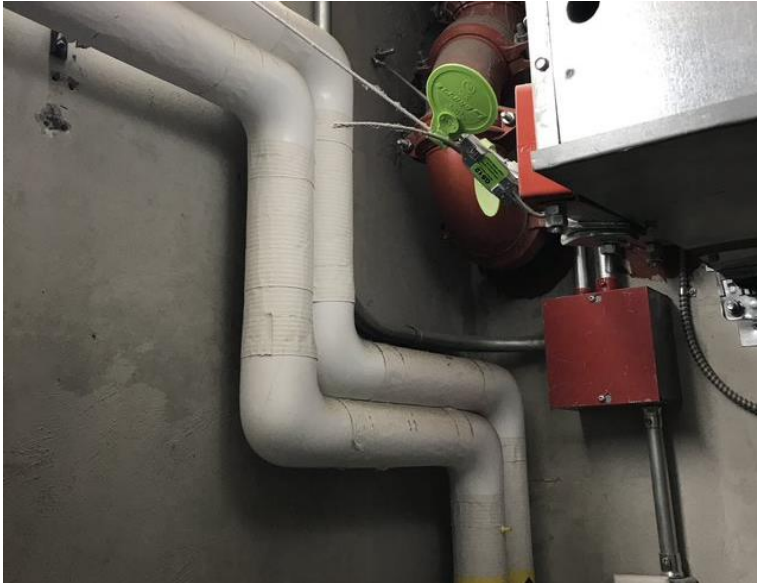
Mechanical pipe straight insulation was observed in the parking garage. MPL made several incisions throughout to investigate its composition, and it was visually identified as fiberglass, and therefore not suspected of containing asbestos.

Mechanical pipe elbows/fittings insulation was observed in the parking garage. MPL made several incisions throughout to investigate its composition, and it was visually identified as fiberglass, and therefore not suspected of containing asbestos.

Photo 1: View of fibreglass pipe insulation observed in the parking garage of the subject building.

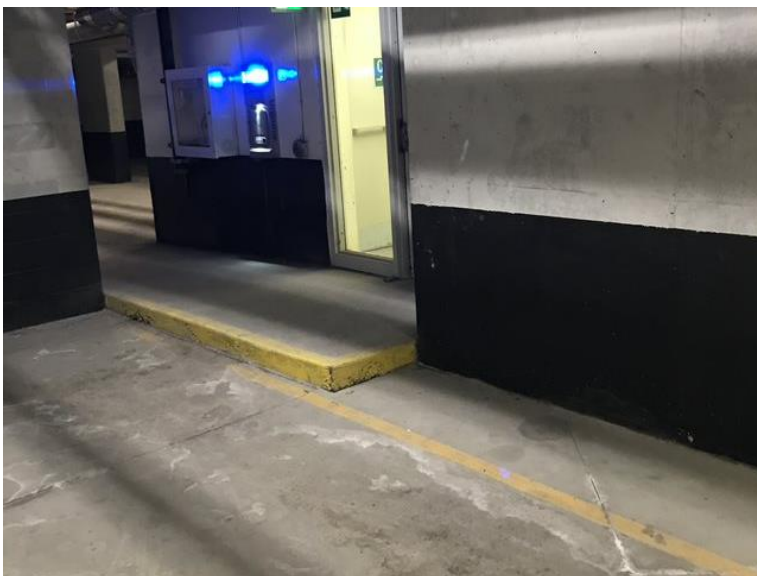
The paint finishes highlighted in blue in the above table were determined to contain low concentrations of lead which are less than or equal to 0.1%. These paint finishes were observed to be in good condition.

Photo 2: View of the low level lead paints (black and yellow) observed in the parking garage of the subject building.

Paints identified to contain lead that are in good condition and do not pose a risk to workers or occupants can be managed in place.
