HAZARDOUS MATERIALS SURVEY AND 2023 REASSESSMENT 62 HENDERSON AVENUE, OTTAWA, ON

Project No.: Z2021102HZ/ CCC-230252-00

University of Ottawa

McIntosh Perry Limited (MPL)

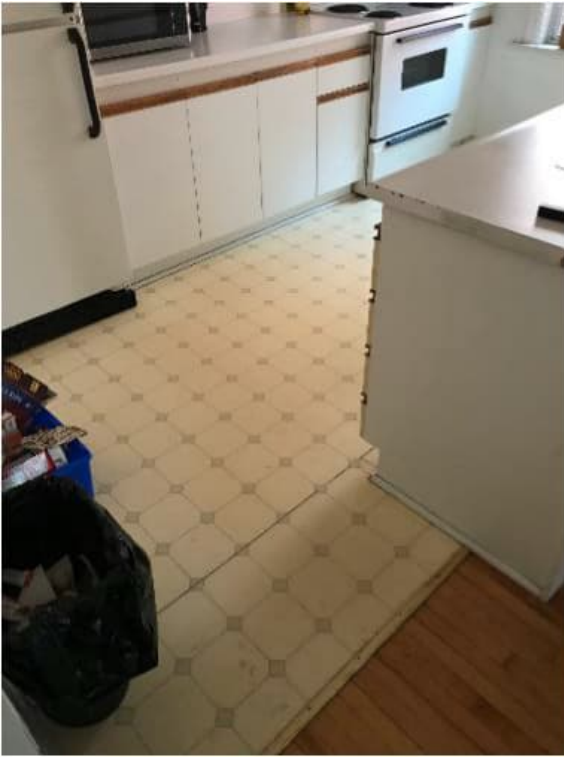
Photo 1: View of typical finishes observed at the building located at 62 Henderson Avenue.

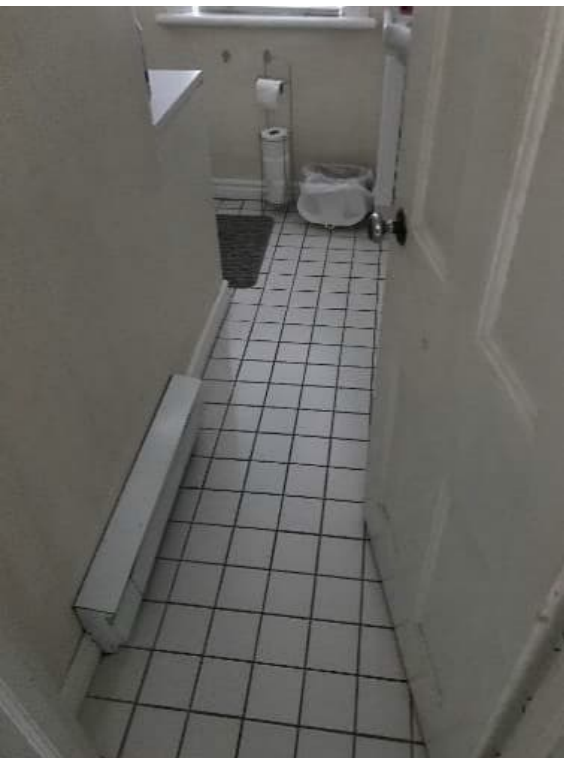
Photo 2: View of typical finishes observed at the building located at 62 Henderson Avenue.

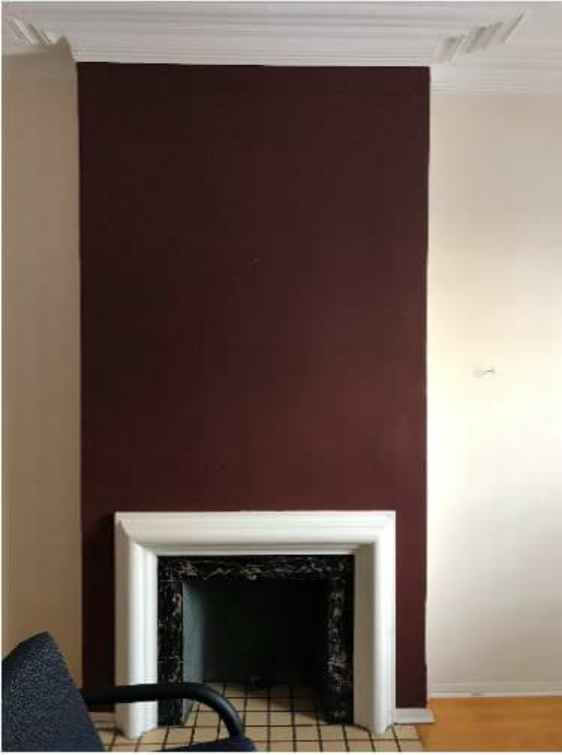
Photo 3: View of typical finishes observed at the building located at 62 Henderson Avenue.

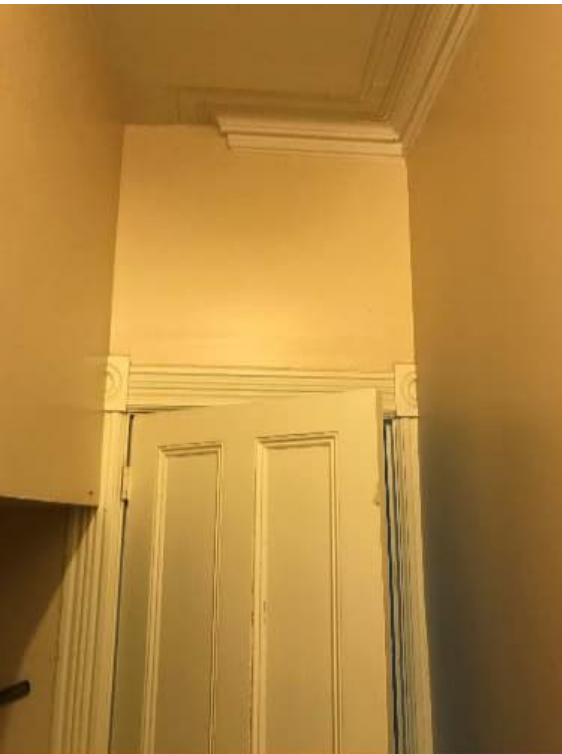
The paint finishes highlighted in pink in the above table are considered lead-containing paints or surface coatings with concentrations greater than 0.1% lead by weight. These paint finishes were observed to be in good condition.

Photo 4: View of lead-containing white trim paint observed in good condition.

Paints identified to contain lead that are in good condition and do not pose a risk to workers or occupants can be managed in place.

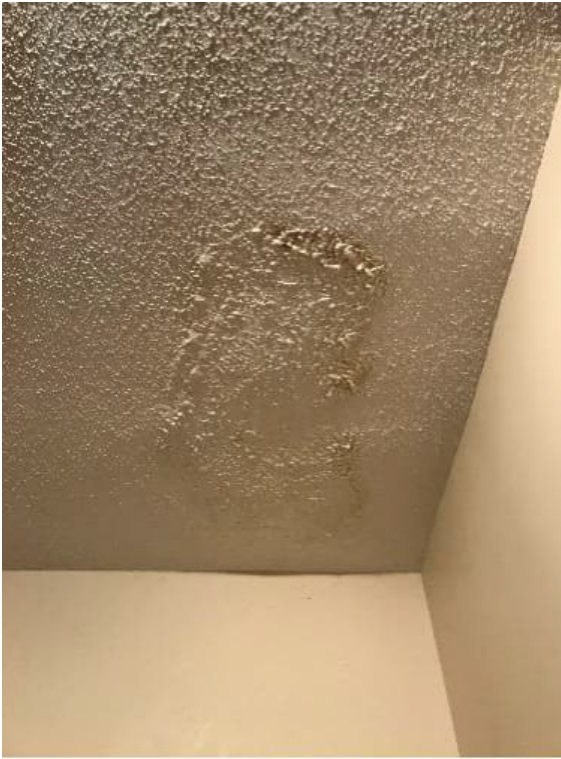
A visual survey of the subject building was conducted to determine if water damage was present. Select areas were identified throughout the subject building where materials were affected by water damage.

Photo 5: View of water-damaged texture coat in the bedroom on the first floor observed to be in poor condition.

Water stained/damaged ceiling texture coat observed throughout the subject building should be replaced as part of regular maintenance, and the underlying cause of the water leakage should be identified and repaired;

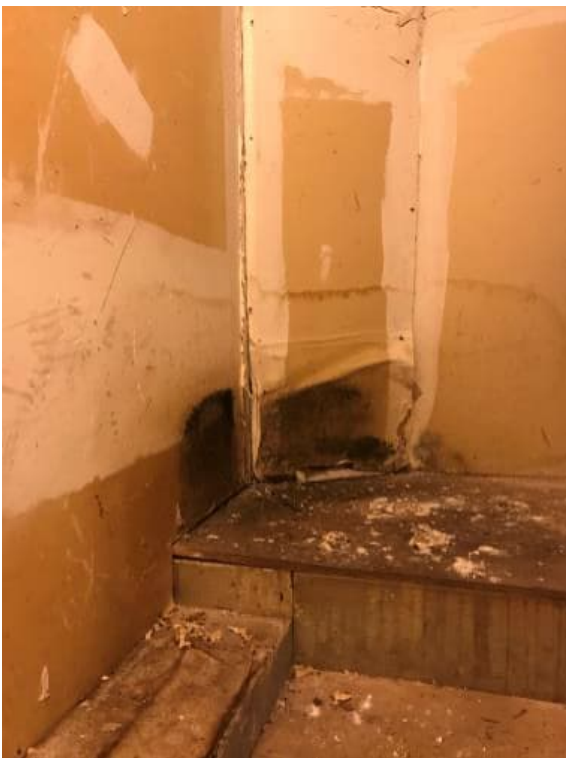
Photo 6: View of water damage/mould growth observed at the top of the basement stairs.

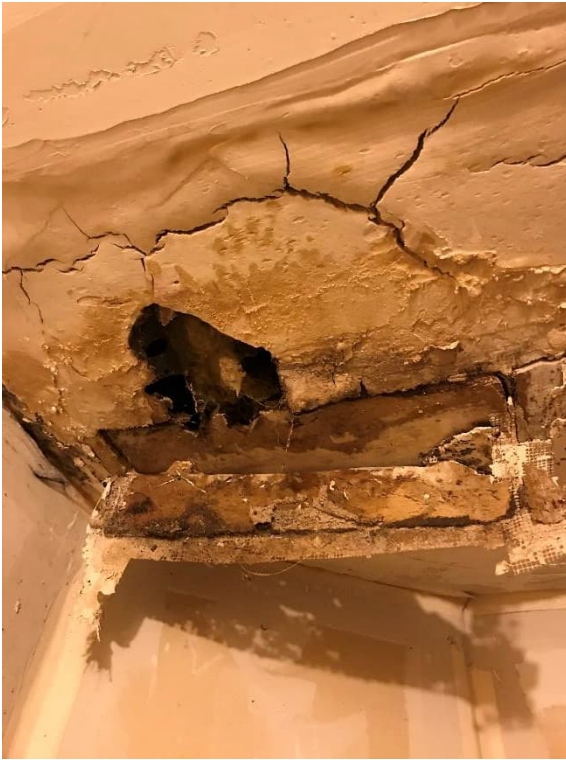
Photo 7: View of water damage/mould growth observed at the top of the basement stairs.

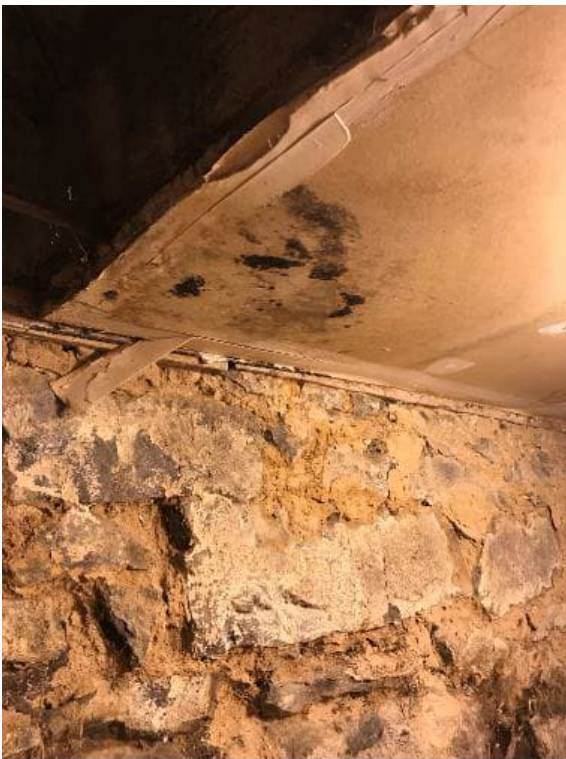
Photo 8: View of mould growth observed on the ceiling in the basement.

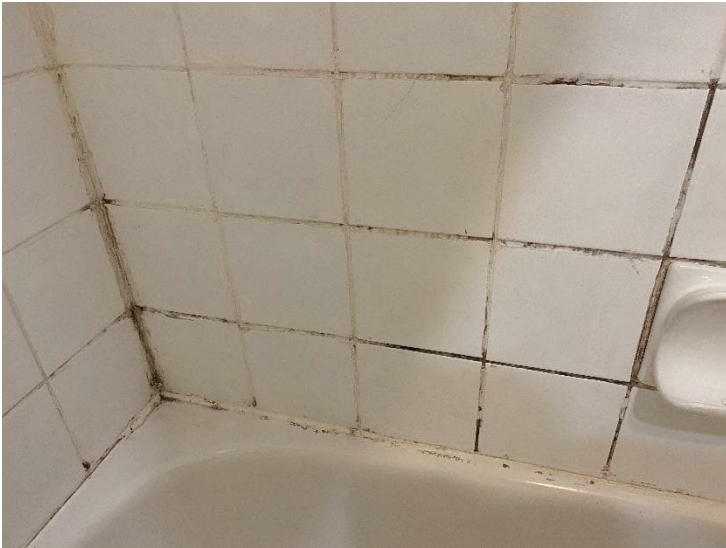
Photo 9: View of mould growth observed on the wall grout in the bathroom.

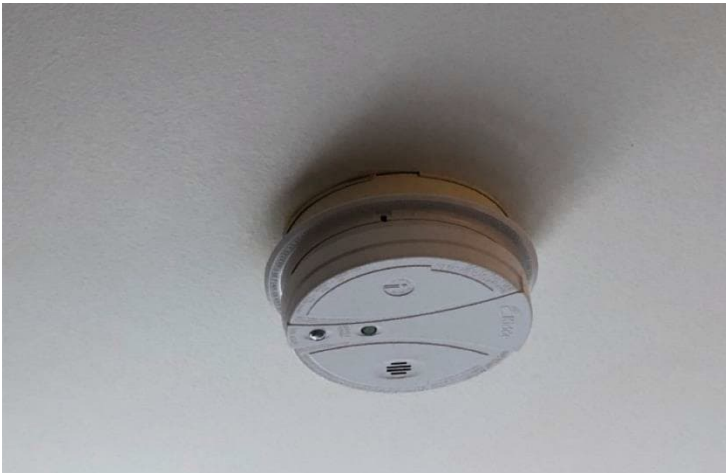
A visual assessment of the subject building was conducted to determine if any electrical components containing radioactive materials were present. Smoke detectors were observed throughout the subject building, which contained small quantities of radioactive material.

Photo 10: Typical view of smoke detectors containing radioactive materials.

The radioactive sources in smoke alarms are sealed and contained within a metal case inside the smoke detector and must not be damaged or tampered with. These materials do not pose a hazard as long as they remain contained and properly disposed of at the time of removal or replacement.

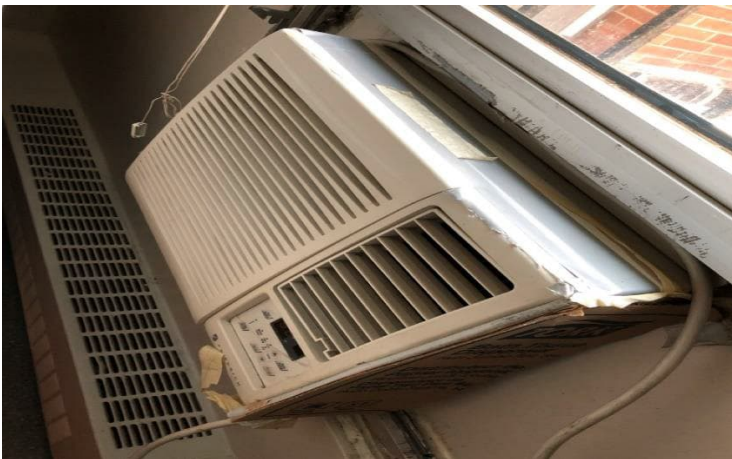
A visual assessment for equipment potentially containing ODSs and other halocarbons was conducted. MPL observed equipment such as refrigerators which have or are suspected of containing ODSs or other halocarbons.

Photo 11: Typical view of ODS containing air-conditioning unit.
