# HAZARDOUS MATERIALS SURVEY AND 2023 REASSESSMENT 62 TEMPLETON STREET, OTTAWA, ON

Project No.: Z2021102HZ / CCC-230252-00

University of Ottawa

McIntosh Perry Limited (MPL)

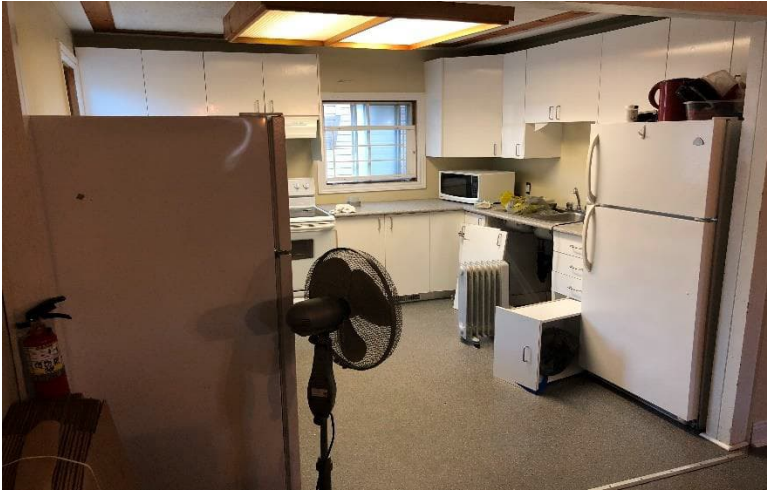
**Photo 1:** Typical view of finishes observed at 62 Templeton Street.

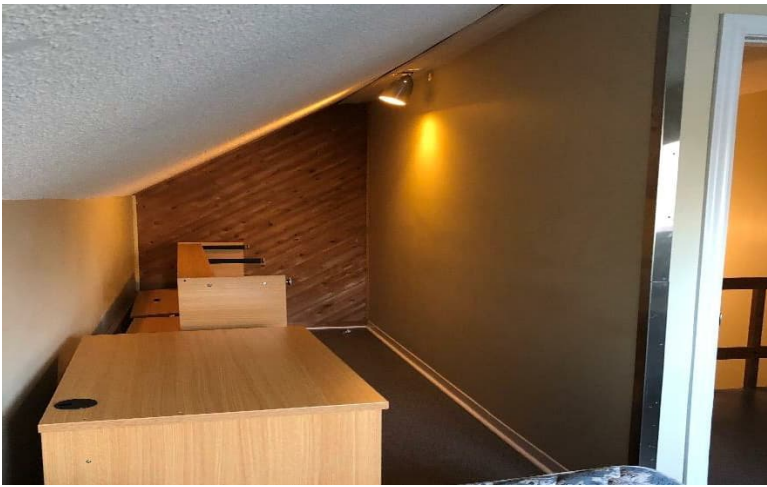
**Photo 2:** Typical view of finishes observed at 62 Templeton Street.

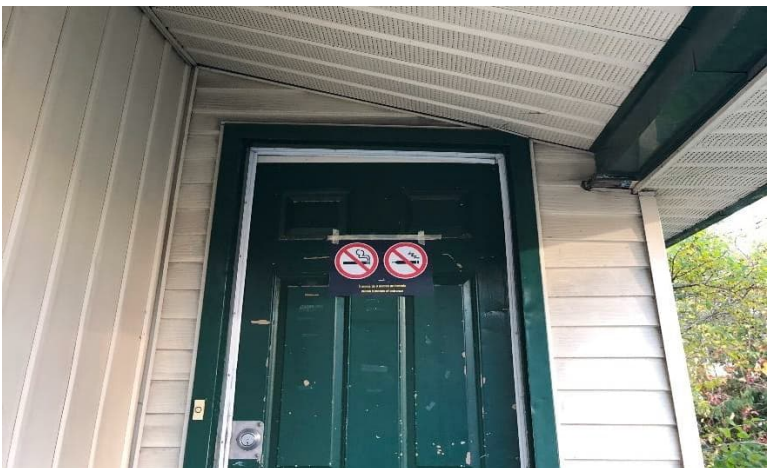
**Photo 3:** View of lead-containing green paint observed to be in poor condition on the front exterior door.

Paints identified to contain lead that are in poor condition must be immediately repaired and/or stabilized following a minimum Type 1/2 lead abatement procedures as per OMOL “Lead on Construction Project” dated April 2011.

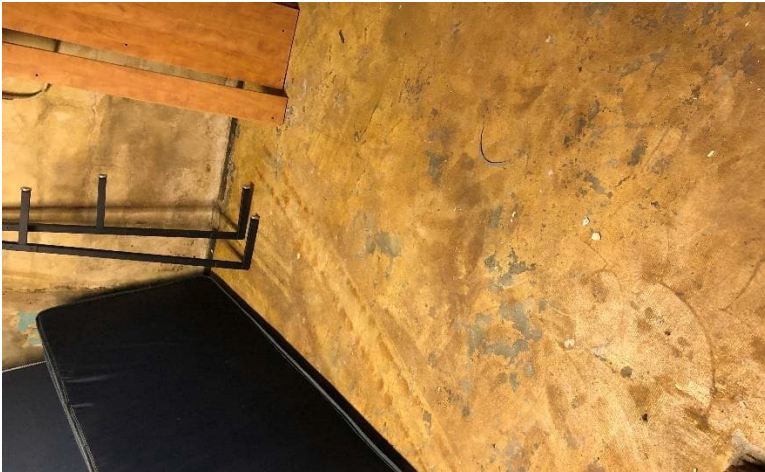
**Photo 4:** View of lead-containing yellow paint observed to be in poor condition on the concrete floor in the basement (photo taken post-flood remediation work by Xpertek in October 2020).

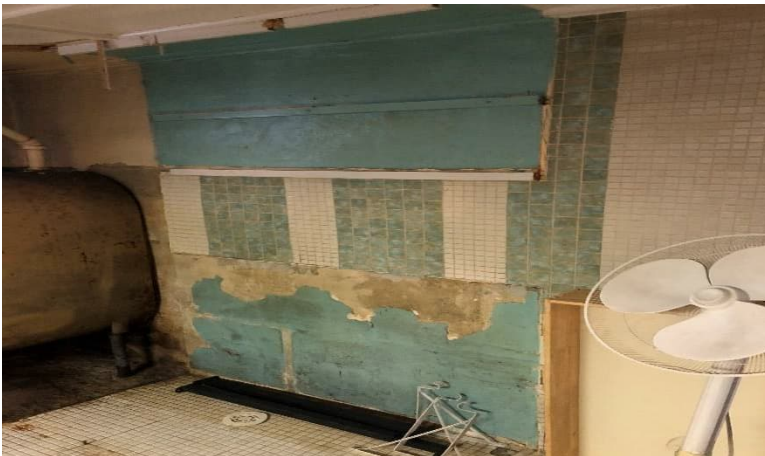
**Photo 5:** View of lead-containing aqua blue paint observed to be in poor condition on the walls in the laundry room throughout the basement (photo taken post-flood remediation work by Xpertek in October 2020).

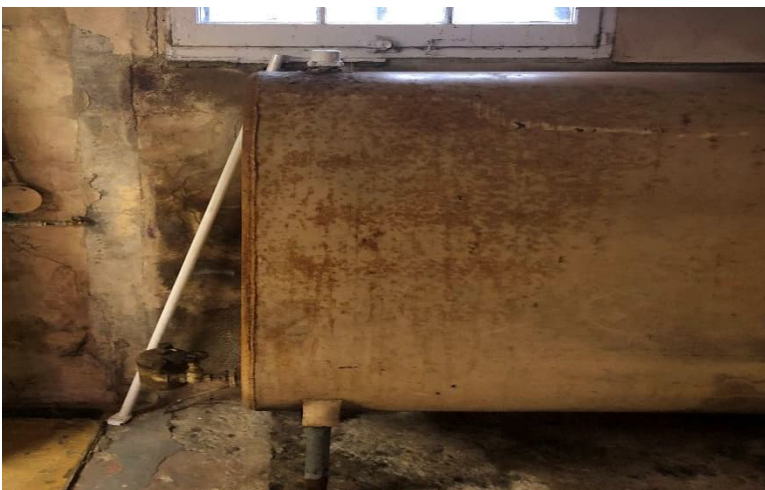
A visual survey of the subject building was conducted to determine if any USTs and ASTs were present. One (1) diesel storage tank was observed in the basement of the subject building.

**Photo 6:** View of AST observed throughout the basement of the subject building (photo taken post-flood remediation work by Xpertek in October 2020).

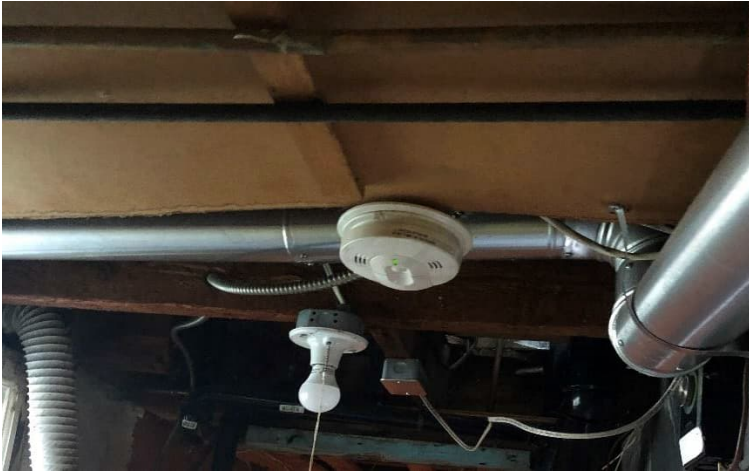
A visual assessment of the subject building was conducted to determine if any electrical components containing radioactive materials were present. Smoke detectors were observed throughout the subject building which contain small quantities of radioactive material.

**Photo 7:** Typical view of smoke detectors containing radioactive material.

The radioactive sources in smoke alarms are sealed and contained within a metal case inside the smoke detector and must not be damaged or tampered with. These materials do not pose a hazard as long as they remain contained and properly disposed of at the time of removal or replacement.
