# HAZARDOUS MATERIALS SURVEY AND 2023 REASSESSMENT 102 HENDERSON AVENUE, OTTAWA, ON

Project No.:0Z2021101HZ/ CCC-230252-00

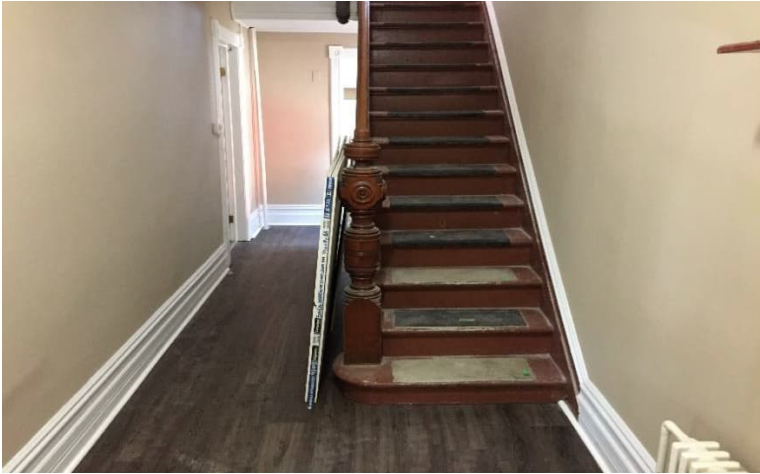
**Photo 1:** View of typical finishes observed at the building located at 102 Henderson Avenue.

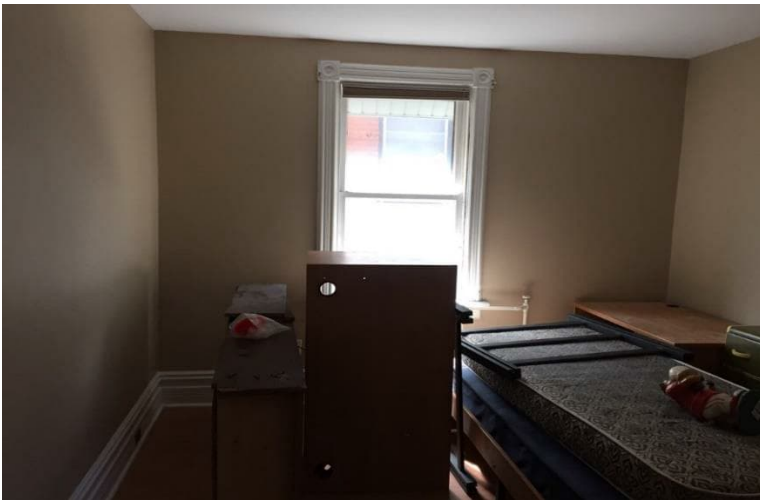
**Photo 2:** View of typical finishes observed at the building located at 102 Henderson Avenue.

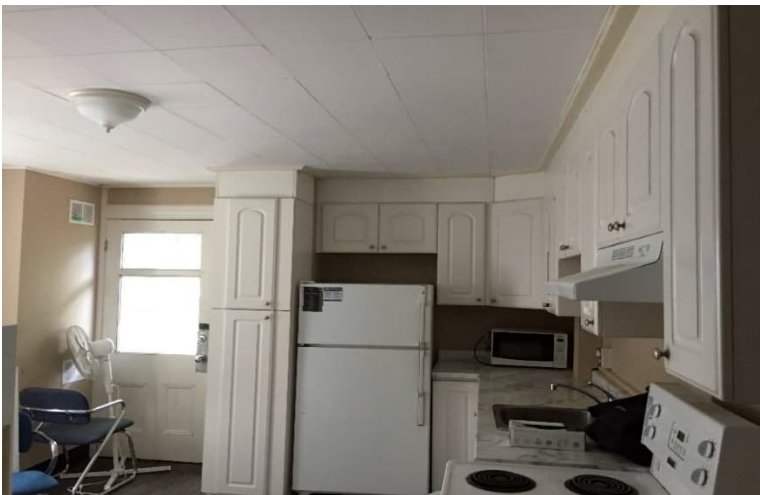
**Photo 3:** View of typical finishes observed at the building located at 102 Henderson Avenue.

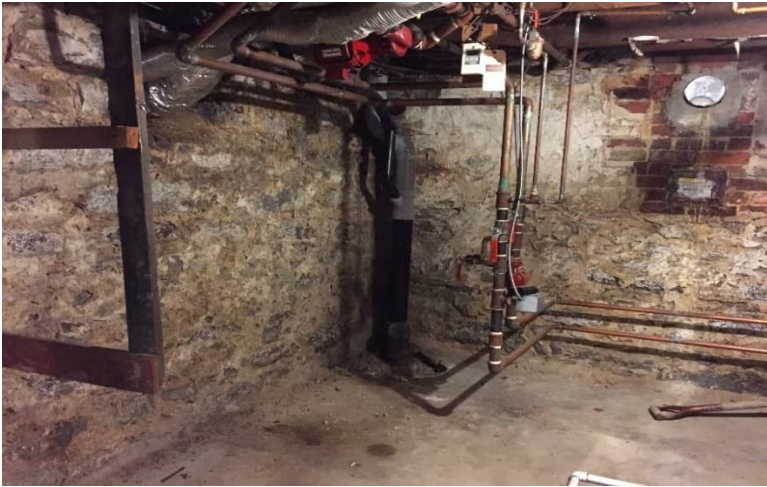
**Photo 4:** View of typical finishes observed at the building located at 102 Henderson Avenue.

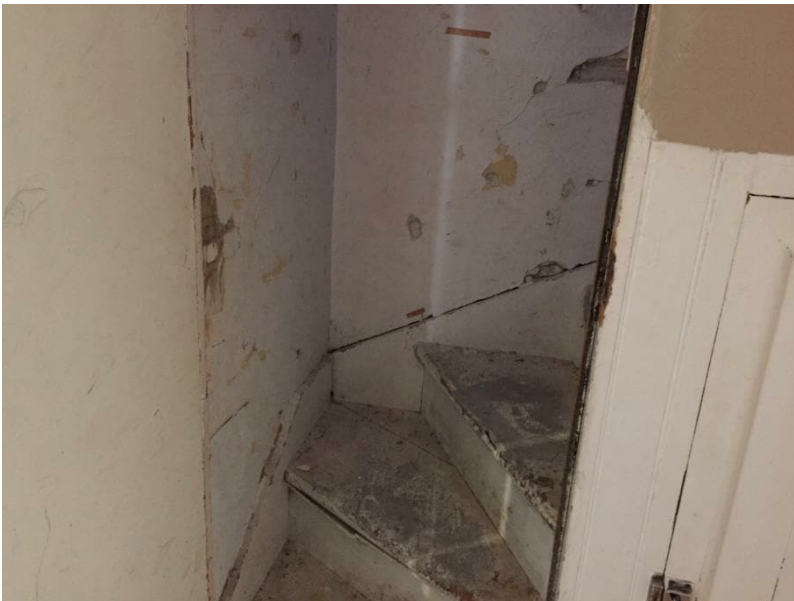
**Photo 5:** View of asbestos-containing wall plaster observed to be in poor condition in the stairwell to the 3<sup>rd</sup> floor of the subject building.

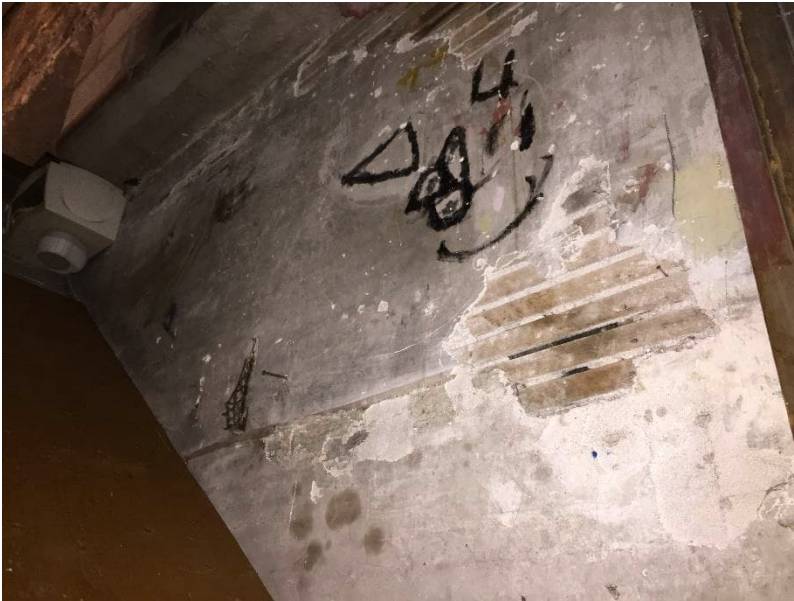
**Photo 6:** View of asbestos-containing wall plaster observed to be in poor condition in the stairwell to the basement of the subject building.

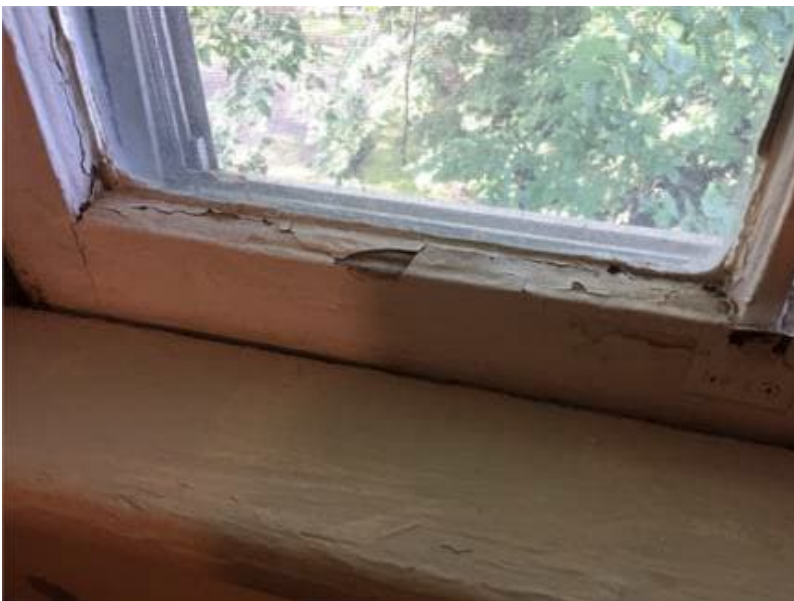
**Photo 7:** View of lead-containing white paint observed to be in poor condition in Room E on the 2<sup>nd</sup> floor of the subject building.

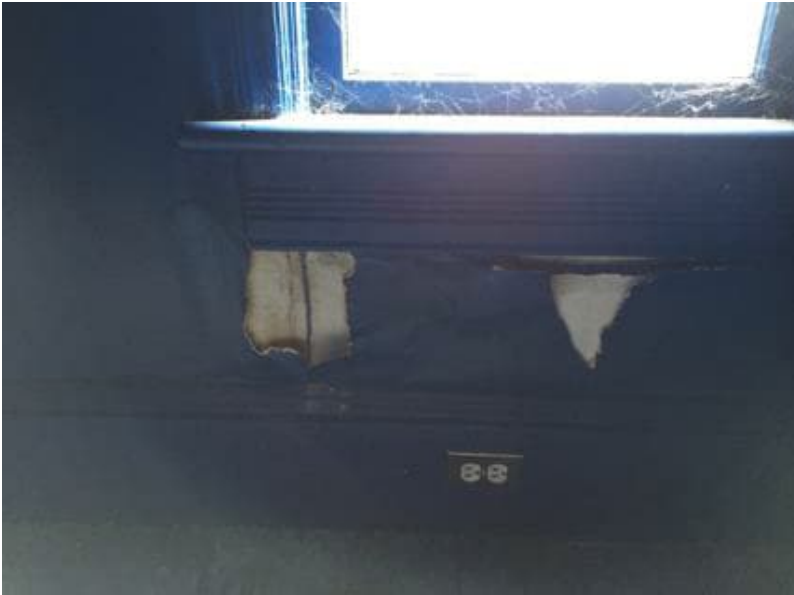
**Photo 8:** View of lead-containing blue paint observed to be in poor condition on the 3<sup>rd</sup> floor of the subject building.

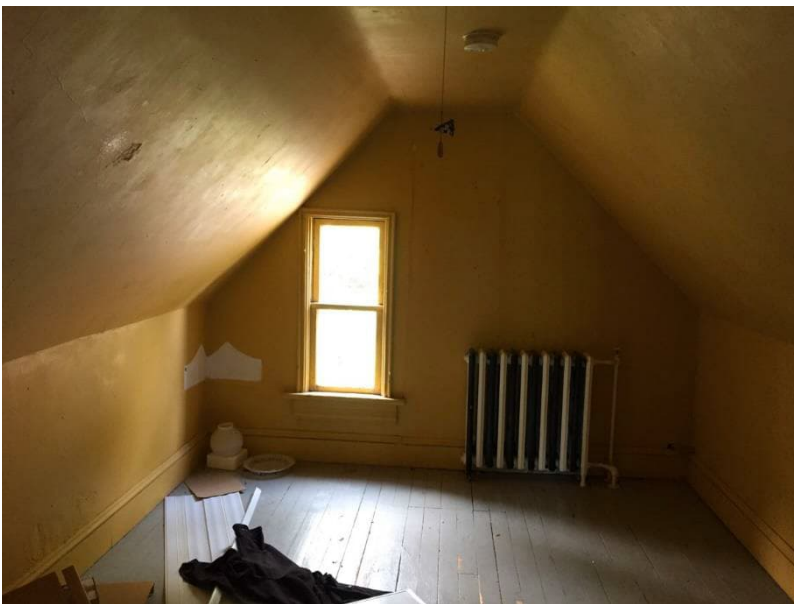
**Photo 9:** View of lead-containing yellow paint observed to be in poor condition on the 3<sup>rd</sup> floor of the subject building.

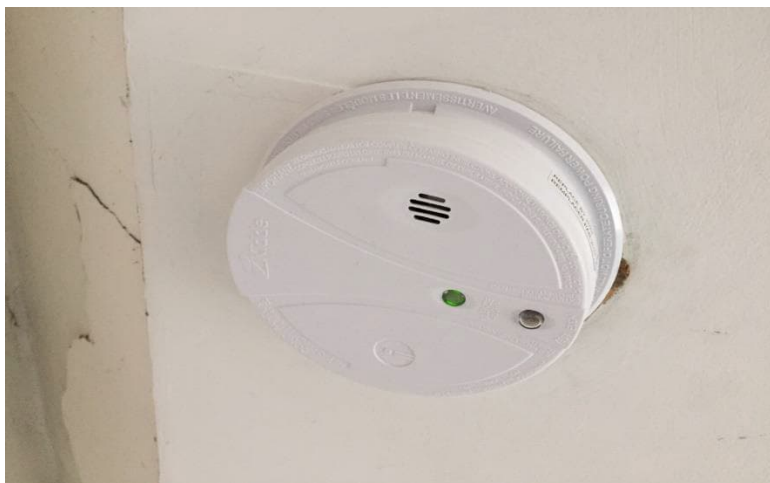
**Photo 10:** Typical view of smoke detectors containing radioactive materials.
